Figure 2  
 INVESTIGATION LOCATIONS  
 AND PROPERTY LAYOUT  
 Duluth Waterfront Property  
 Duluth, Minnesota

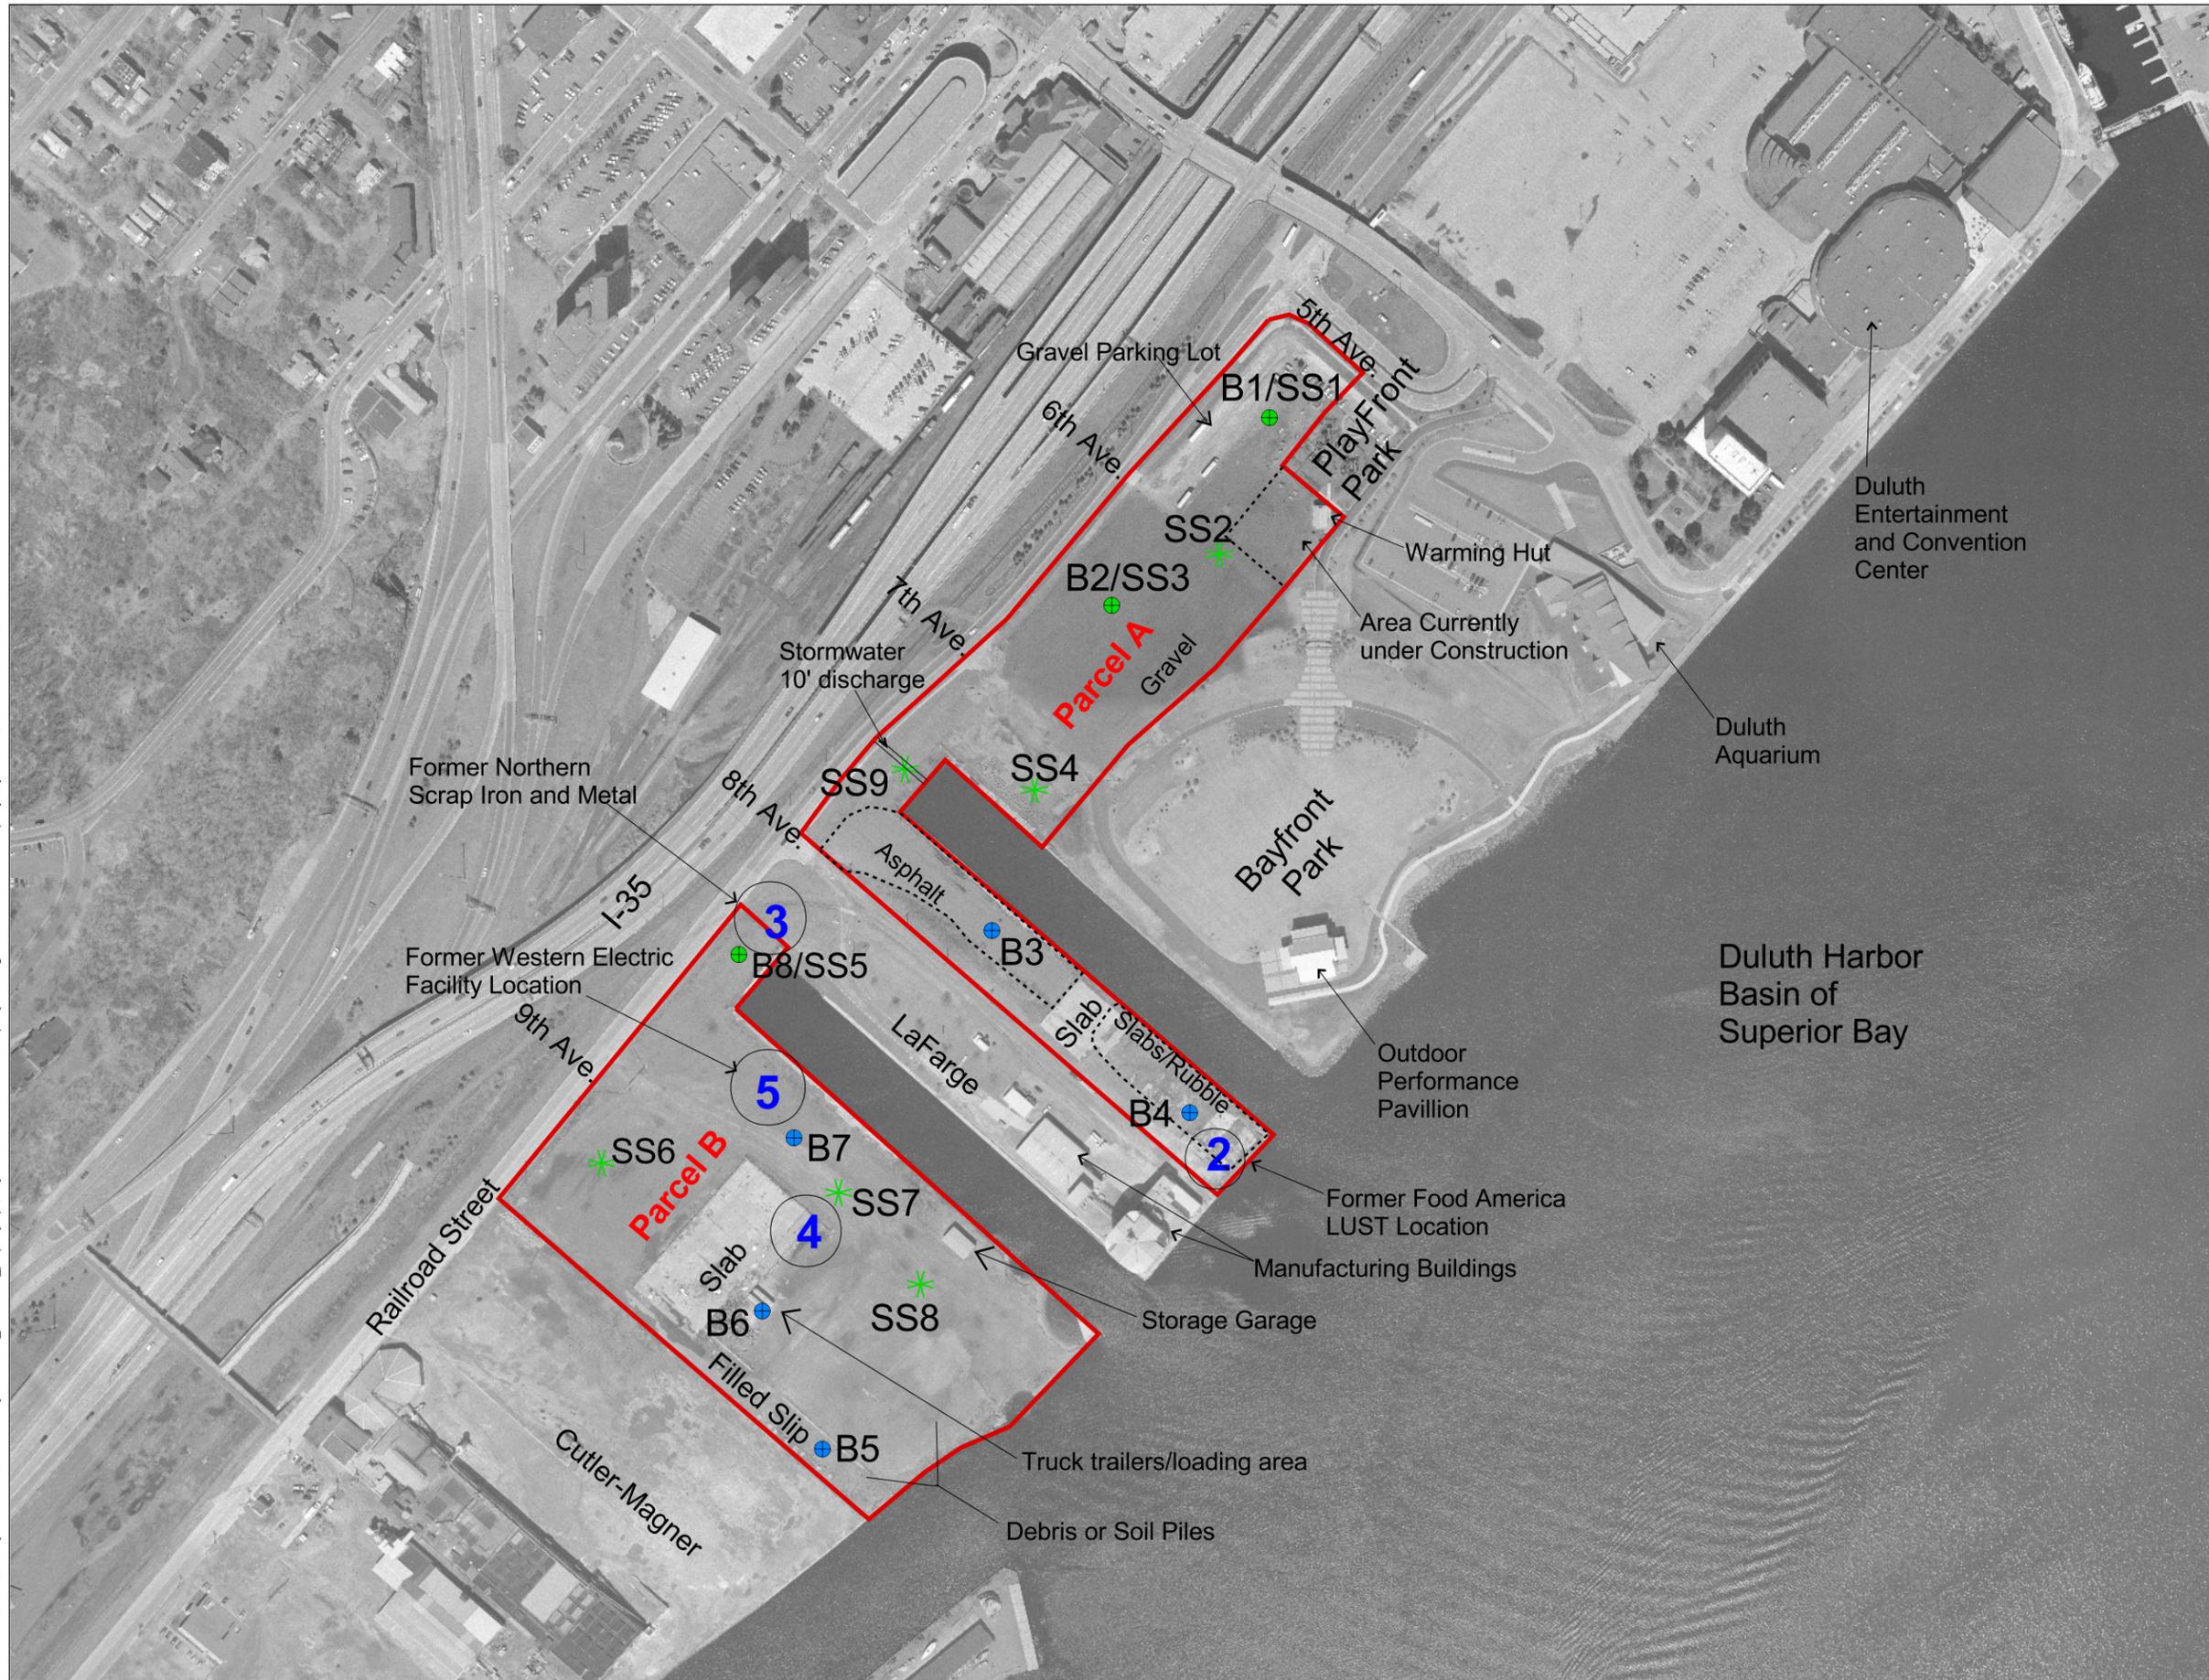
Note: An abandoned pipeline associated with former manufactured gas operations is reported along the northwest boundaries of both parcels.
