# ST. LOUIS RIVER CORRIDOR PARKS MINI-MASTER PLANS

JUNE 2016

This document is a compilation of mini-master plans for 11 neighborhood and multi-use parks in the St. Louis River Corridor. Each park's mini-master plan is a chapter in the document. The parks, from west to east, are: Historical Park, Fond du Lac Park, Blackmer Park, Riverside Park, Smithville Park, Norton Park, Grassy Point Park, Keene Creek Park, Merritt Community Recreation Area, Harrison Community Recreation Area, and Piedmont Community Recreation Area. Each park is unique in setting, context, use, issues, and needs.

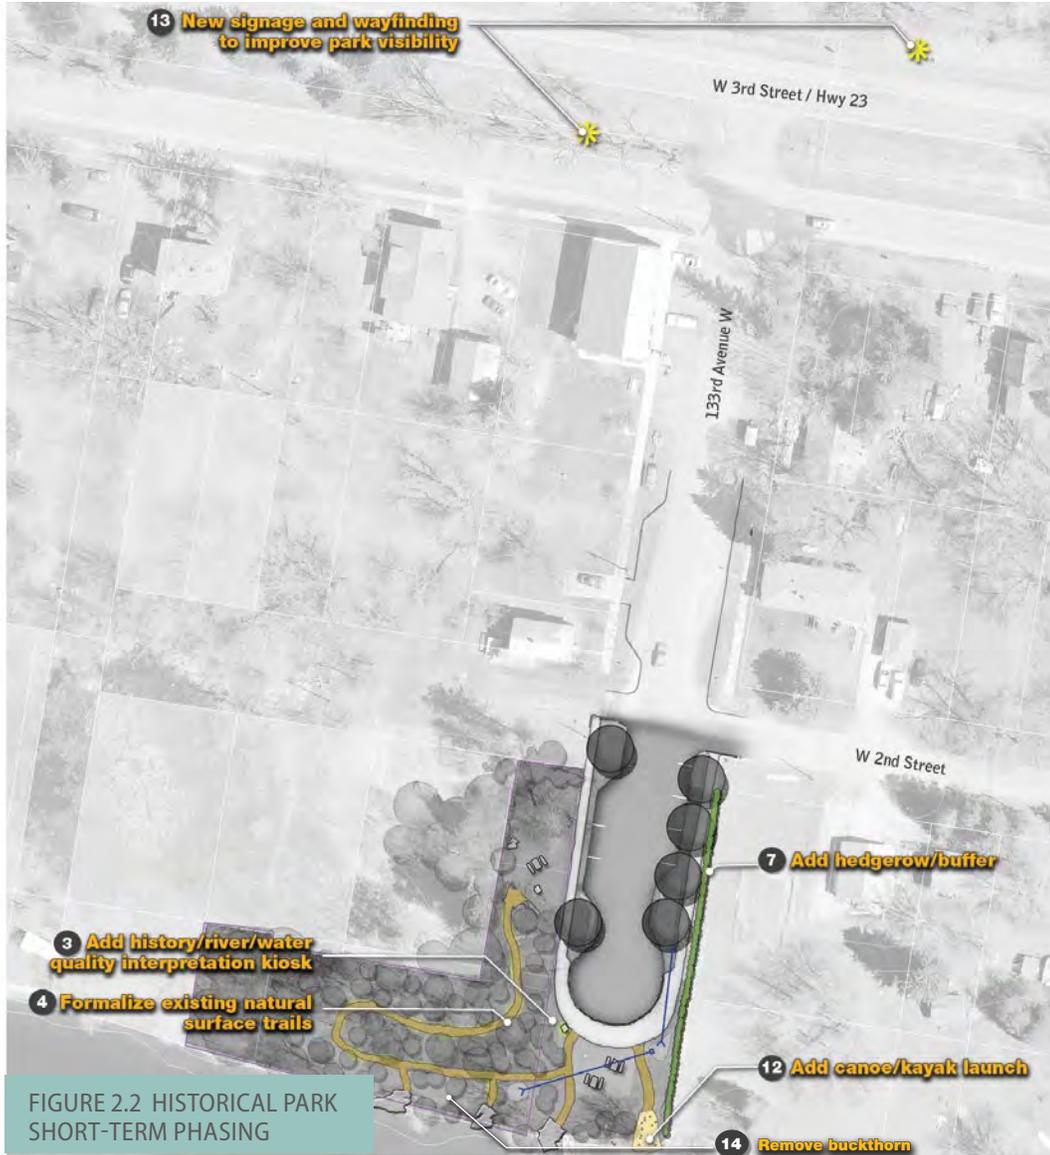
FIGURE 2.2 HISTORICAL PARK SHORT-TERM PHASING

ACTION			COST
#	CATEGORY	DESCRIPTION	
3	Circulation	Install New Kiosk	\$7,500
4	Circulation	Formalize Existing Nature Surface Trails	\$2,100
7	Vegetation	Add hedgerow/buffer	\$1,600
12	Recreation	Build New Canoe/Kayak Launch	\$5,000
13	Circulation	Install New Park Wayfinding Sign	\$2,000
14	Vegetation	Remove buckthorn and other invasive species	\$5,000
Total Short-Term Improvement Costs			\$23,200

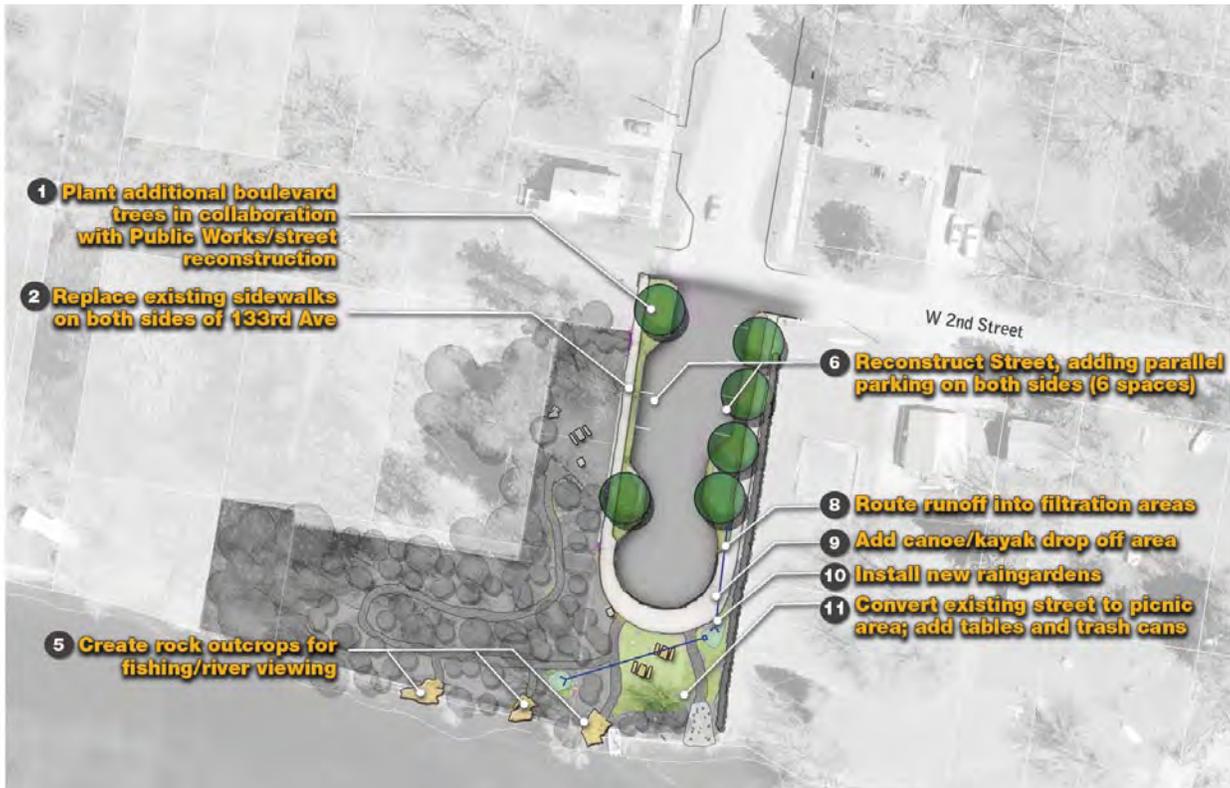
FIGURE 2.3 HISTORICAL PARK LONG-TERM PHASING

ACTION			COST
#	CATEGORY	DESCRIPTION	
1	Vegetation	Plant Additional Boulevard Trees	\$2,800
2	Circulation	Replace Existing Sidewalk on 133rd Ave	\$21,000
5	Recreation	Create Rock Outcrop for Fishing/Viewing	\$60,000
6	Infrastructure	Reconstruct Street	\$-
8	Stormwater	Route street runoff into parkland	\$6,750
9	Stormwater	Install New Raingarden/Filtration Areas	\$6,750
10	Circulation	Add New Canoe/Kayak Drop-Off Area	\$5,600
11	Furnishings	Convert Existing Street Into Picnic Area - Add Picnic Tables & Trash Cans	\$5,000
Total Long-Term Improvement Costs			\$105,100
Total Short-Term Improvement Costs			\$ 23,200
Total Improvement Costs			\$128,300

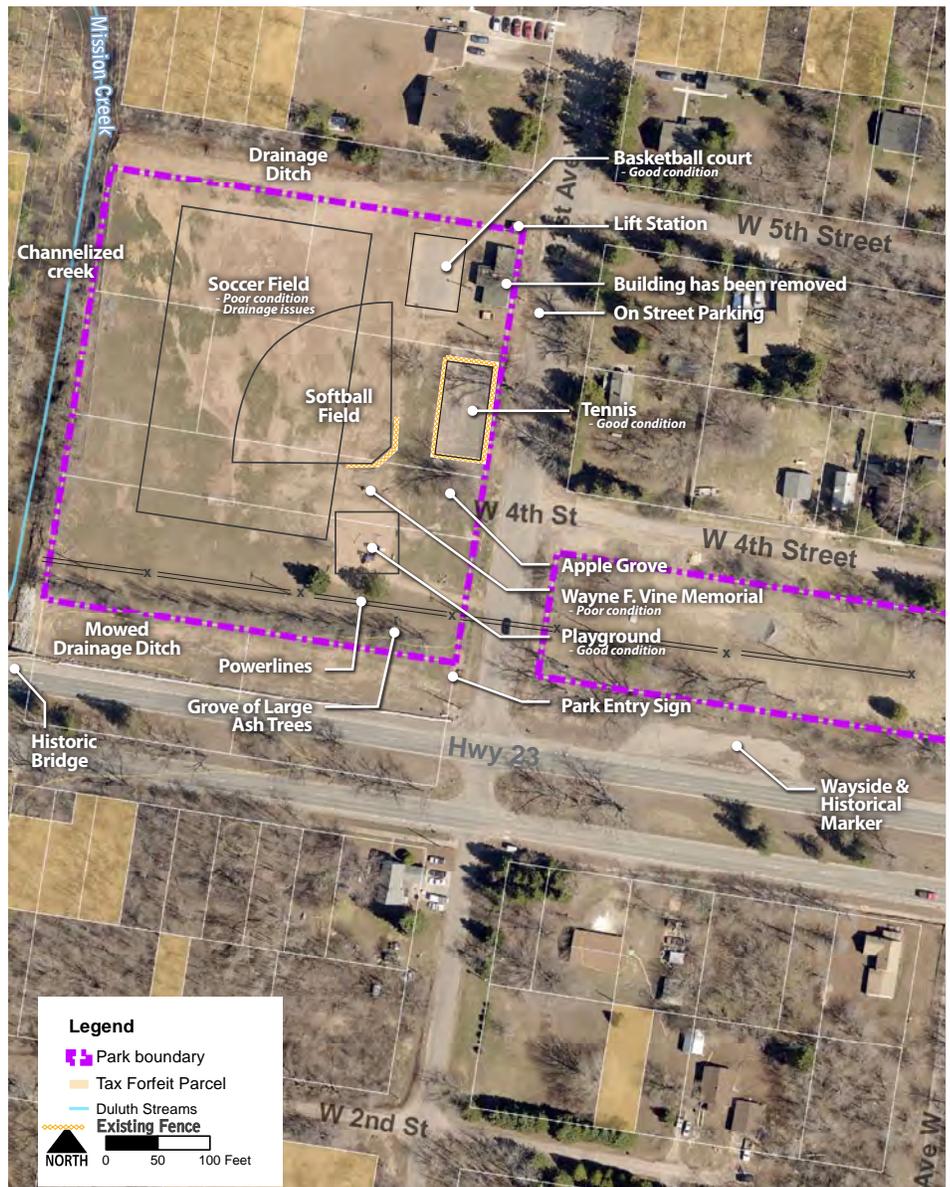
FOND DU LAC PARK SITE INVENTORY

- » Memorial has been damaged – missing a piece
- » Stormwater drainage is an issue throughout the park, field damage still exists from 2012 flooding
- » Some ATV traffic through the park has been an issue

Fond du Lac Park contains a playground, basketball court, and tennis court, which are all in good condition. Overlapping soccer and softball fields are in need of regrading and improved turf conditions. A park building was recently removed. An apple tree grove and memorial are located near the playground. The park has good vehicle access from Hwy 23 and pedestrian access for residents who live north of Hwy 23. Powerlines and poles run along the southern edge of the park between the recreation area and Hwy 23. An existing wayside and historical marker along Hwy 23 are part of the eastern portion of the park, which is unused today. Hwy 23 is currently being reconstructed by MNDOT.

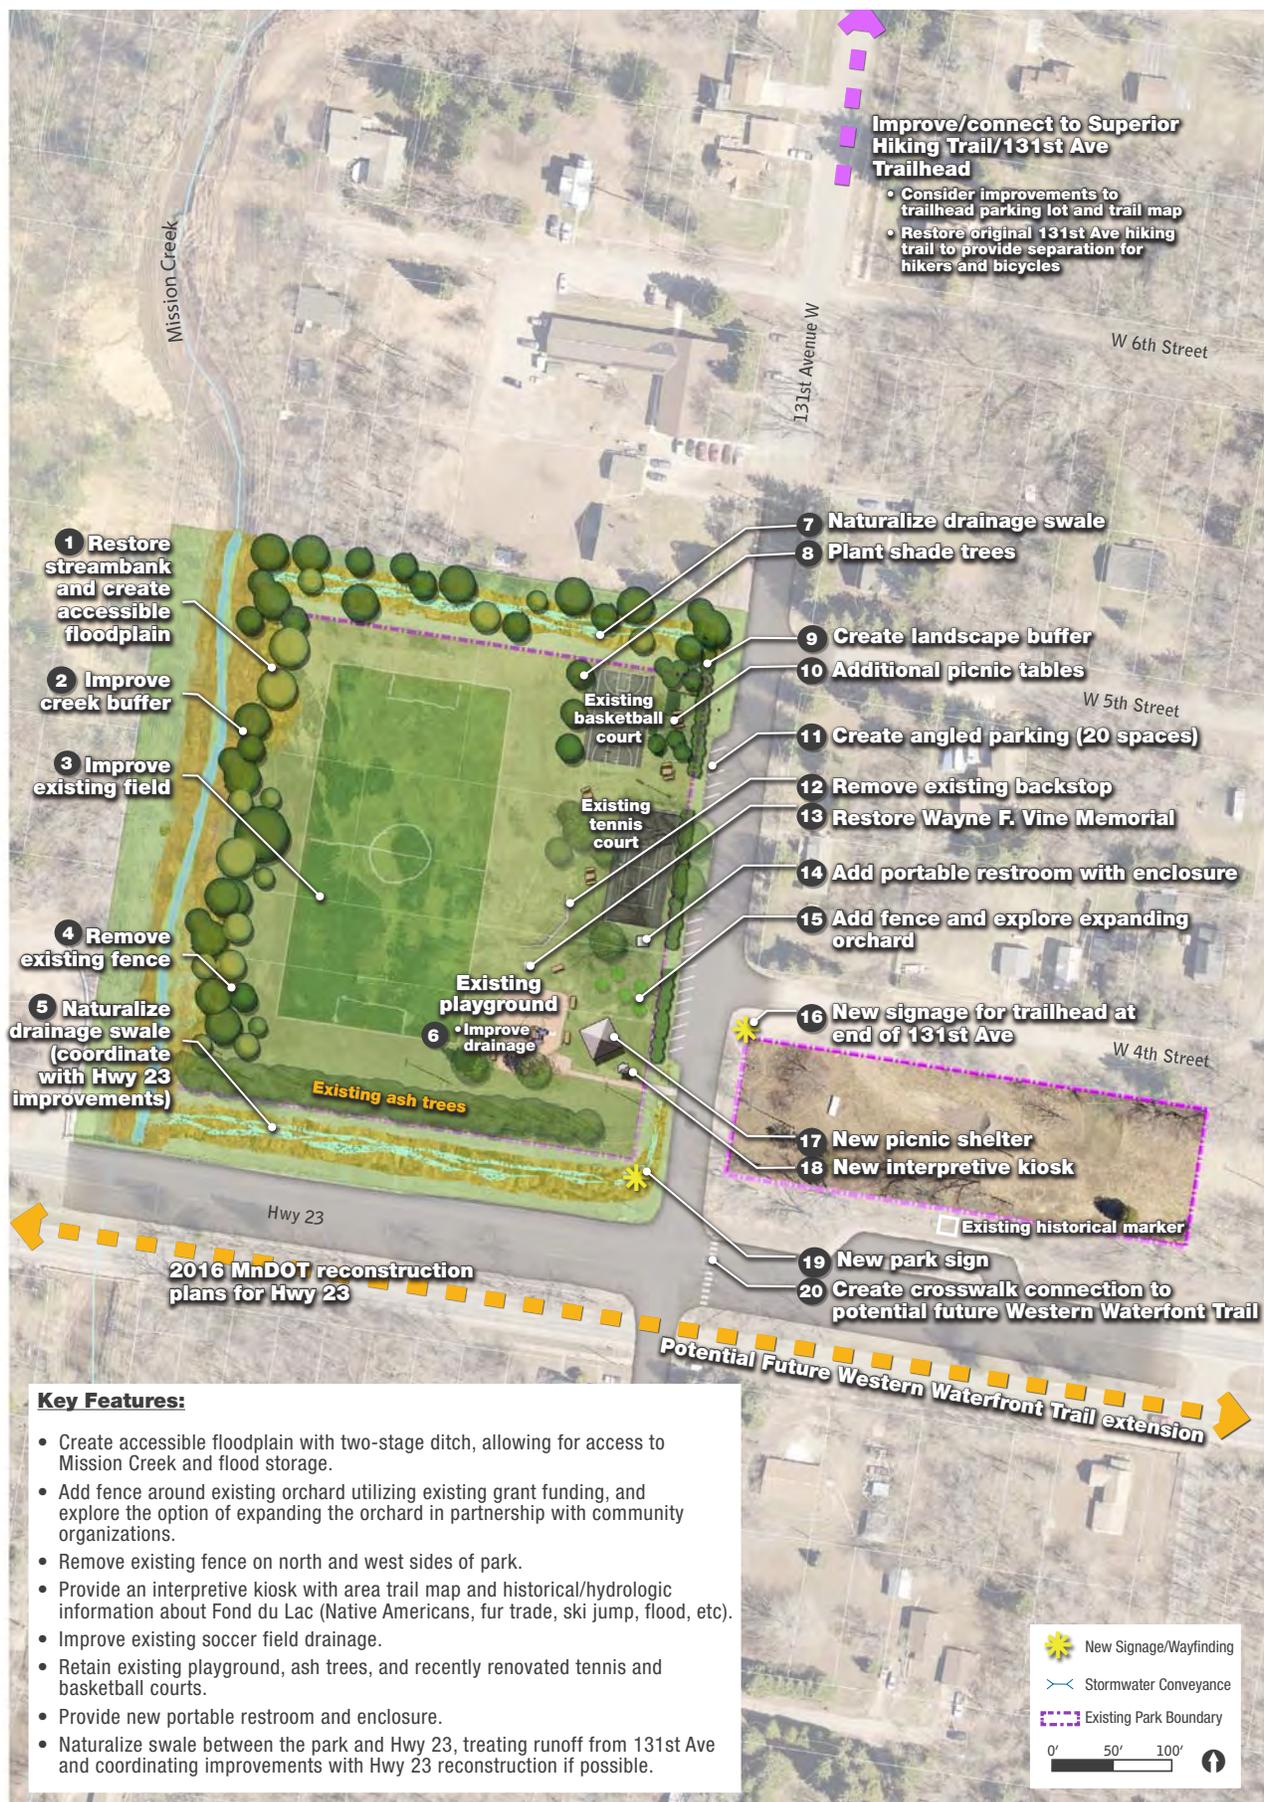
FIGURE 2.4 FOND DU LAC PARK MINI-MASTER PLAN

A desire was expressed by representatives of Arrowhead Youth Soccer to improve the soccer field conditions. The organization stopped using the field for practice after the flood damage occurred.

Since the park building has been removed, neighbors would like a picnic shelter to provide shade and be a gathering space in the park. A shelter could also be a good feature for housing power supplies for potential events in the park. A temporary bathroom is desired and was listed as a priority in the online survey.

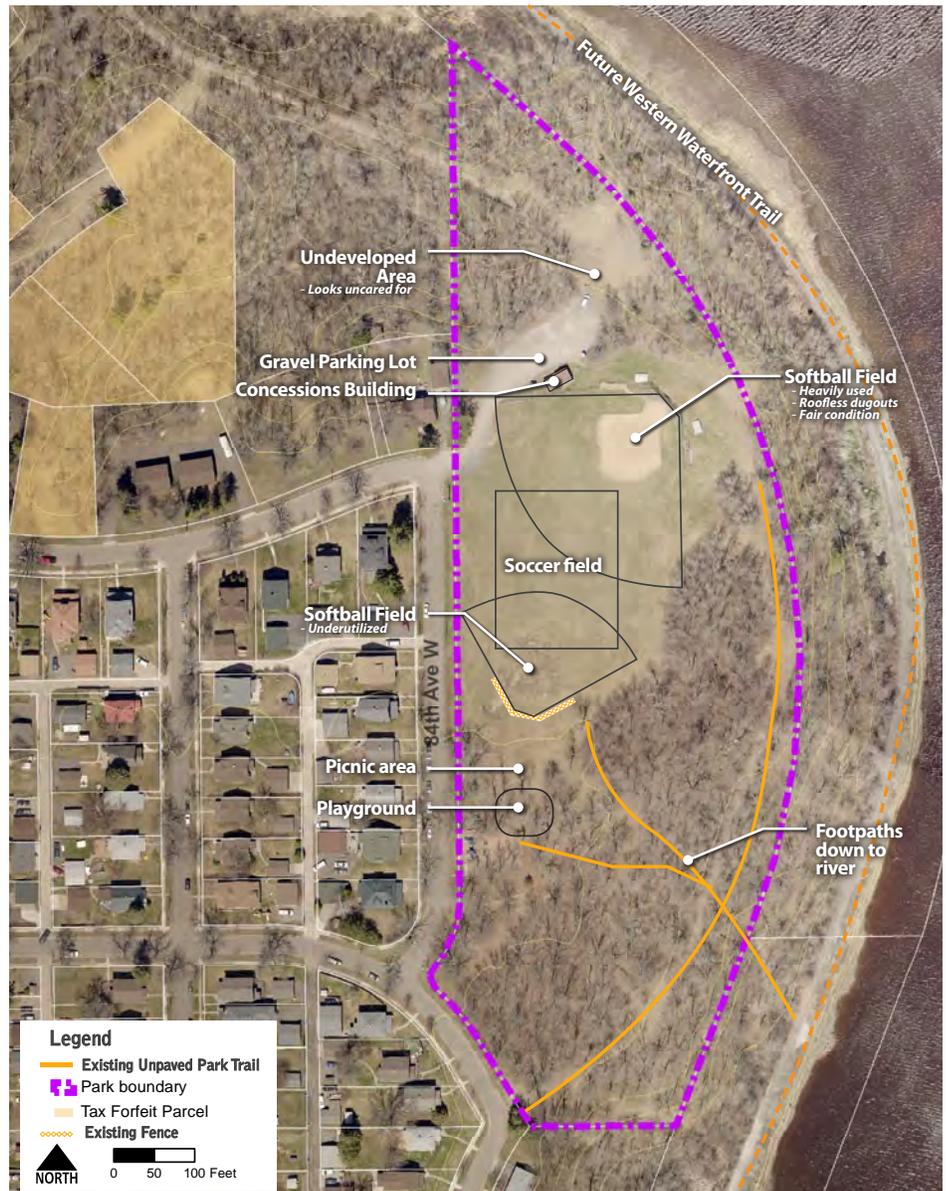
BLACKMER PARK SITE INVENTORY

- » Parking is unorganized and unregulated – gravel parking lot needs improvements
- » Undeveloped, open space north of the gravel parking lot is an eye sore
- » Access to the river is limited and informal/unsafe
- » Some erosion exists along footpaths that lead down to the river
- » Lack of permanent restroom and drinking water

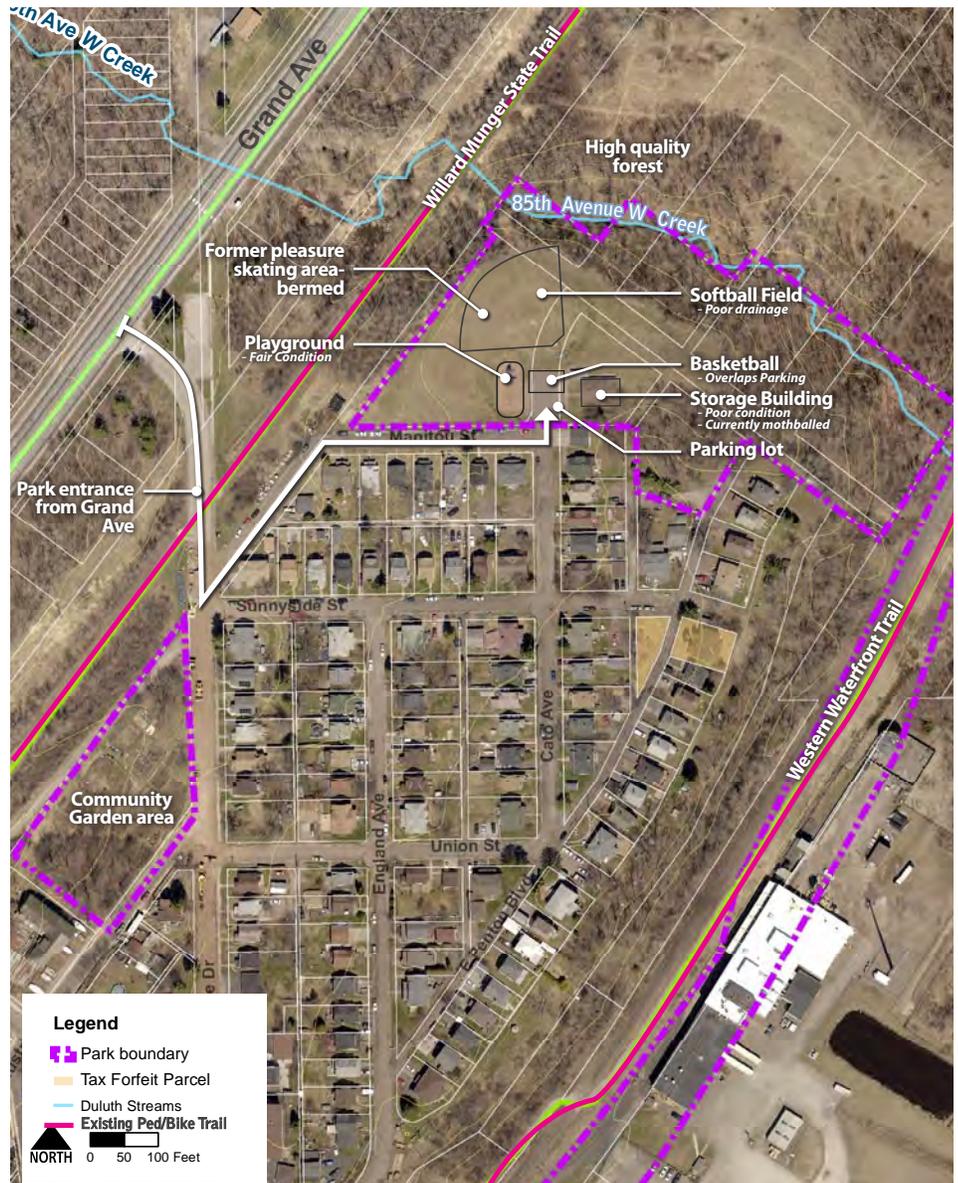
RIVERSIDE PARK SITE INVENTORY

- » Lack of seating and gathering space
- » Lack of shelter/shade, especially near playground
- » Lack of restrooms and drinking water
- » Building is an eye sore
- » Park is close to major trails, but trail connections to park do not exist
- » Playground is small and for young children only
- » Basketball hoop is in parking lot – not usable if cars are parked there
- » Softball field is bermed for old pleasure skate area – open space is not as usable as it could be if field was graded to be level and the backstop was removed

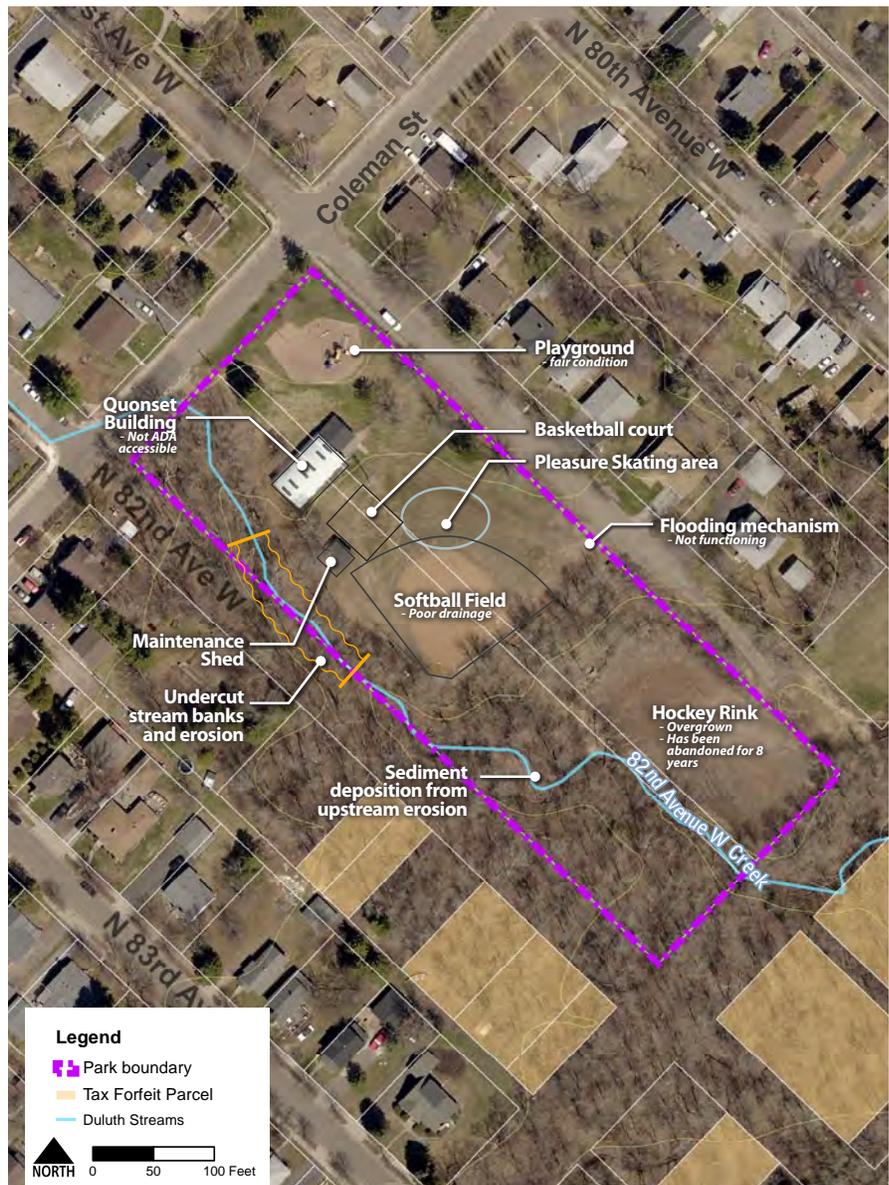
NORTON PARK SITE INVENTORY

- » 82nd Ave Creek has severe erosion and undercutting of stream banks
- » Overgrown hockey rink is unusable space
- » The Quonset Hut is not ADA accessible
- » Flooding mechanism for the pleasure rink on the softball field frequently malfunctions
- » The softball field has poor drainage

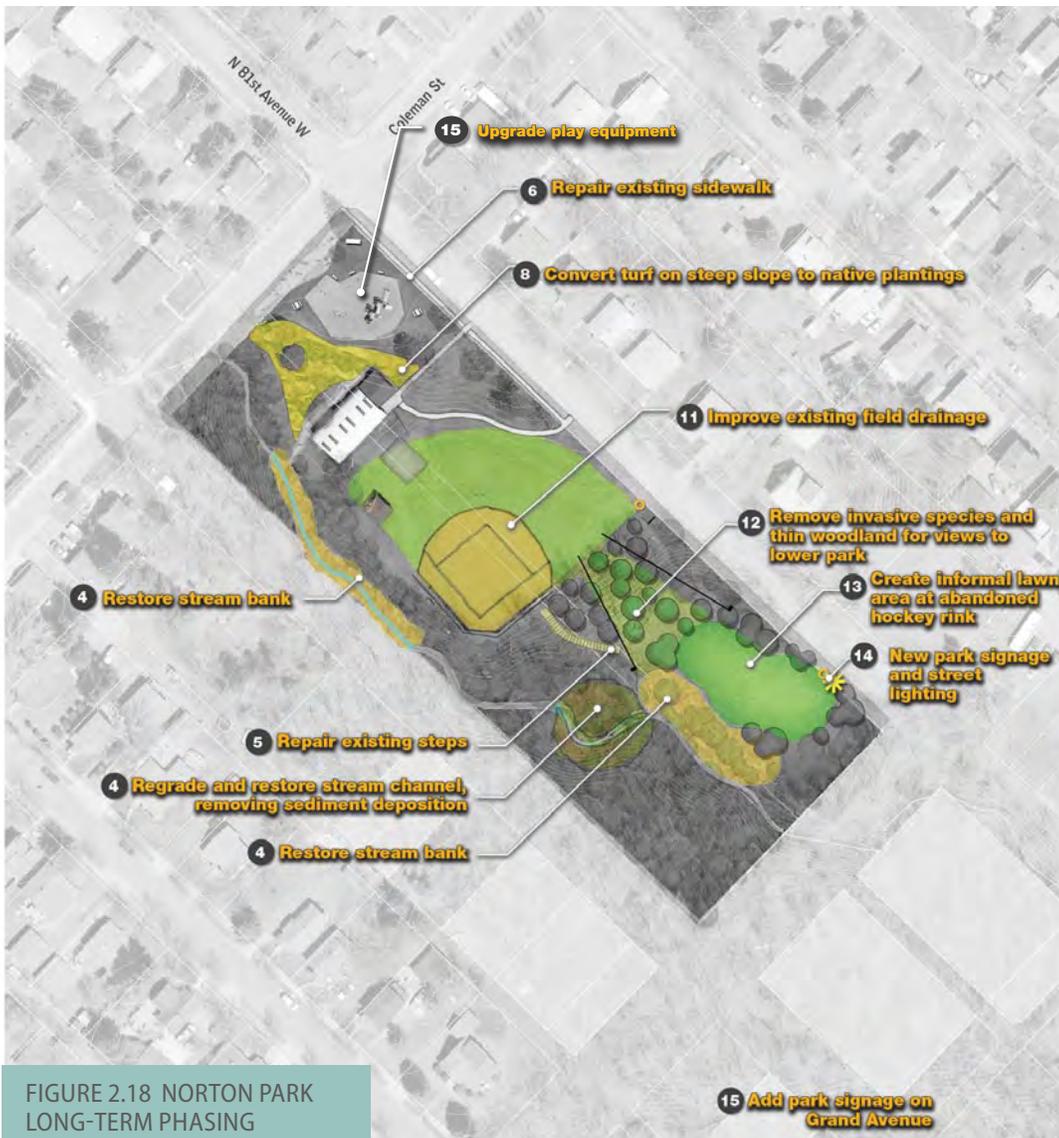
FIGURE 2.18 NORTON PARK LONG-TERM PHASING

ACTION			COST
#	CATEGORY	DESCRIPTION	
4	Natural Resources	Stream Restoration Work at Norton	\$55,000
5	Circulation	Repair Existing Steps	\$10,000
6	Circulation	Replace and Extend Existing Sidewalk - 6' concrete trail	\$12,450
8	Vegetation	Convert Turf on Steep Slope to Native Plantings	\$50,400
11	Recreation	Improve Drainage	\$50,000
12	Vegetation	Remove Invasive Species and Thin Woodland	\$800
13	Vegetation	Create Informal Lawn Area	\$22,000
14	Circulation	New Park Signage	\$1,000
14	Lighting	New Street Lighting	\$6,000
15	Recreation	Upgrade play equipment	\$75,000
Total Long-Term Improvement Costs			\$282,650
Total Short-Term Improvement Costs			\$ 50,250
Total Improvement Costs			\$332,900

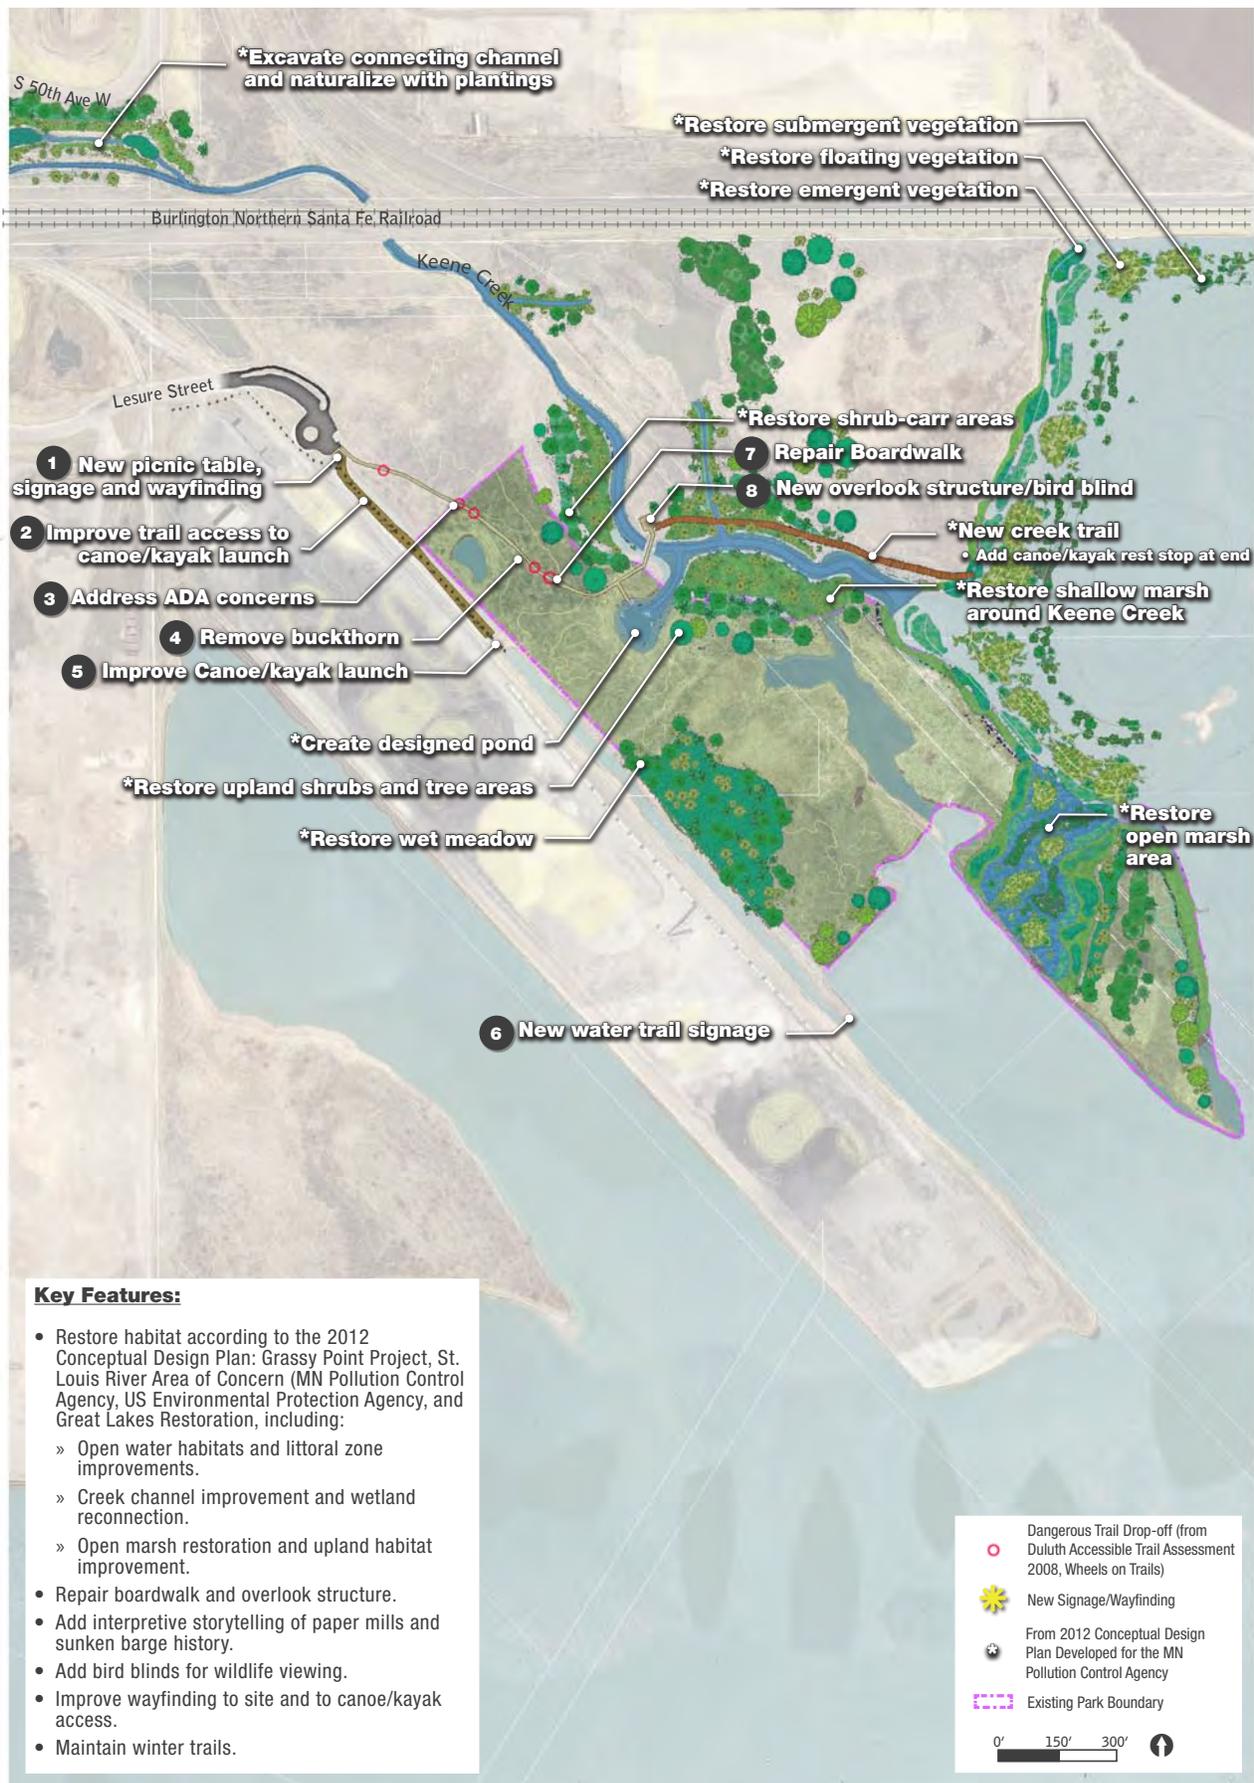
FIGURE 2.19 GRASSY POINT PARK MINI-MASTER PLAN CONCEPT

The concept plan for Grassy Point Park prioritizes and identifies the natural resource and habitat restoration improvements that are currently being planned by the MN DNR and MPCA. Other improvements include trail repair and accessibility, and canoe/kayak launch improvements. Close coordination with the DNR will ensure proper installation of improvements.

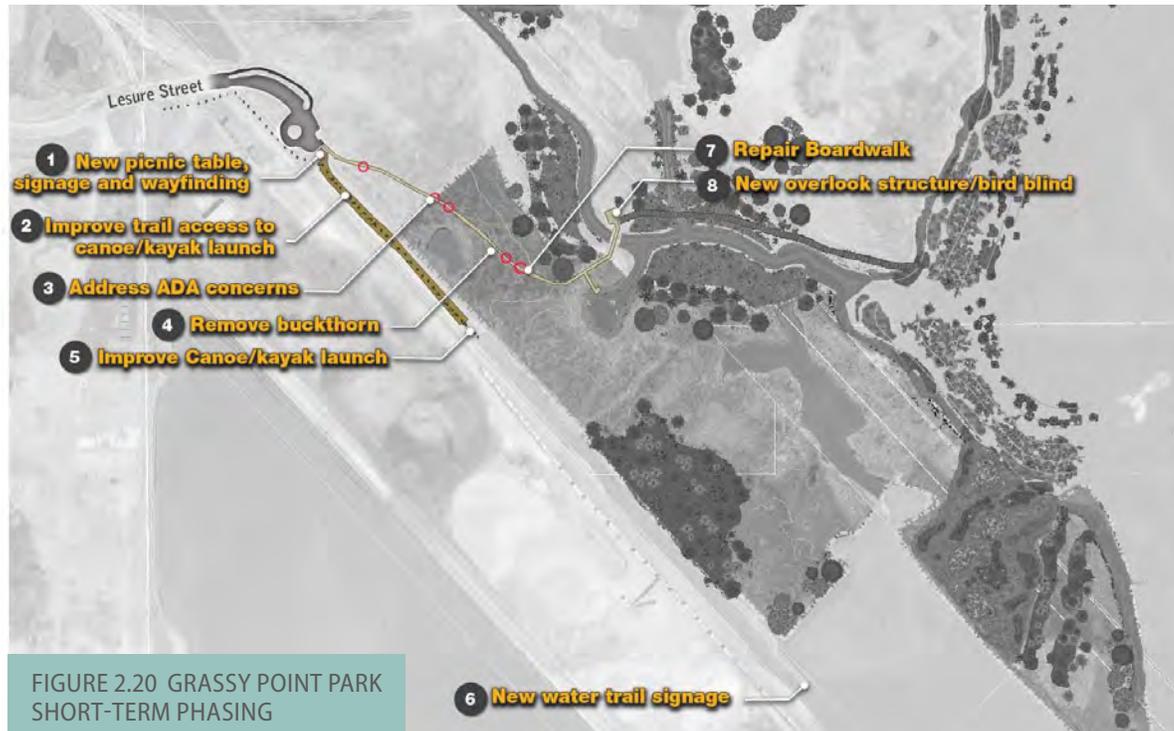
FIGURE 2.20 GRASSY POINT PARK SHORT-TERM PHASING

ACTION			COST
#	CATEGORY	DESCRIPTION	
1	Circulation	Install New Park Sign	\$5,000
1	Circulation	Install New Park Wayfinding Signs (2)	\$2,000
1	Furnishings	Install New Picnic Table	\$2,000
2	Circulation	Improve Trail Access to Canoe/Kayak Launch	\$6,000
3	Circulation	Address ADA Concerns on Boardwalk	\$5,000
4	Vegetation	Remove buckthorn	\$6,000
5	Recreation	Improve Canoe/Kayak Access	\$5,000
6	Circulation	New Water Trail Signage	\$1,000
7	Circulation	Repair Boardwalk	\$1,500
8	Recreation	New Overlook Structure/Bird Blind	\$12,500
Total Short-Term Improvement Costs			\$46,000
Total Improvement Costs			\$46,000

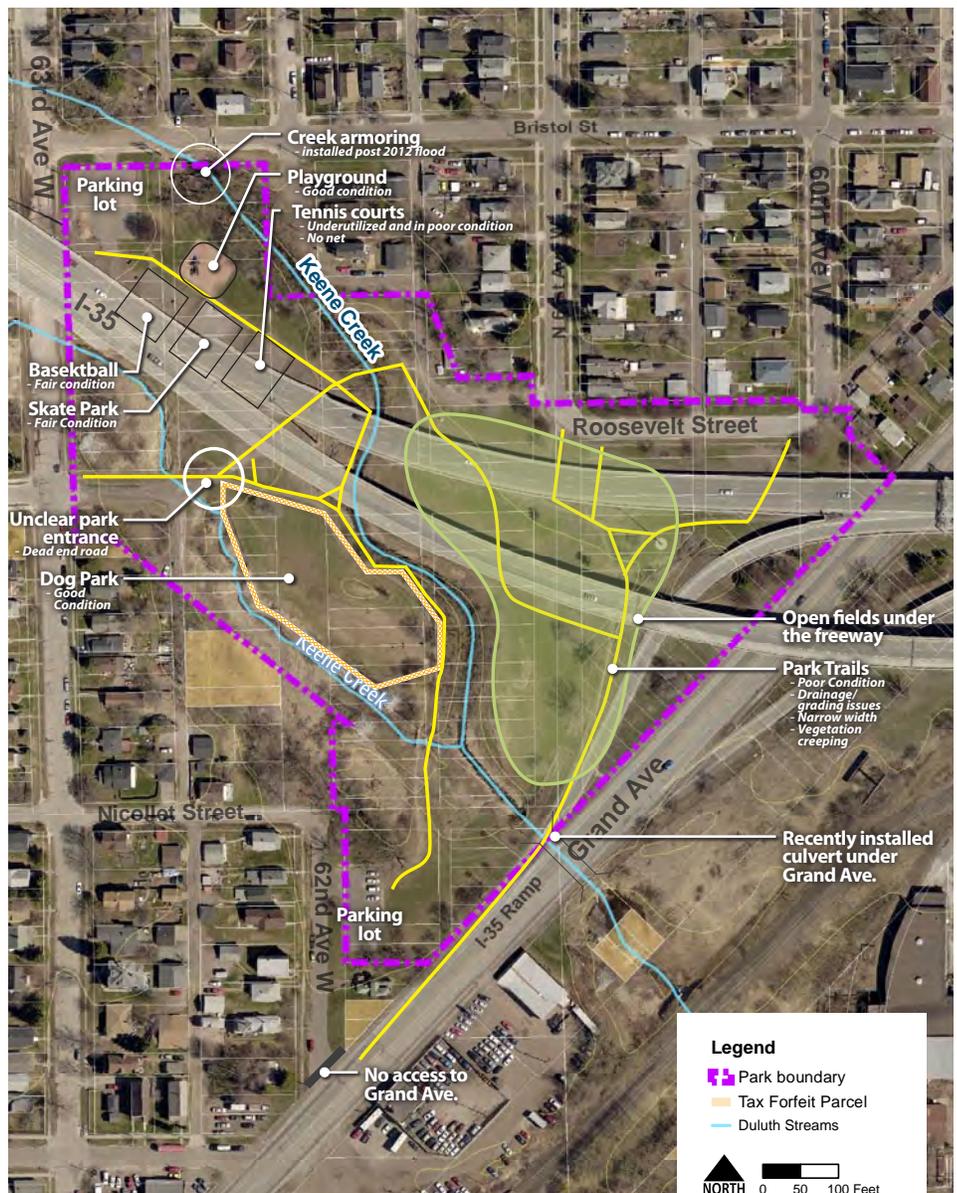
KEENE CREEK SITE INVENTORY

- » Basketball court surface is uneven
- » Tennis courts are underutilized and in disrepair
- » Paved trails are in poor condition, sagging and eroding from stormwater issues
- » Lack of access from Grand Avenue
- » Lack of drinking water and restrooms
- » 2012 flood damage is still visible in the park – more cleanup is needed
- » Lack of shelter/pavilion for picnic tables and gathering
- » Lack of lighting for night time safety
- » Lack of ADA accessibility throughout the park
- » Garbage and park furnishings are sometimes found in the creek
- » Weedy/unkempt areas of the park are unsightly

Keene Creek Park is a popular, multi-use park. Several recreational features are located in the northwestern corner of the park, which include an updated playground popular with neighborhood residents, a well-used basketball court, two tennis courts in poor condition, and a skate park.

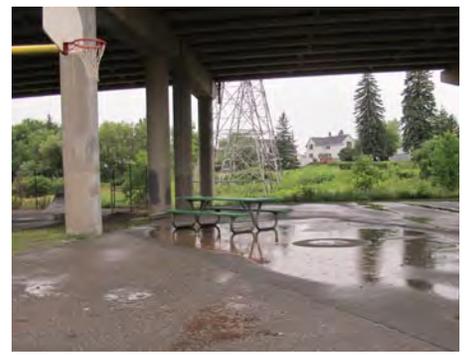
The existing surface of the basketball court is in poor condition

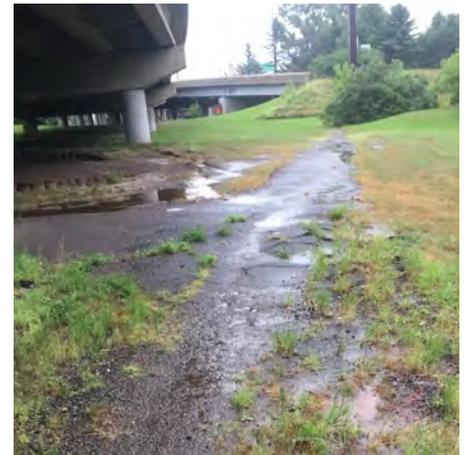
Many existing trail surfaces are in poor condition

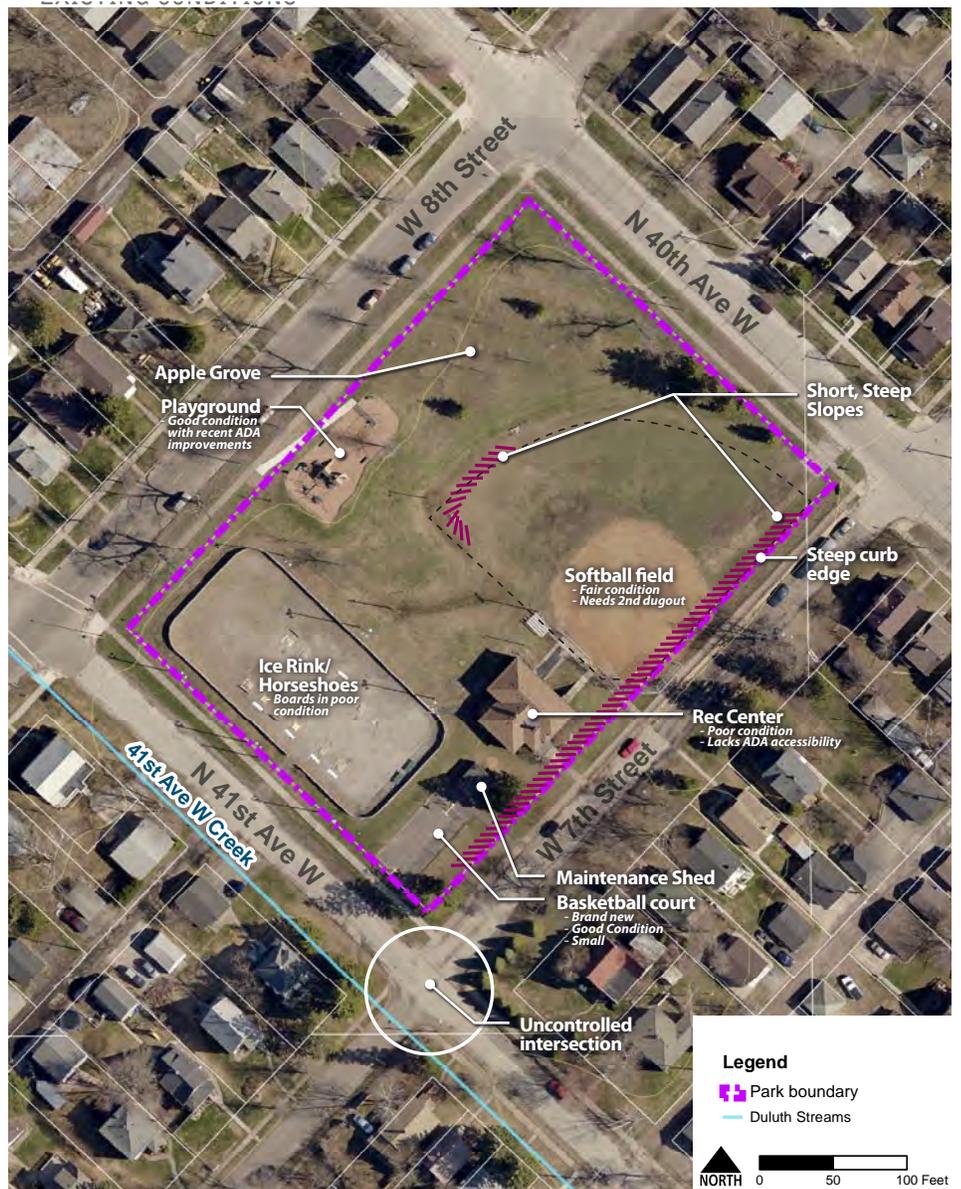
MERRITT COMMUNITY RECREATION AREA SITE INVENTORY

- » Park building is in poor condition, lacks ADA accessibility, and is rarely open to the public/park users
- » The ice rink lights are controlled on a timer in the building and not reliable to be on when needed
- » Hockey boards are in poor condition – no money to replace
- » Stormwater drainage issues exist throughout the park—on the playground and softball field there are several areas that pond
- » A warming house is needed for skating

The facilities in Merritt are generally in fair to good condition. A few recent updates have been made to the playground area and basketball court. Some features are on their last legs for usability and will need to be updated soon.

The basketball court is smaller than a typical regulation field, relatively new, and in good condition. The softball field is well used with an infield that could use some resurfacing. The softball field has one chain link dugout, bleachers, and lights. The hockey boards stay up all year and are in poor condition. Horseshoe pits are located in the hockey rink area, but they are scheduled for relocation to Wheeler Park. The playground has had recent ADA accessibility improvements, but the benches and some of the equipment are in poor condition.

The park building is in poor condition. It has not been updated in years, is not ADA accessible, and is not able to be easily updated.

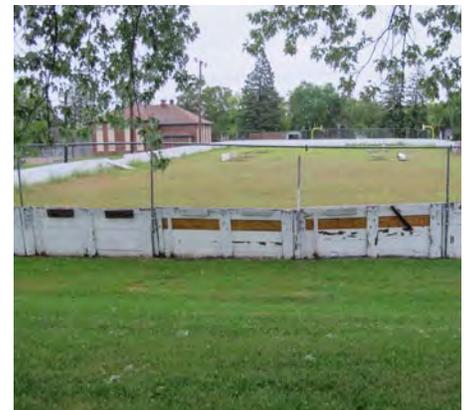
Boards at the existing broomball rink are in fair condition

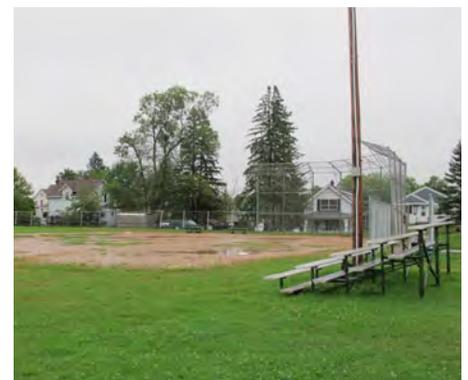
The ballfield lacks a second dugout

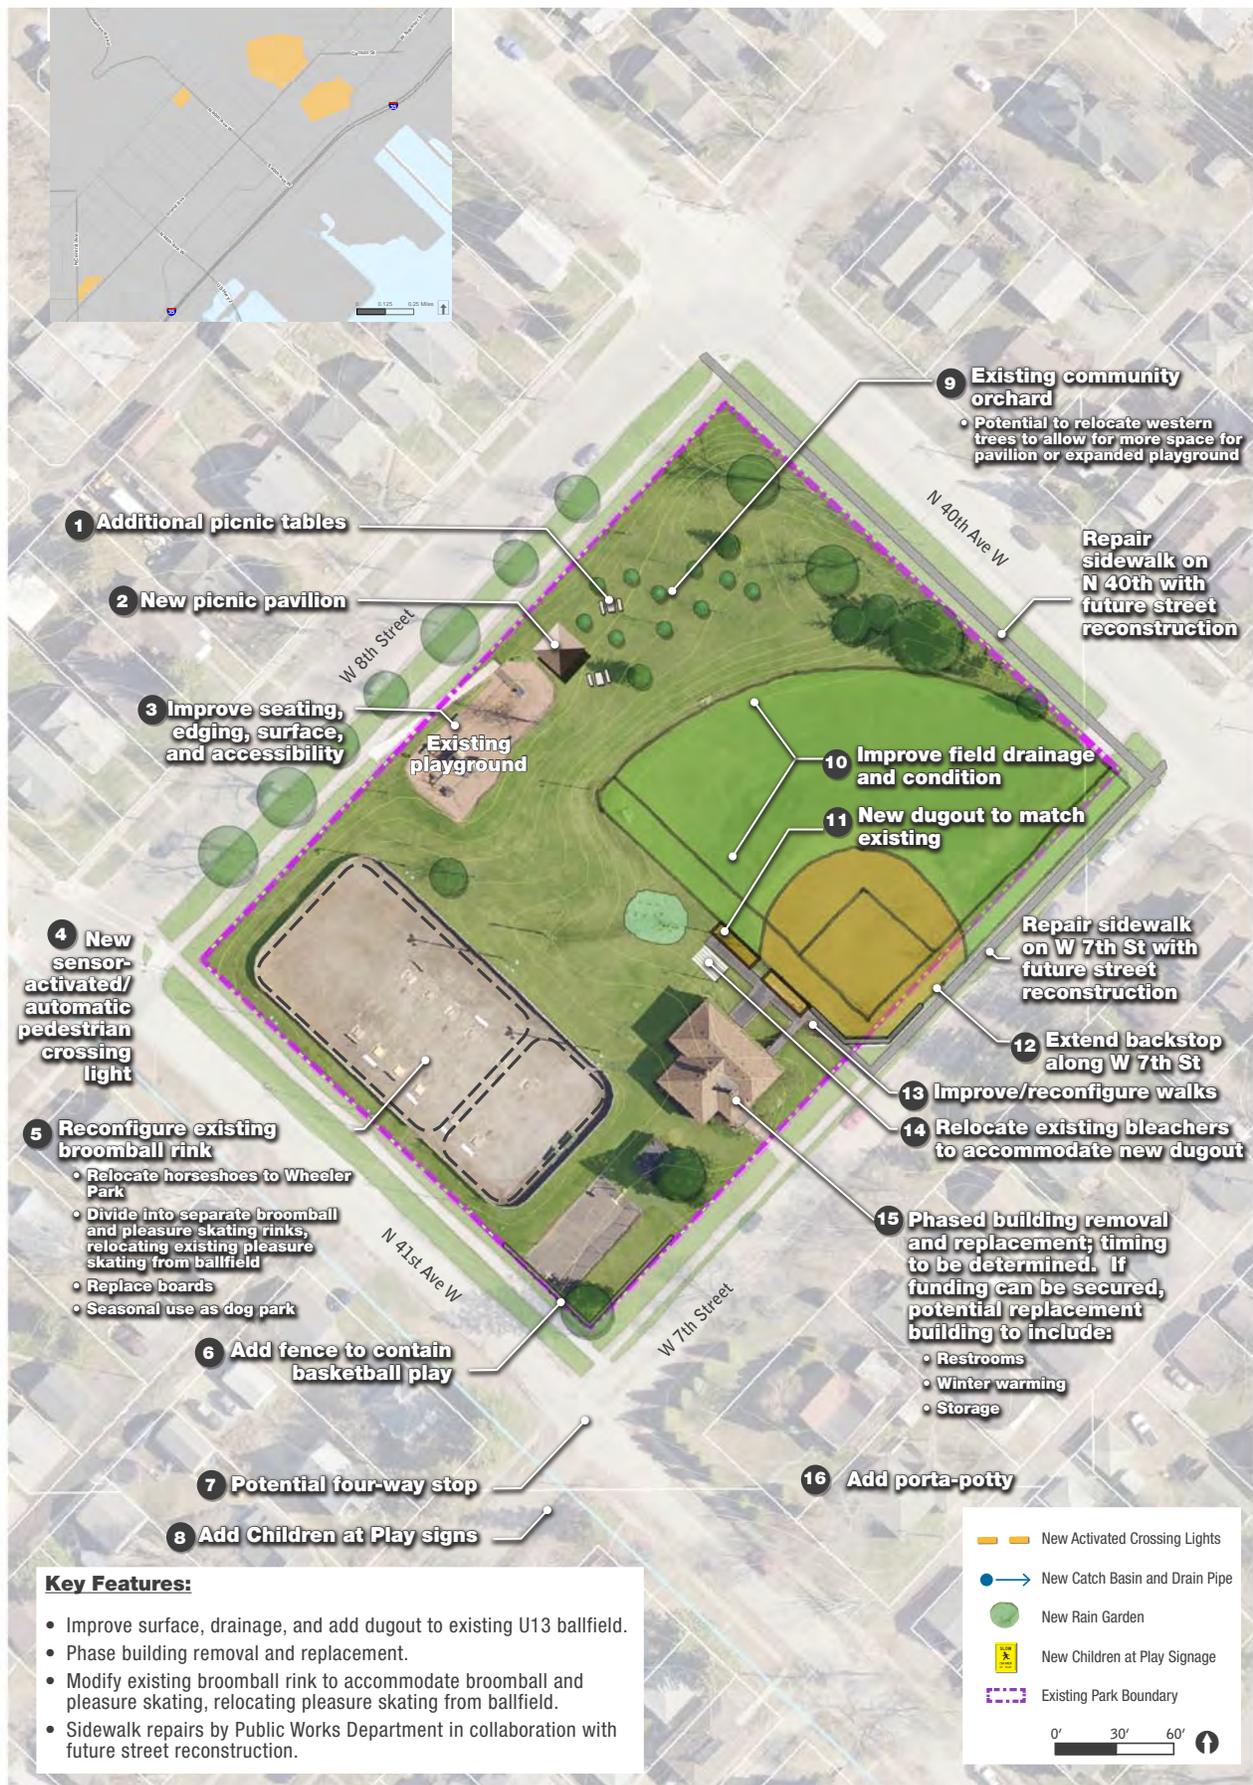
FIGURE 2.25 MERRITT COMMUNITY RECREATION AREA MINI-MASTER PLAN CONCEPT

The concept plan for Merritt Community Recreation Area includes overall drainage improvements, minor recreational improvements, and park gathering spaces, including a pavilion and building replacement, and accessibility, and canoe/kayak launch improvements.

Overall, updates to the existing park features are necessary to continue the functionality of the park. The softball field needs resurfacing, drainage pipe in the outfield, and a second dugout. The hockey rink needs new boards and better managed lighting for dark winter nights. The hockey rink is voluntarily maintained by Northwoods Children’s Services. A shade structure with benches and picnic tables is desired near the existing playground. The playground container and equipment needs to be updated to remove safety hazards.

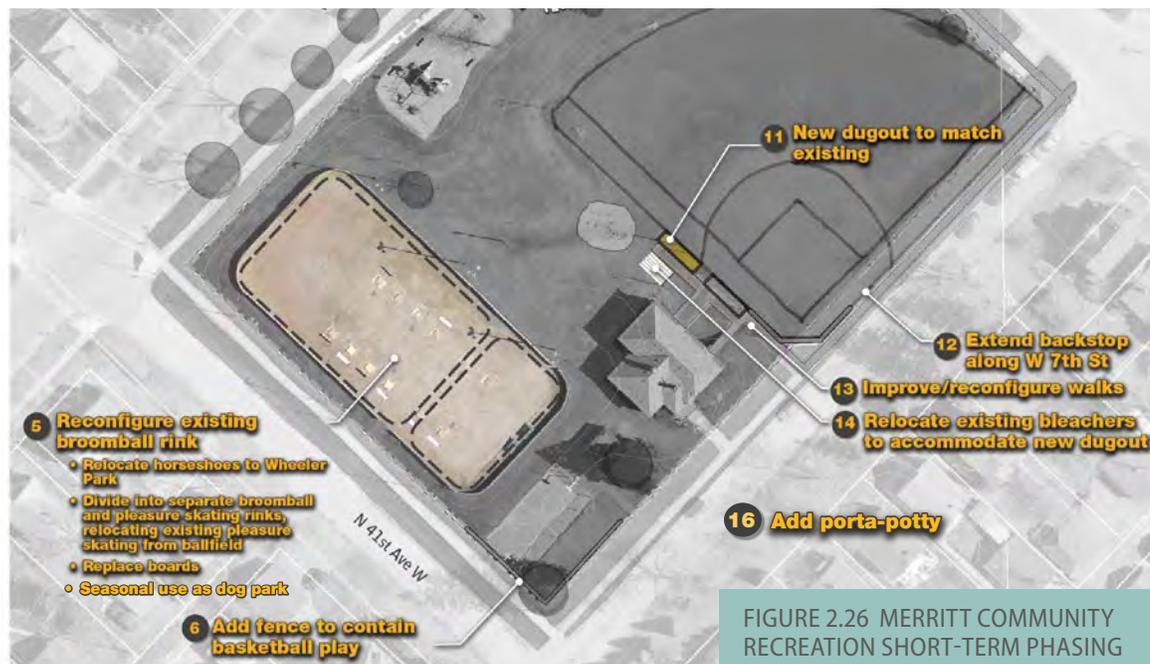
FIGURE 2.26 MERRITT COMMUNITY RECREATION SHORT-TERM PHASING

ACTION			COST
#	CATEGORY	DESCRIPTION	
5	Demolition	Remove/Relocate Existing Horseshoes	With Wheeler costs
5	Recreation	Partition Existing Rink with Boards	\$5,000
5	Recreation	Replace Existing Hockey Boards	\$25,000
6	Infrastructure	Install New Chain Link Fence	\$10,800
11	Recreation	Build New Chain Link Fence Dugout	\$3,500
12	Recreation	Extend Existing Backstop	\$6,000
13	Circulation	Improve / Reconfigure walkways	\$10,360
16	Furnishings	Add porta-potty	\$2,500
Total Short-Term Improvement Costs			\$63,160
