# ST. LOUIS RIVER CORRIDOR PARKS MINI-MASTER PLANS

JUNE 2016

This document is a compilation of mini-master plans for 11 neighborhood and multi-use parks in the St. Louis River Corridor. Each park's mini-master plan is a chapter in the document. The parks, from west to east, are: Historical Park, Fond du Lac Park, Blackmer Park, Riverside Park, Smithville Park, Norton Park, Grassy Point Park, Keene Creek Park, Merritt Community Recreation Area, Harrison Community Recreation Area, and Piedmont Community Recreation Area. Each park is unique in setting, context, use, issues, and needs.

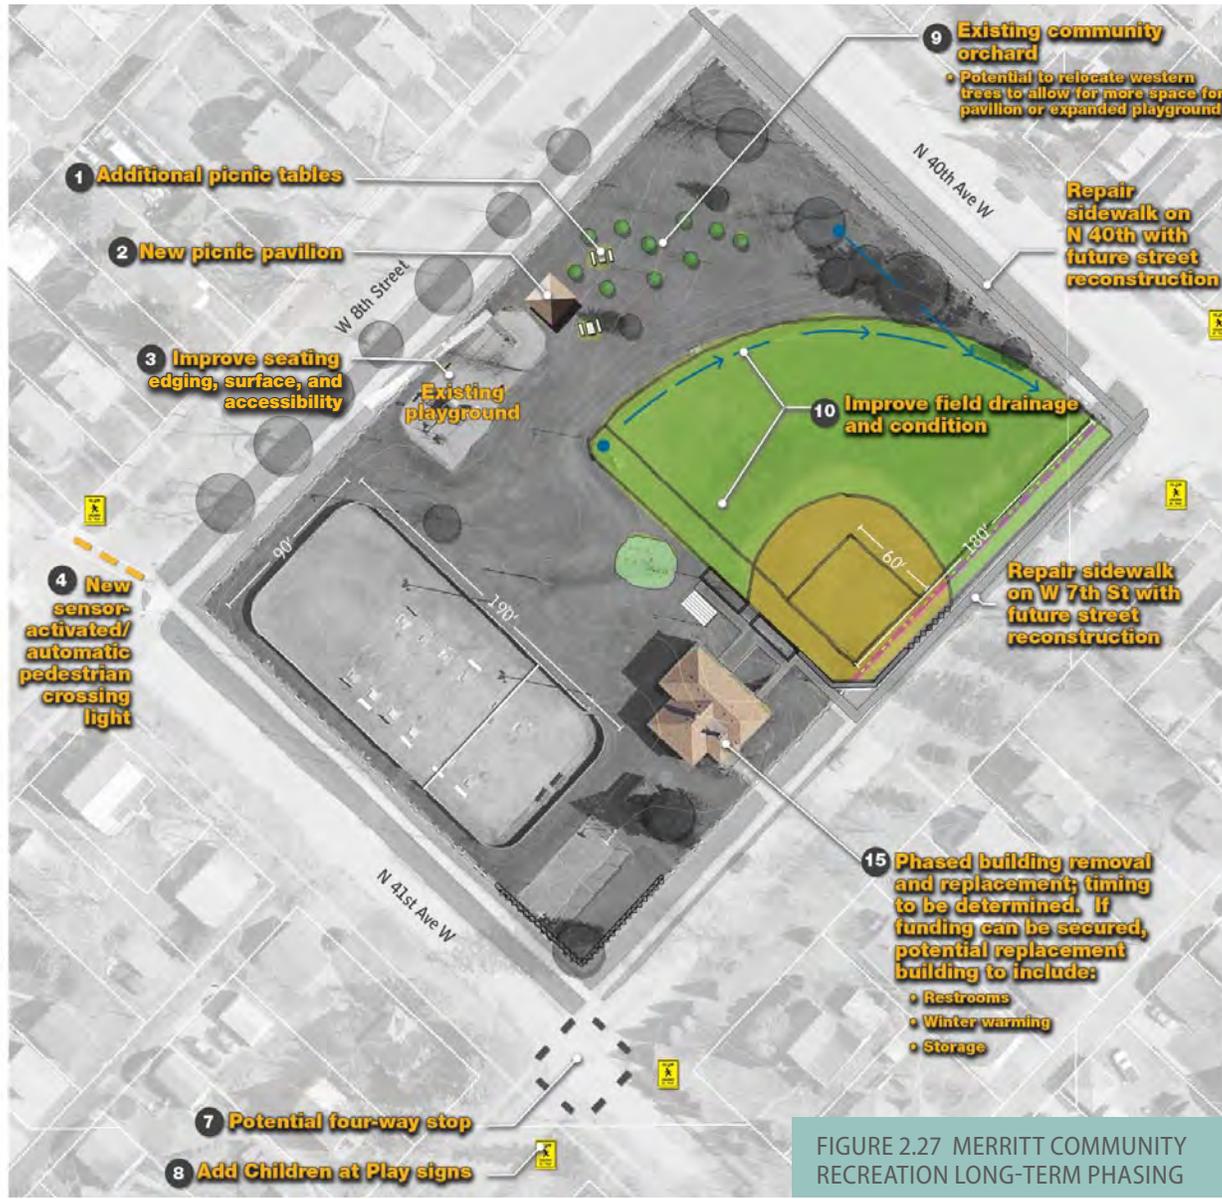
FIGURE 2.27 MERRITT COMMUNITY RECREATION LONG-TERM PHASING

ACTION			COST
#	CATEGORY	DESCRIPTION	
1	Furnishings	Add Picnic Tables (2)	\$4,000
2	Buildings	Build New Picnic Shelter	\$30,000
3	Furnishings	Improve Seating - New Benches (3)	\$3,600
4	Circulation	New Sensor-Activated/Automatic Pedestrian Crossing	\$10,000
7	Circulation	New Four-Way Stop - Signs	\$4,000
8	Circulation	Add Children At Play Signs	\$5,000
9	Demolition	Relocate Existing Apple Trees (3)	\$750
10	Recreation	Improve Field Drainage & Condition	\$50,000
10	Stormwater	Install New Raingarden	\$25,500
15	Demolition	Remove Existing Building	TBD
15	Buildings	Build New Community Building	\$500,000
Total Long-Term Improvement Costs			\$632,850
Total Short-Term Improvement Costs			\$63,160
Total Improvement Costs			\$696,010

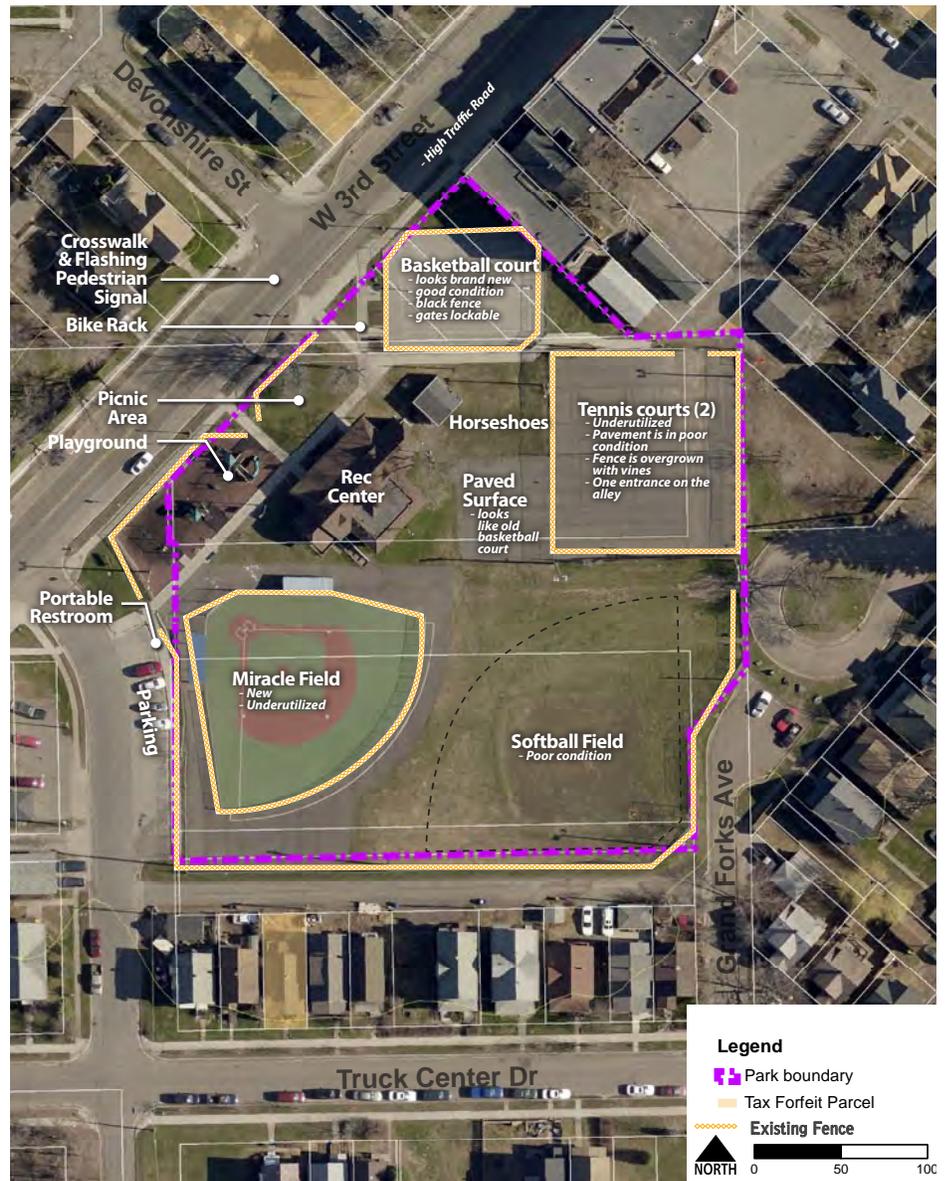
HARRISON COMMUNITY RECREATION AREA SITE INVENTORY

- » Softball field is underutilized and in poor condition
- » Fencing creates barriers to circulation
- » Tennis courts are in poor condition and underutilized
- » Recreation building has water issues in the basement
- » Playground surface is unsafe
- » Lack of parking during events and large gatherings
- » Lack of clear circulation/connectivity through the park
- » Some invasive species (Japanese knotweed) and weedy areas exist along fencing

The northwestern half of Harrison Recreation Area is generally in good condition: the playground, park building, basketball court, and Miracle Field are all well used and maintained. The southeastern half of the park is underutilized and has not been updated in years: the softball field, tennis courts, and former basketball court pavement are in fair condition, but could use major improvements if further use is to continue.

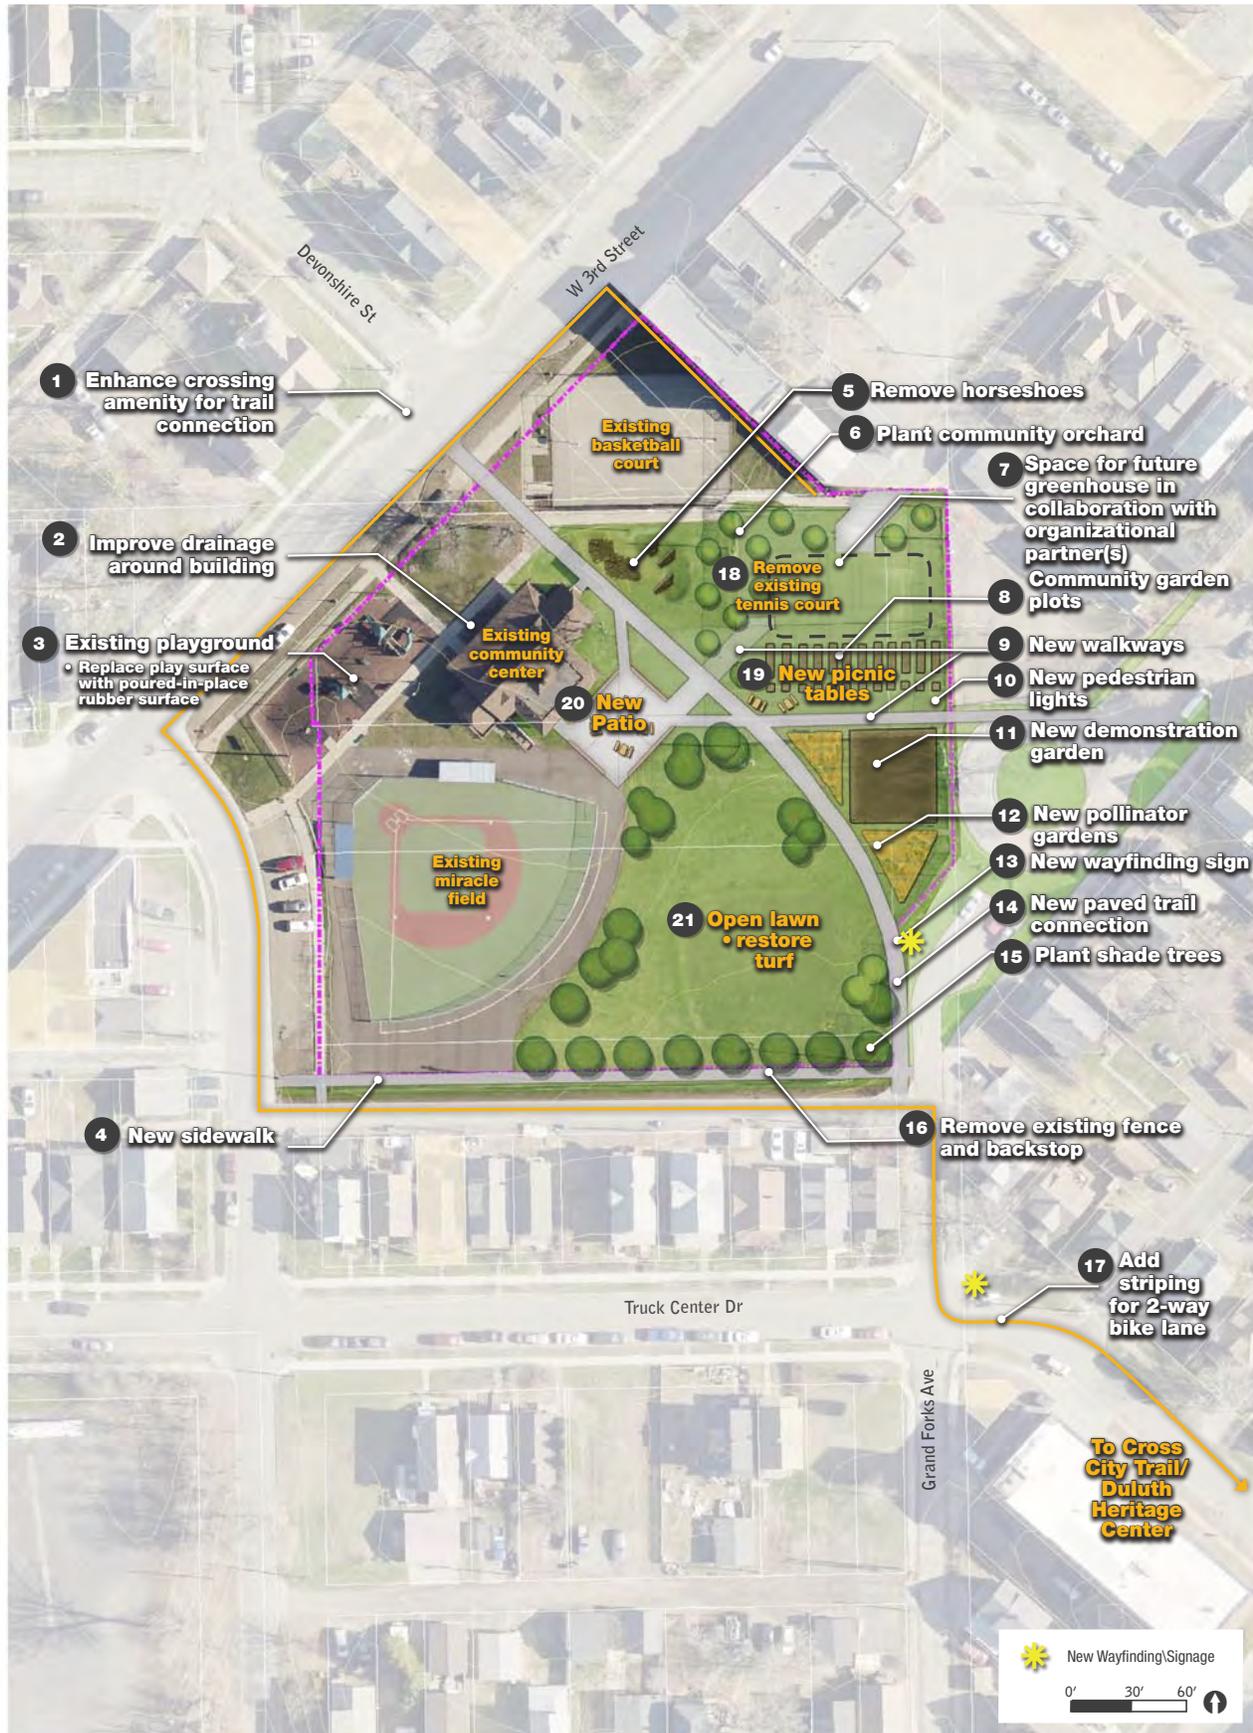
FIGURE 2.28 HARRISON COMMUNITY RECREATION AREA MINI-MASTER PLAN CONCEPT

The concept plan for Harrison includes the removal of the tennis courts and softball field for the addition of community gardens, a picnic area, a new trail connection, and space for a potential greenhouse to be managed by a partnership organization. The removal of fencing and addition of shade trees should improve the overall appearance and feel of the entire park. Additional minor improvements are noted throughout the park.

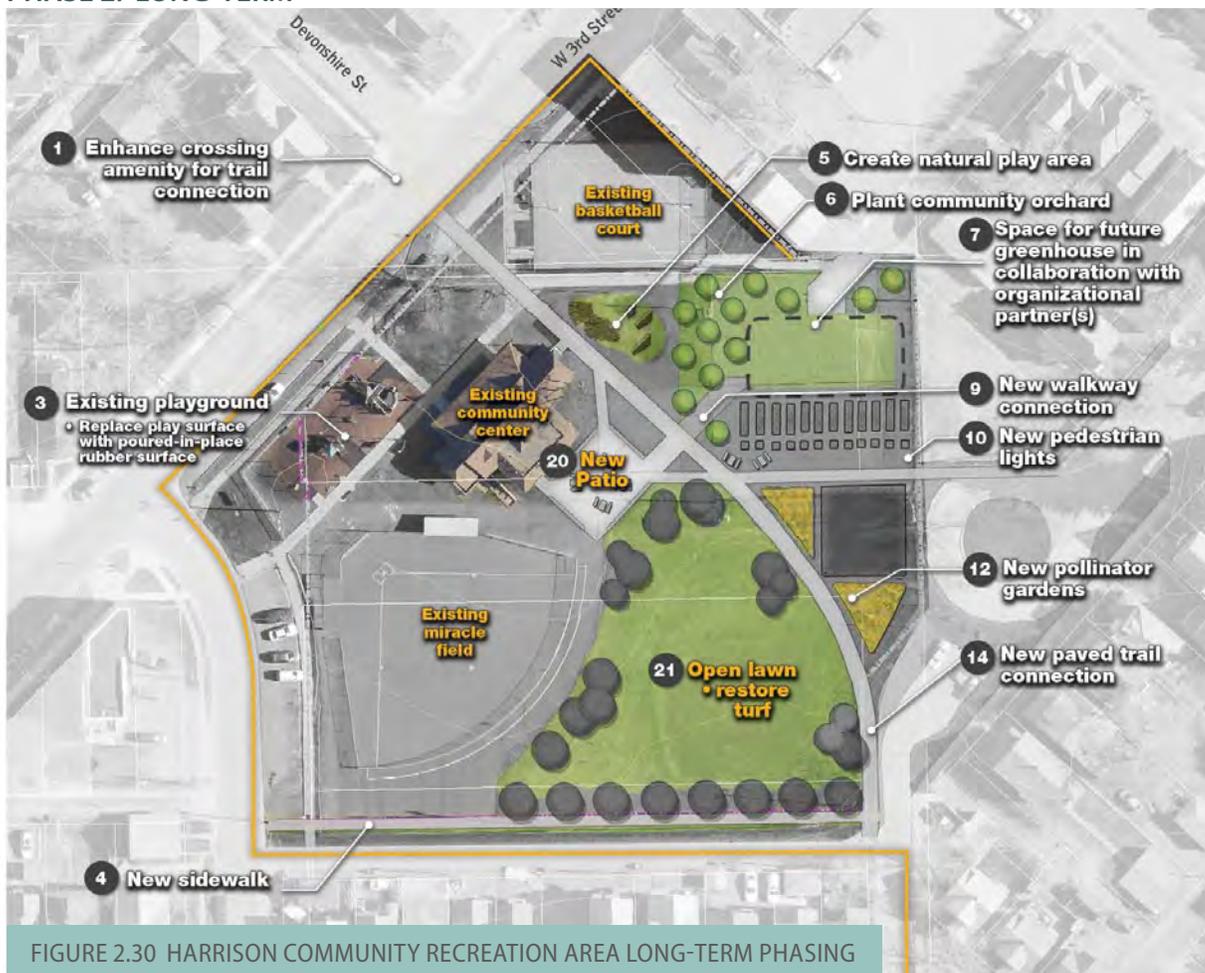
FIGURE 2.30 HARRISON COMMUNITY RECREATION AREA LONG-TERM PHASING

ACTION			COST
#	CATEGORY	DESCRIPTION	
1	Circulation	Enhance Pedestrian Crossing Amenity	\$10,000
3	Recreation	Replace Play Surface with Poured-In-Place Rubber Surface	\$63,000
4	Circulation	New Sidewalk - 4' Concrete	\$38,500
5	Recreation	Create Natural Play Area	\$50,000
6	Vegetation	Plant New Ornamental/Fruit Tree	\$2,800
7	Building	Space for new Greenhouse	TBD
9	Circulation	New Walkways - 10' Concrete Connection from Patio	\$5,000
10	Lighting	New Pedestrian Lights	\$16,000
12	Vegetation	New Pollinator Gardens	\$5,850
14	Circulation	New Paved Trail Connection - 6' Concrete	\$26,400
20	Circulation	New Patio	\$49,500
21	Vegetation	Open Lawn	\$5,000
Total Long-Term Improvement Costs			\$272,050
Total Short-Term Improvement Costs			\$79,275
Total Improvement Costs			\$351,325

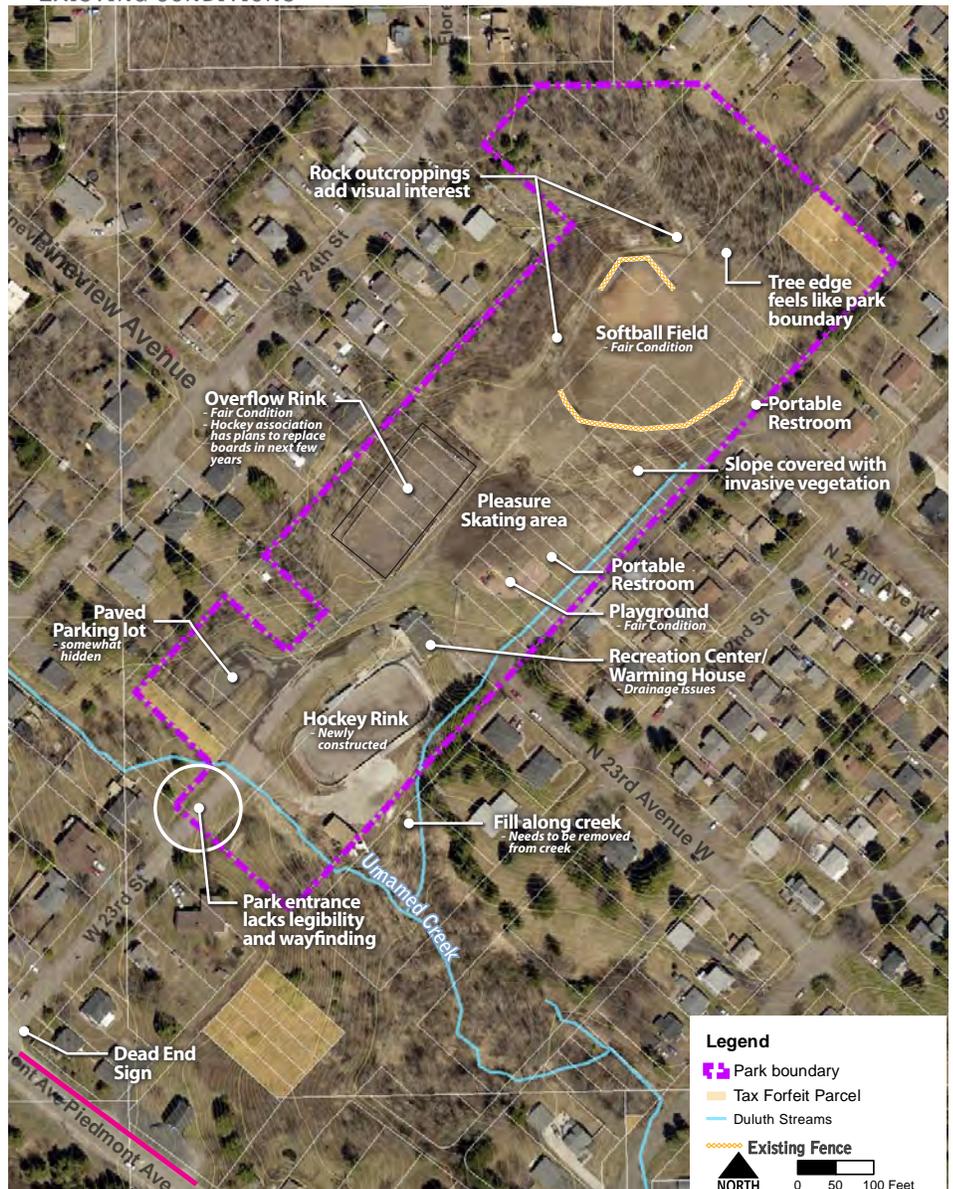
PIEDMONT COMMUNITY RECREATION AREA SITE INVENTORY

- » Major stormwater drainage issues exist throughout the park—during rain events, water creates deep channels, which undercuts and damages paved driveways and surfaces
- » Lack of parking for events, cars park on the alley between N 22nd and 23rd Avenues
- » Invasive tansy covers the upper slope between the softball field and pleasure skate/playground area
- » Softball field fencing is leaning
- » Softball field has poor drainage
- » Lack of recreation opportunities beyond hockey and softball
- » Lack of ADA accessibility throughout the park
- » Playground lacks sight lines from softball and hockey areas
- » Circulation and access for vehicles and pedestrians within the park need improvement

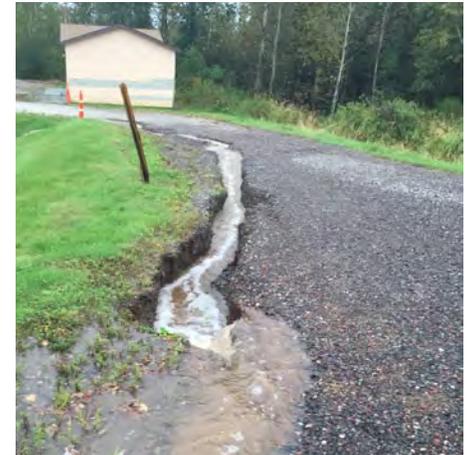
Erosion in the park is a major concern and poses a threat to public safety and water quality

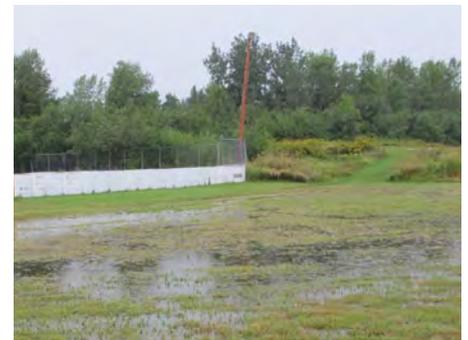
Poor stormwater management results in saturated conditions and unusable space

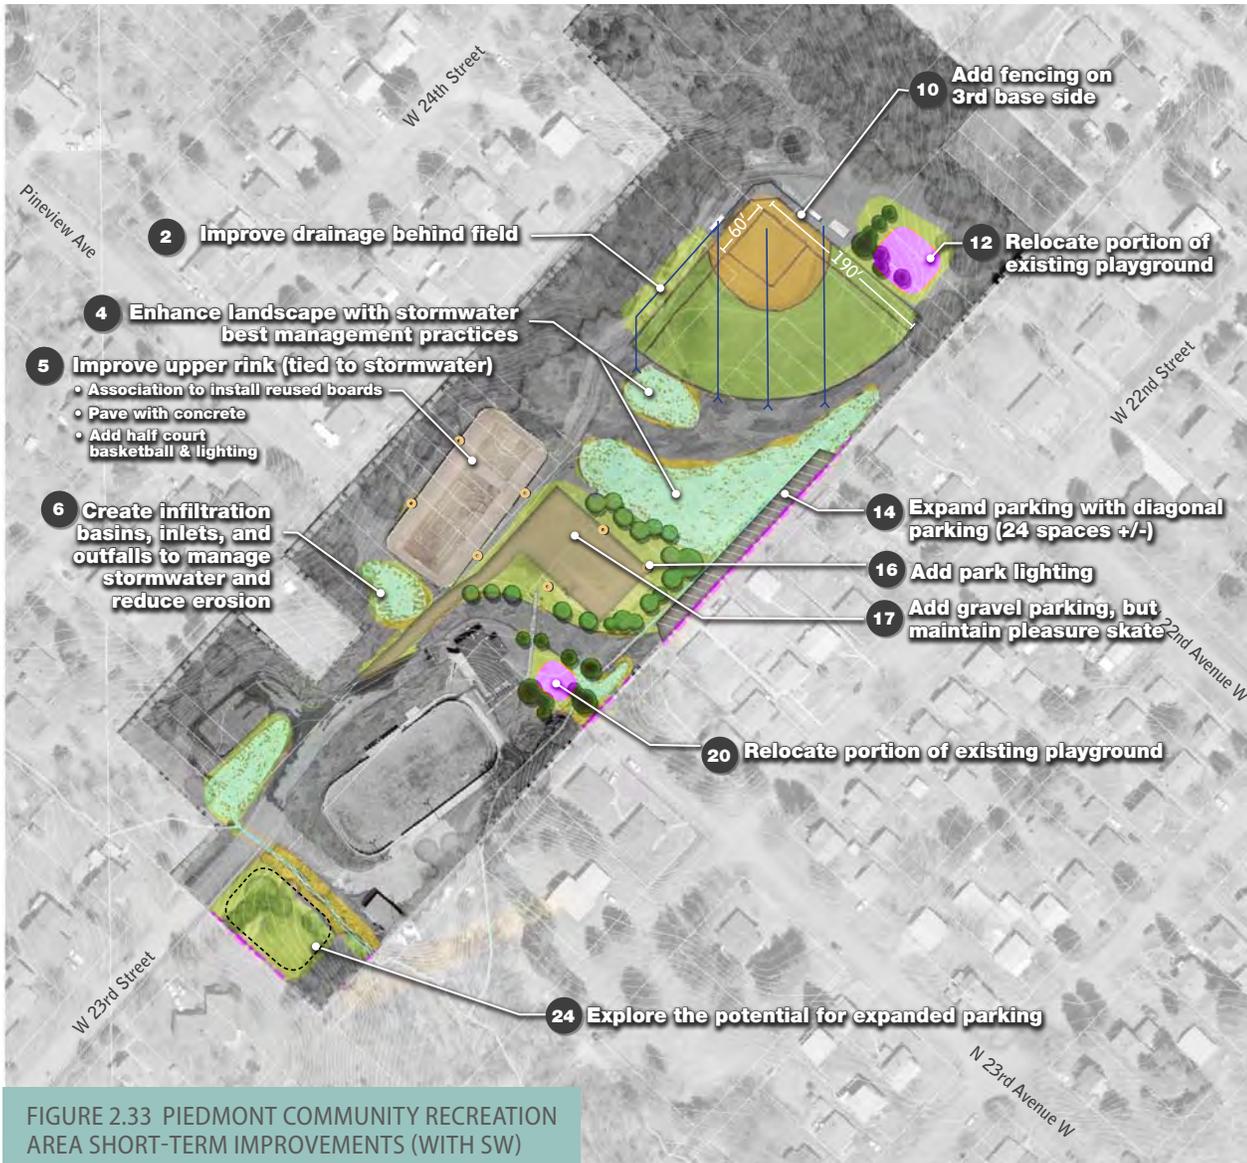
FIGURE 2.33 PIEDMONT COMMUNITY RECREATION AREA SHORT-TERM IMPROVEMENTS (WITH SW)

ACTION			COST
#	CATEGORY	DESCRIPTION	
2	Recreation	Improve field drainage (behind field, regrade, reseed)	\$100,000
4	Stormwater	Create Vernal Pool and Enhance Wetland Vegetation	\$25,000
5	Recreation	Improve Upper Rink - Pave with Concrete + Install Reused Boards + Install Half-court Basketball and lighting (tied to #6)	\$92,000
6	Stormwater	Create Infiltration Basins, Inlets and Outfalls to Manage Stormwater and Reduce Erosion	\$100,000
10	Recreation	Add 3rd Base Fencing	\$5,000
12 & 20	Recreation	Relocate portions of existing playground (edging, footings, play surface)	\$15,000
14	Circulation	Expand Parking with Diagonal Parking (gravel, stormwater, signage)	\$84,000
16	Lighting	Add Park Lighting	\$12,000
17	Circulation	Add gravel parking (mid-terrace)	\$21,000
24	Circulation	Explore potential for expanded parking	TBD
Total Short-Term Costs (with Stormwater)			\$454,000
Total Short-Term Costs			\$512,254 (+ building improvement costs)
