Wheeler Field

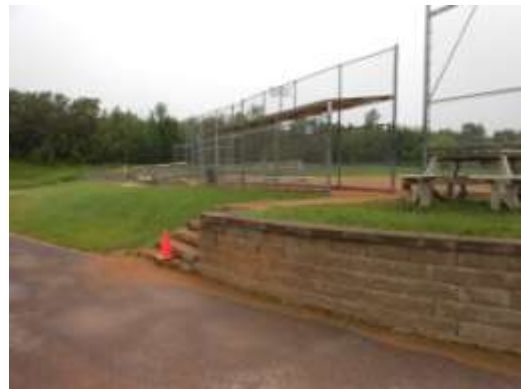
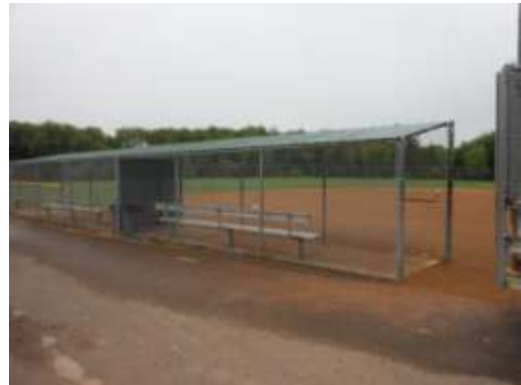
Fields 2 and 3

An accessible route is currently provided to the fields and the dugouts (both home and visitor are located on the 3rd base side). There is wheelchair space within the dugouts. *This is a good example of accessibility.*

Priority 2- Relocate games from Field 1 to Fields 2 and 3.

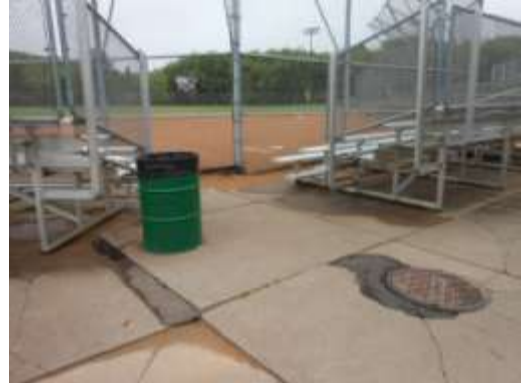
Field 2- Spectator Seating

There are 2 portable bleachers positioned on concrete behind the backstop. There is currently room for 1 wheelchair viewing position between the 2 bleachers.

Priority 3- Reposition the portable bleachers to provide additional wheelchair viewing positions. *ADA 221.2*

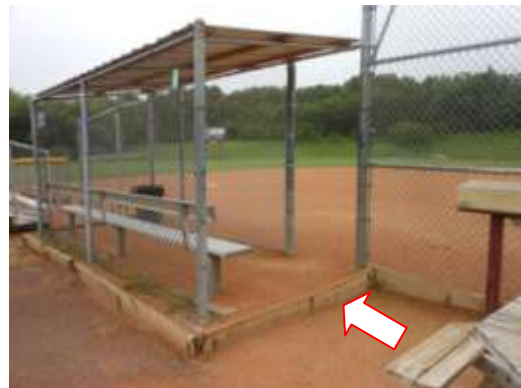
Field 4

There is not currently room within the dugout for a wheelchair space. There is currently a 3" rise into the 1st base dugout and an 8" rise into the 3rd base dugout.

Priority 2- Patch/fill to eliminate the rise into the dugouts. *ADA 303*

Priority 3- Modify the bleacher to provide a wheelchair space within the dugout. *ADA 221.2.1.4*

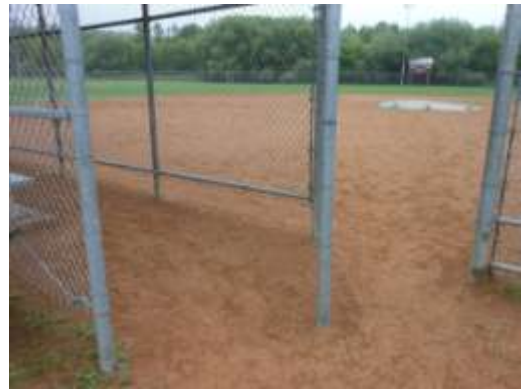
Field 5

An accessible route is currently provided to the fields and the dugouts. There is wheelchair space within the dugouts. *This is a good example of accessibility.*

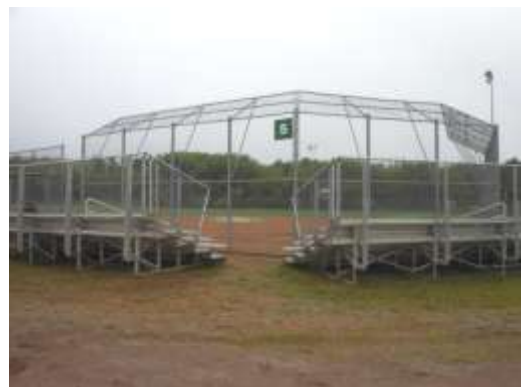
Field 5- Spectator Seating

There are 4 portable bleachers positioned in the grass/dirt behind the backstop. There is currently room for wheelchair viewing positions. *This is a good example of accessibility.*

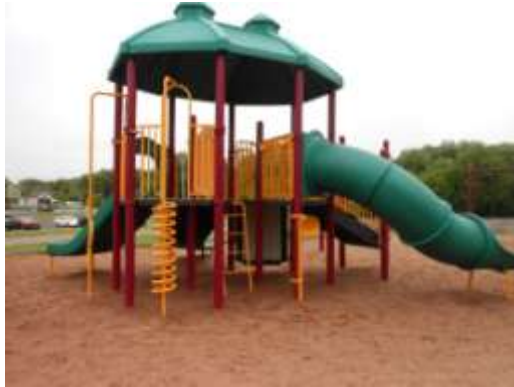
Defined Play Area

The defined play area includes 1 composite play structure, to-fro swings (2 strap style, 2 bucket style), digger, talk tube and play panels. An adequate quantity of ground level components have been provided. *This is a good example of accessibility.*

Loose fill sand is used throughout the defined play area.

Priority 2- Replace the loose fill sand with a surface material with a type that complies with ASTM 1292 for impact attenuation and ASTM 1951 for accessibility. *ADA 206.2.17*

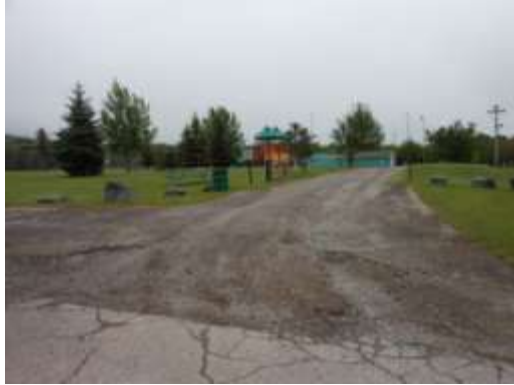
Defined Play Area- Route

There is not currently an accessible route to the defined play area.

Priority 2- Create an accessible route to the defined play area from the service road. *ADA 206.2.2*

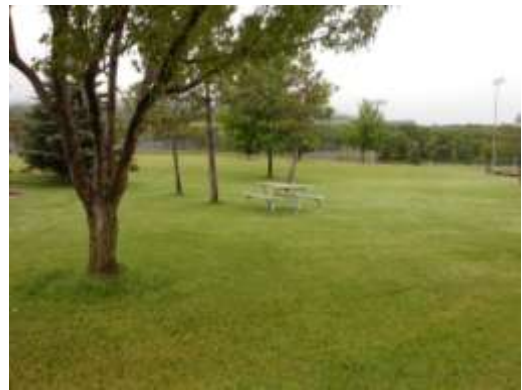
Picnic Tables

There are tables in the grass near the playground and the baseball fields. Currently none of the tables provides a position with knee and toe clearance and there is not an accessible route.

Priority 2- Create an accessible route to the picnic area.

Priority 3- Provide a picnic table that provides knee and toe clearance. *Recommended based on Draft Accessibility Guidelines for Outdoor Developed Areas 1011.4*

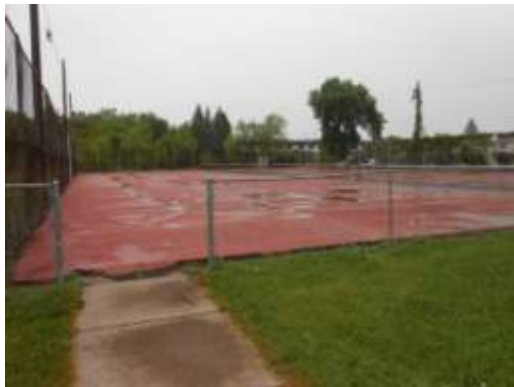
Route

An accessible route is currently provided from the parking lot and fieldhouse to the tennis court entry. The entry point to the tennis court is currently damaged and deteriorating, with a rise exceeding 1/2".

Priority 2- Patch the entry to the tennis courts. ADA 303

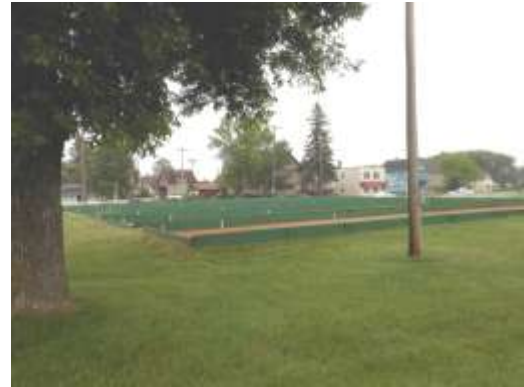
Route

The bocce courts are located to the east of the fieldhouse. An accessible route is not currently provided.

Priority 2- Create an accessible route to the bocce courts. (Approximately 30'.) ADA 206.2.2

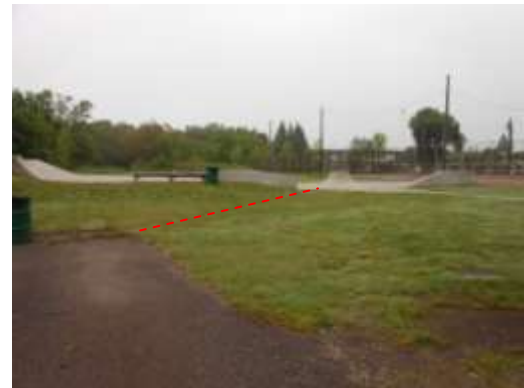
Route

There is not currently an accessible route to the skate park.

Priority 2- Create an accessible route to the border of the skate park. (Approximately 60'.) ADA 206.2.2

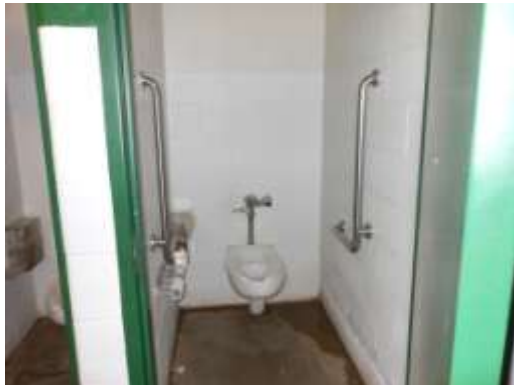
Toilet Rooms

There are multi-fixture men's and women's toilet rooms provided in the concession building. Currently the toilet rooms provide an ambulatory accessible toilet stall, but not a 5' wide accessible stall.

Priority 2- Remodel the toilet rooms to provide a 5' wide accessible toilet stall, including compliant grab bars. ADA 213.2

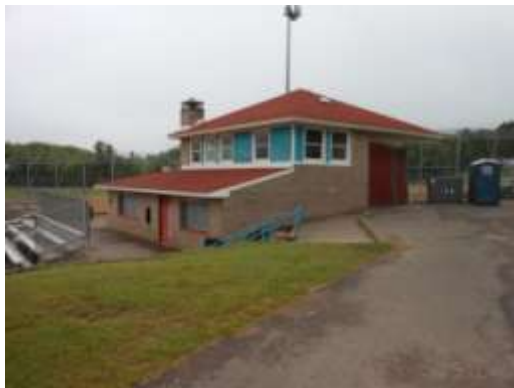
Score Keeper / Office

The upper level of the concession building is a score keepers booth and office. There is not currently an accessible route to the upper level entry (6 exterior risers).

Priority 3- Create an accessible route to the score keepers booth. *ADA 206.2.2, 206.4*

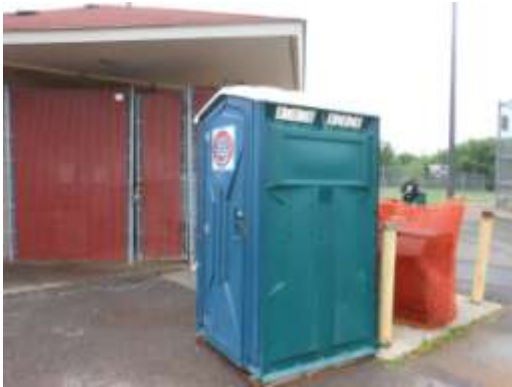
Portable Toilet- Field 1

There is currently a portable toilet located near Field 1. The portable toilet is located on an accessible route, but is not an accessible style.

Priority 2- Provide a minimum of 1 larger/accessible style portable toilet. *ADA 206.2.2, 213.2 Exception 3*

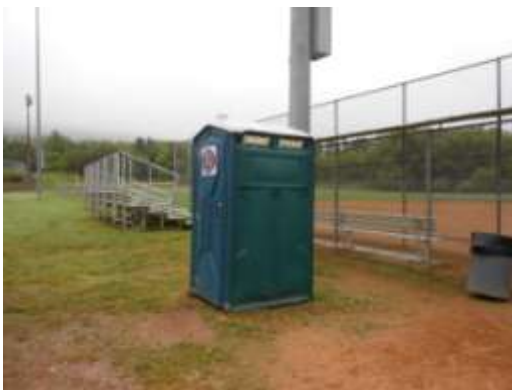
Portable Toilet- Field 5

There is currently a portable toilet located near Field 5. The portable toilet is not an accessible style and is located in the grass/dirt.

Priority 2- Provide a minimum of 1 larger/accessible style portable toilet at an accessible location. *ADA 206.2.2, 213.2 Exception 3*

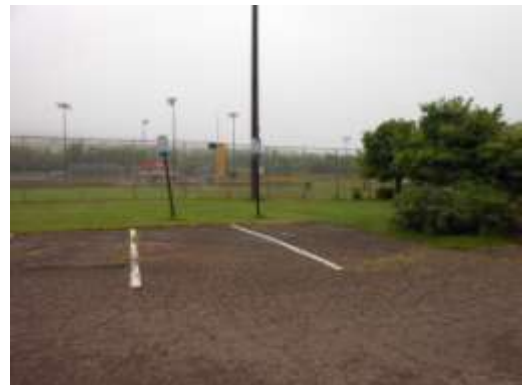
Size- Baseball Field

The 2 spaces designated as accessible are currently 8' wide and do not have an aisle.

Priority 2- Restripe the accessible parking spaces to provide an 8' wide minimum space with an 8' wide minimum aisle. (Note: 2 spaces can share an aisle.) *MN1341 502.4.2*

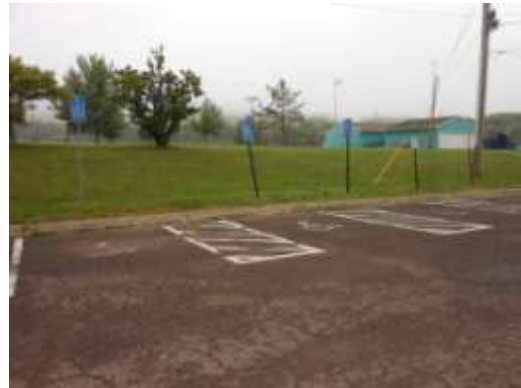
Signs- Baseball Field

The signs designating the accessible parking spaces are currently faded (completely white).

Priority 2- Replace the signs with new ones, ensure they are mounted at 60-66" AFF. MN1341 502.7
