# Bayfront Park

## Activities / Amenities

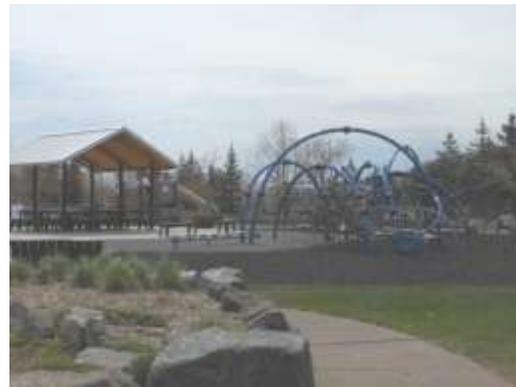
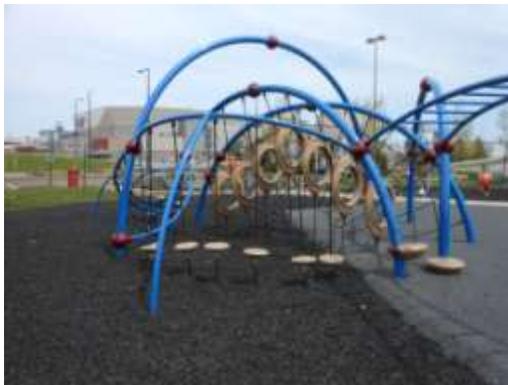
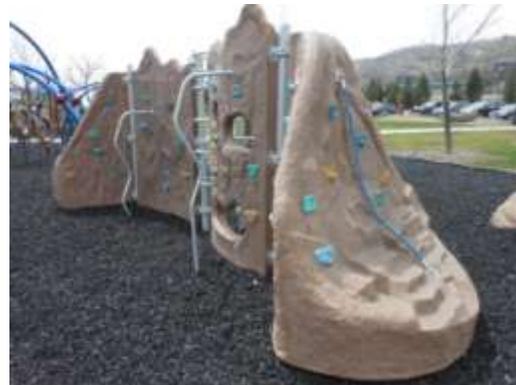
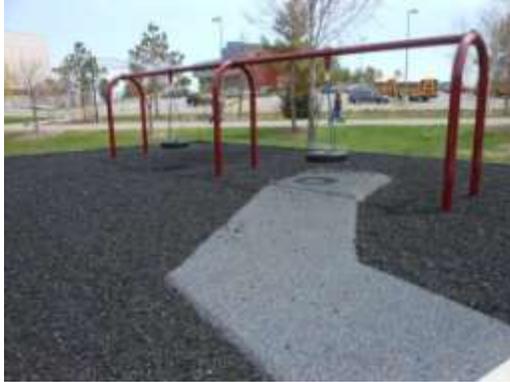
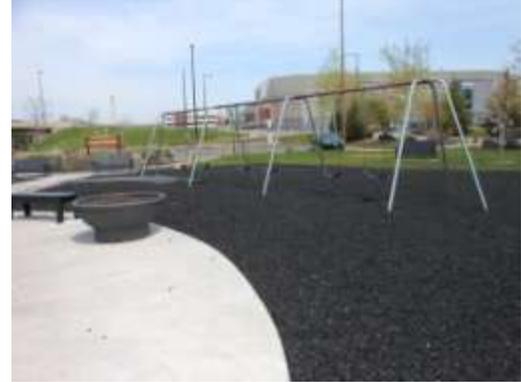
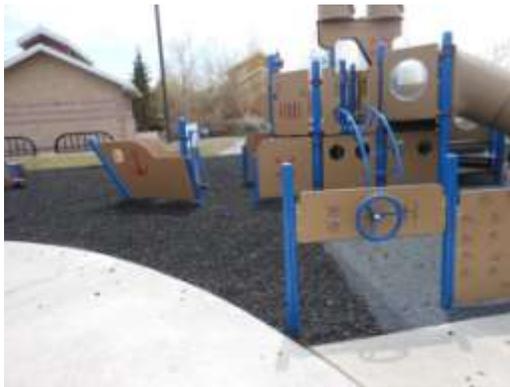
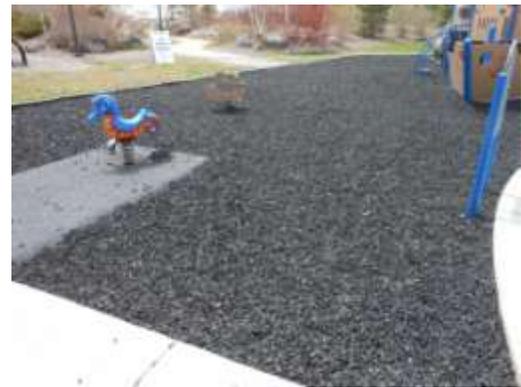
### Defined Play Areas

The defined play area includes 2 composite play structure (1 for 2-5 year olds, 1 for 5-12 year olds), to-fro swings (5 strap style, 4 bucket style and 1 formed), tire swings, spring rockers (2), play panels and a rock wall climber. An adequate quantity of ground level components have been provided. Loose fill rubber chunks combined with unitary surface material are used throughout. *These are good examples of accessibility.*

**Priority 3-** Maintain the surface depth of the loose fill surface material, especially where the loose fill meets the unitary surface material.

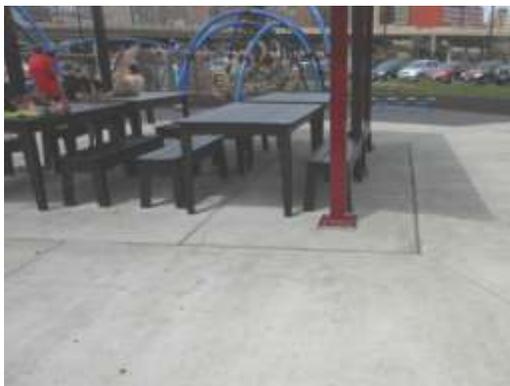
**Picnic Pavilion**

There is a picnic pavilion in the center of the defined play areas, located on an accessible route. There are 4 tables positioned under the shelter, currently all of the tables provide knee and toe clearance at the end. *This is a good example of accessibility.*

*There are no recommendations at this time.*

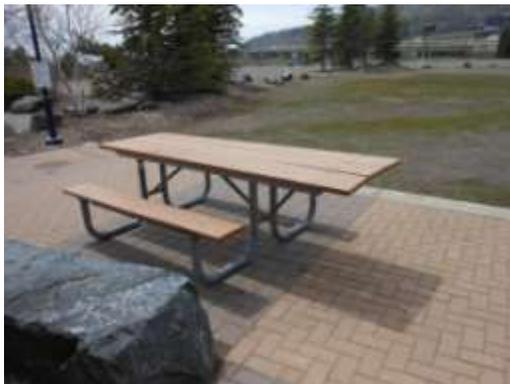
**Picnic**

There are picnic tables scattered throughout the park near the play area and Family Center building. Tables that provide knee and toe clearance have been located on an accessible route. *This is a good example of accessibility.*

*There are no recommendations at this time.*

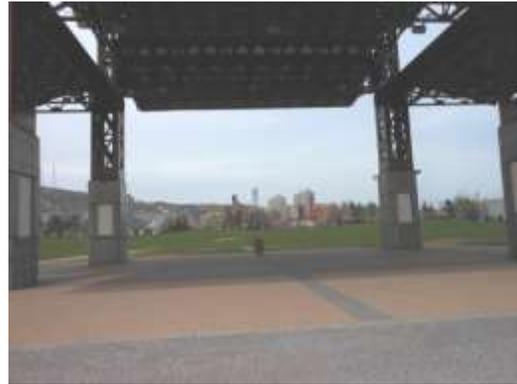
### Stage

There is a permanent stage with a shade structure at the center of the park. The permanent stage is on grade. *This is a good example of accessibility.* It is the understanding of JQP, Inc. that for temporary events, raised stages are added.

**Priority 1-** Ensure that an accessible route is provided to temporary stages. *ADA 201.3*

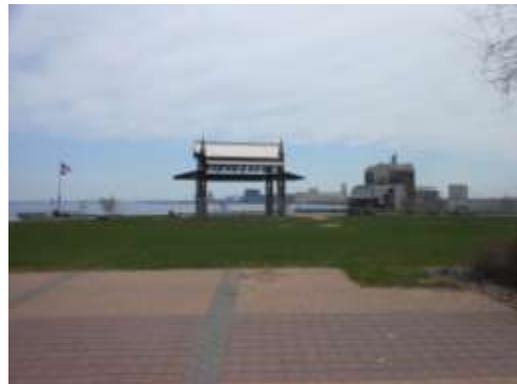
### Seating

Permanent seating is not provided. There is open lawn seating. An accessible hard surface route is provided up to the edge of the grass (opposite the stage) and the route continues around the lawn and behind stage (at times the view is blocked by trees).

**Priority 1-** Ensure an accessible route is provided to the lawn seating area. (Ensure that event organizers to not place barriers in a location that obstructs the accessible route.) *ADA 221.5*

**Priority 1-** Work with event organizers to ensure that ticketing policies comply with the ADA.

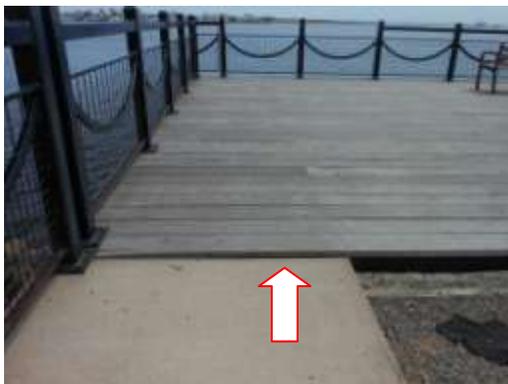
There is a viewing platform (Slip #1) that extends into the harbor. There is currently a rise exceeding 1/2" where the concrete meets the boardwalk.

**Priority 2-** Patch or bevel to reduce the rise. *ADA 303*

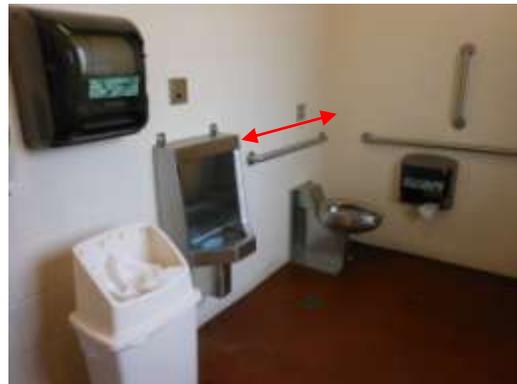
### **Toilet Rooms**

There are 2 single user toilet rooms within the family center. Both toilet rooms currently provide features of accessibility. *This is a good example of accessibility.*

The urinal in the men's toilet room is currently within the clearance for the toilet (reduces the clearance to 52" vs. 60").

*No action at this time. ADA 213.2 Exception 4 states that only 50% of single user toilet rooms clustered at a single location need to comply (the women's toilet room currently complies).*

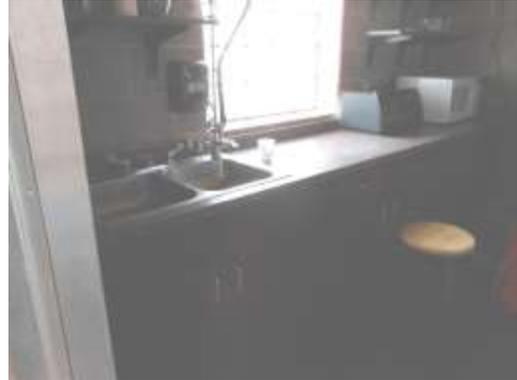
### **Sink**

A sink is currently located in the vending machine area. The rim of the sink is at 36".

**Priority 3-** At such time remodeling occurs, lower the sink to 34" maximum. *ADA 212.3, 606.3*

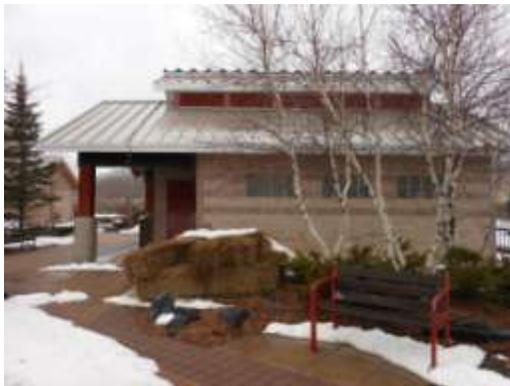
A bathroom building is provided near the play area. JQP, Inc. prepared a detailed report of the bathroom building, it has been included in the facilities report.

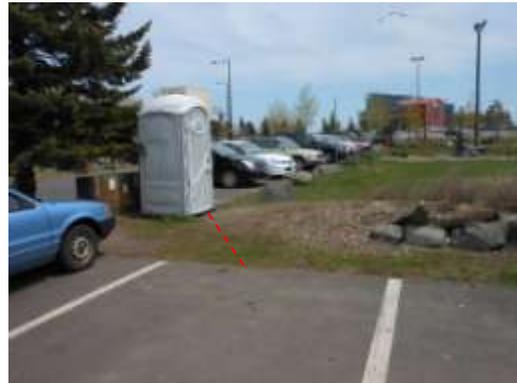
### **Single Toilet**

There is a portable toilet located in the grass near the parking lot and play area. It does not currently provide any features of accessibility.

**Priority 3-** Provide an accessible portable toilet at an accessible location.

Note: accessible toilets are provided in the nearby bathroom building and family center, but those buildings are not open to the public at all hours.

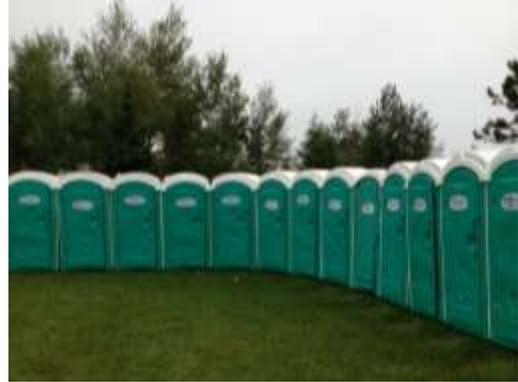
## **Events**

Portable toilets are brought in for large events that take place in Bayfront Festival Park.

**Priority 1-** Ensure that when portable toilets are brought in for events, a minimum of 5% of the toilet units are accessible and located on an accessible route. *ADA 213.2 Exception 3*

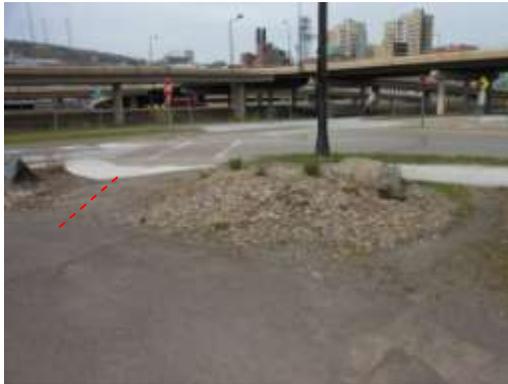
### **City Sidewalk**

There is a city sidewalk along the perimeter of the park. There is not currently an accessible connection between the sidewalk and the park.

**Priority 2-** Create an accessible link to the city sidewalk. *ADA 206.2.1*

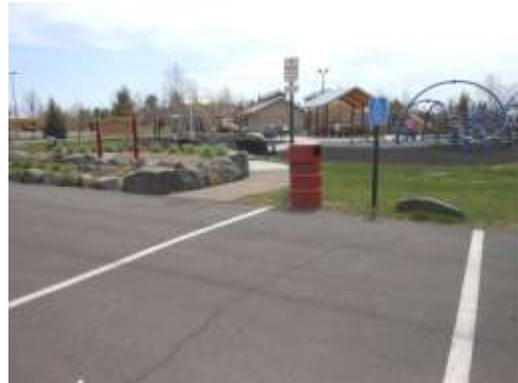
### **Parking- Northeast**

There are currently 2 parking spaces designated as accessible on the northeast side of the park. The spaces are currently 12' wide and do not provide an aisle. (There is a 30' wide space between the 2 spaces, but it has not been striped or designated as 'no parking'.)

The signs designating the accessible parking spaces are currently at 54" AFF.

**Priority 2-** Stripe an 8' wide minimum aisle for each of the spaces. *MN1341 502.4.2*

**Priority 3-** Raise the parking signs so the bottom edge is 60"-66" above the surface of the parking space. *MN1341 502.7*

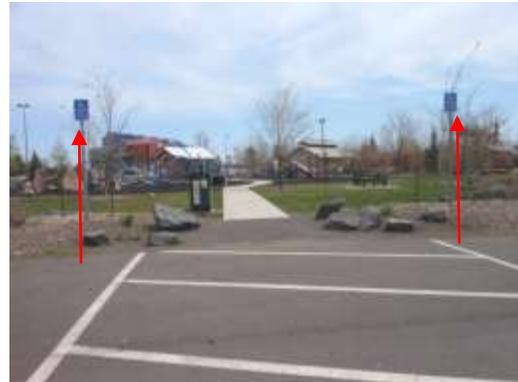
### **Parking- Northwest**

There are currently 2 parking spaces designated as accessible on the northwest side of the park. The spaces are currently 9' wide with a 16' wide aisle between. *This is a good example of accessibility.* The signs designating the accessible parking spaces are currently at 98" AFF.

**Priority 3-** Lower the parking signs so the bottom edge is 60"-66" above the surface of the parking space. MN1341 502.7

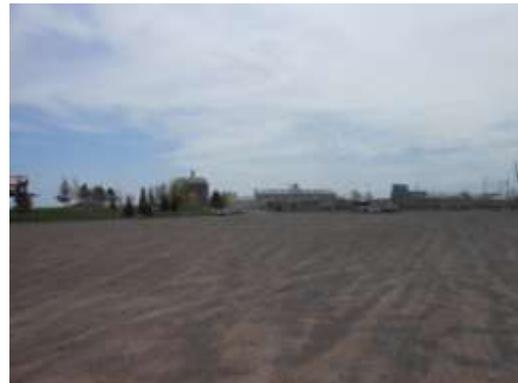
### **Gravel Lot**

There is a large gravel lot used for event parking. There are currently no designated parking spaces and no designated accessible parking spaces.

**Priority 3-** Designate accessible parking spaces during events. ADA 208.2
