RE: **Certified Local Government Comment on the nomination of: Lincoln Park, 25th Avenue West and 5th Street, Duluth, St. Louis County to the National Register of Historic Places**

Lincoln Park
Name of Property

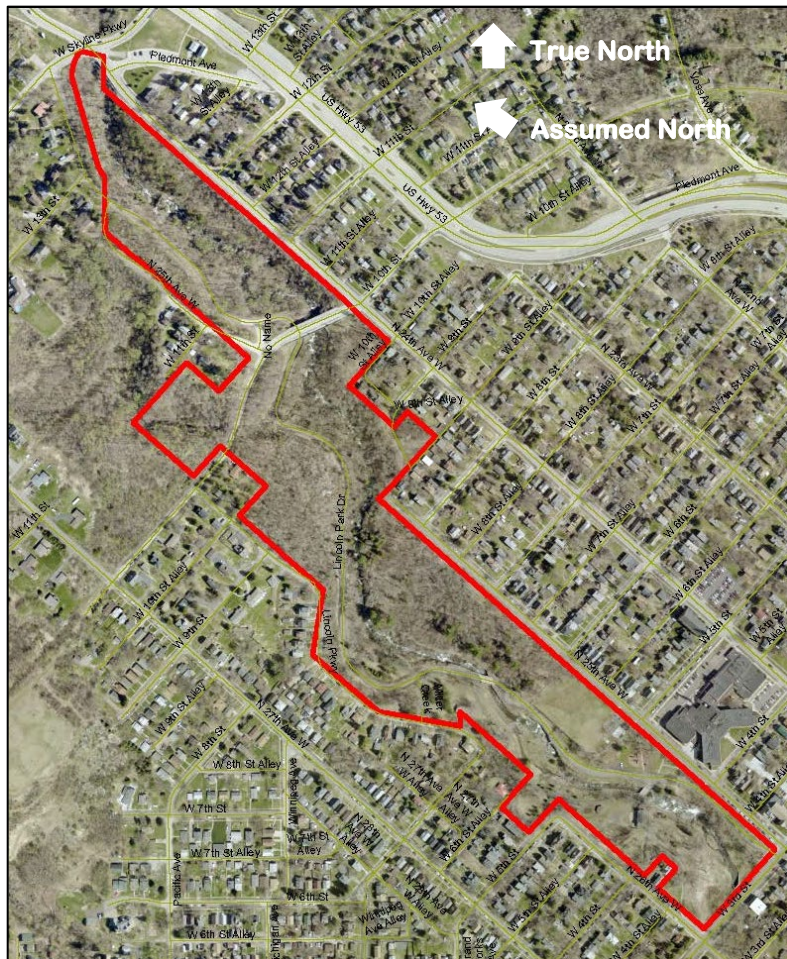
*Lincoln Park boundaries are outlined in red.
(from City of Duluth, "Declaration of Restrictive Covenant,"
2023. Exhibit 2)*

The western boundary is more complicated. It follows North 25th Avenue West between Skyline Parkway and West 10th Street, then jogs northwest to include a wooded ravine before crossing West 10th Street. Continuing south and west, it edges residential lots before connecting with Lincoln Parkway at the alignment of the West 10th Street alley. It remains on the parkway until nearing West 6th Street, where it briefly runs northwest before taking a southern course on the alignment of North 26th Avenue West. After a slight bump to the west to include a small area between the West 6th Street alley and West 5th Street, the boundary follows 26th Avenue to 3rd Street, excluding a private parcel east of that road. All in all, the park contains approximately 43.3 acres.

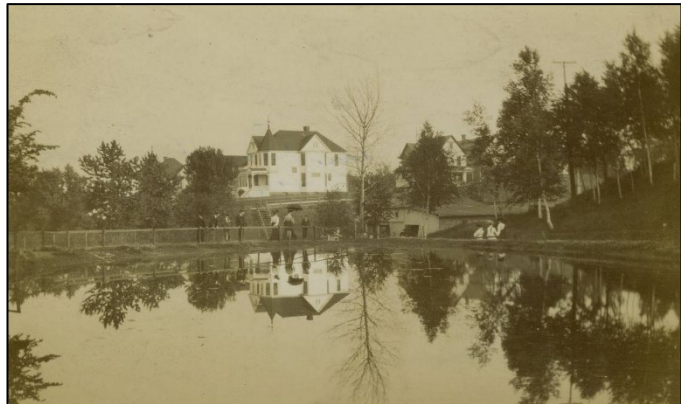
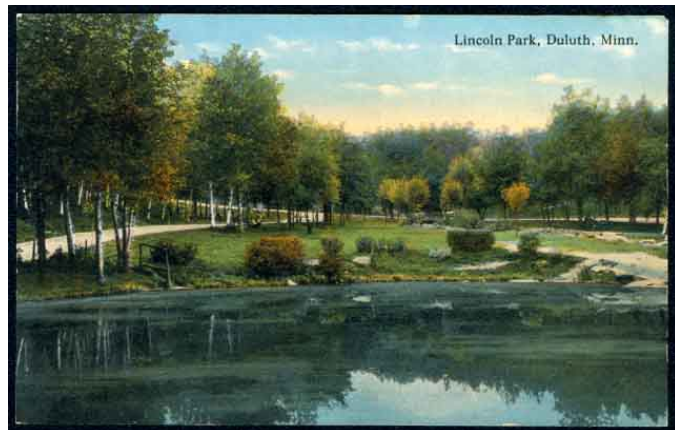
*Artificial lake in Lincoln Park, looking southwest towards corner of 5th Street and 26th Avenue, ca. 1904 (above), and north, ca. 1914 (below).
(Minnesota Historical Society)*

The location of these water features was not shown on any known drawings, but two historic images indicate the lake’s approximate location on the west side of the creek between 5th and 6th Streets. A house visible in the background of one of the photographs still stands at the corner of 5th Street and 26th Avenue. Remnant landscape features—raised areas once part of the lake’s southeast and southwest edge—provide further confirmation of the location. To the east and north, Miller Creek’s flooding and efforts to address it have removed evidence of the lake’s other shores.

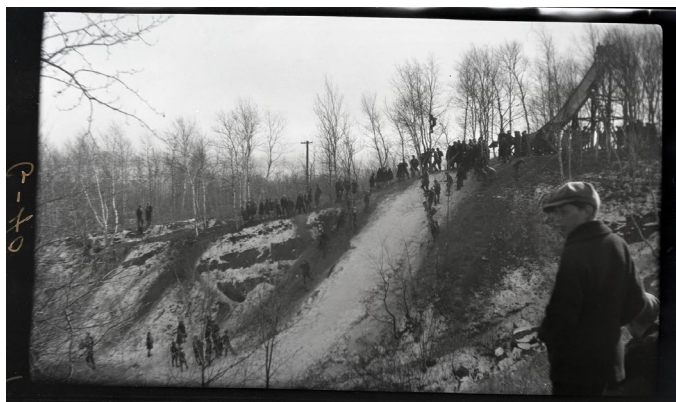
Lincoln Park Bridge carrying West 10th Street in 1929, two years after it opened (top right). Lincoln Park toboggan slide (top left) and ski jump (below) in 1931. (F. Rodney Payne, photographer; Archives and Special Collections, University of Minnesota Duluth)

Lincoln Park gained a toboggan slide in 1927, joining one in Chester Park that had been established earlier. Park staff erected the upper section of Lincoln Park's slide of wood and the community pitched in to form the lower section from snow. The department's annual report claimed it was "longer than any other slide in the city and the most exciting." Two years later, the annual report acknowledged that "the toboggan slides in Lincoln Park were again maintained largely through the efforts of some of the boys in the community. The Park Department cooperated with them in putting up a wooden scaffolding for the beginning of the slide and building up the curves." In December 1930, an additional winter sport option appeared: "The Park Department built a small ski slide in Lincoln Park just below Ninth Street which is suitable for boys learning how to jump."³⁰

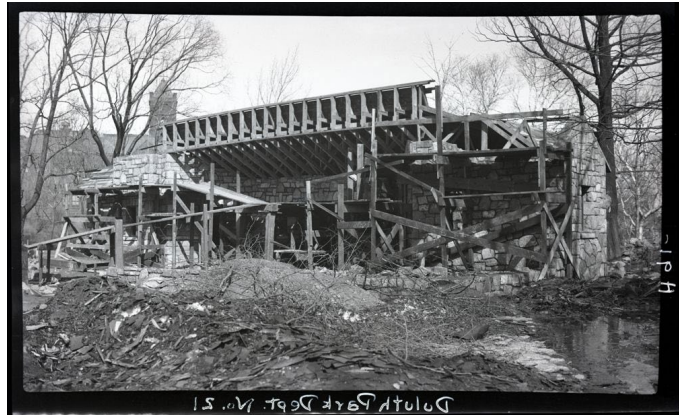
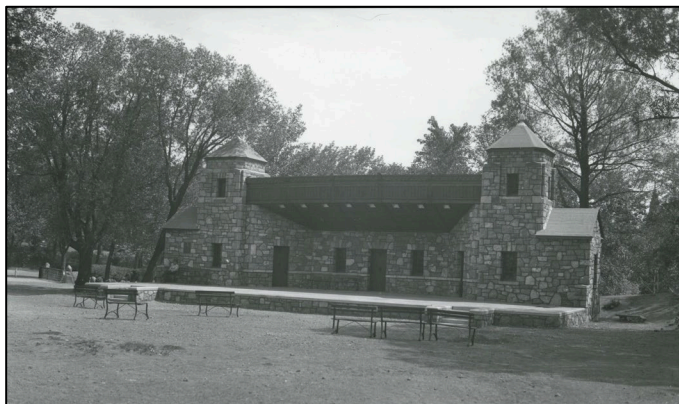
*Pavilion under construction in 1934 (above; F. Rodney Payne, photographer) and completed (below).
(Archives and Special Collections,
University of Minnesota Duluth)*

The next year, though, saw the start of a major project, the construction of a stone pavilion in partnership with the Civil Works Administration (CWA). The department's annual report showed an expenditure of \$12,000 in that year on the project and observed: "All of the relief work . . . was done by the most primitive methods and with practically no equipment." The city paid \$2,000 to have the pavilion's slate roof installed in 1935 and another \$500 for "grading, top dressing, graveling and seeding in vicinity of band stand." Work on the plumbing was finally accomplished in fall 1936 but the department did not consider the project finished until 1939.³⁵

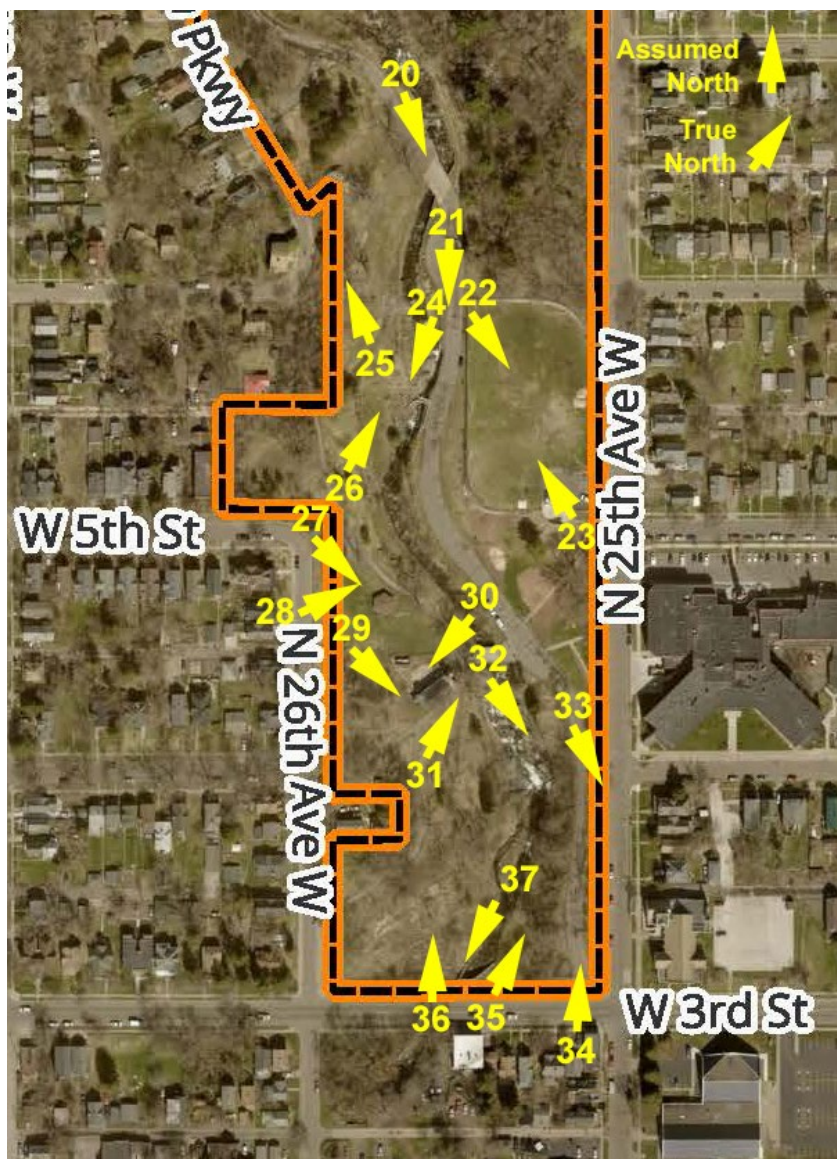
Photo key of lower park

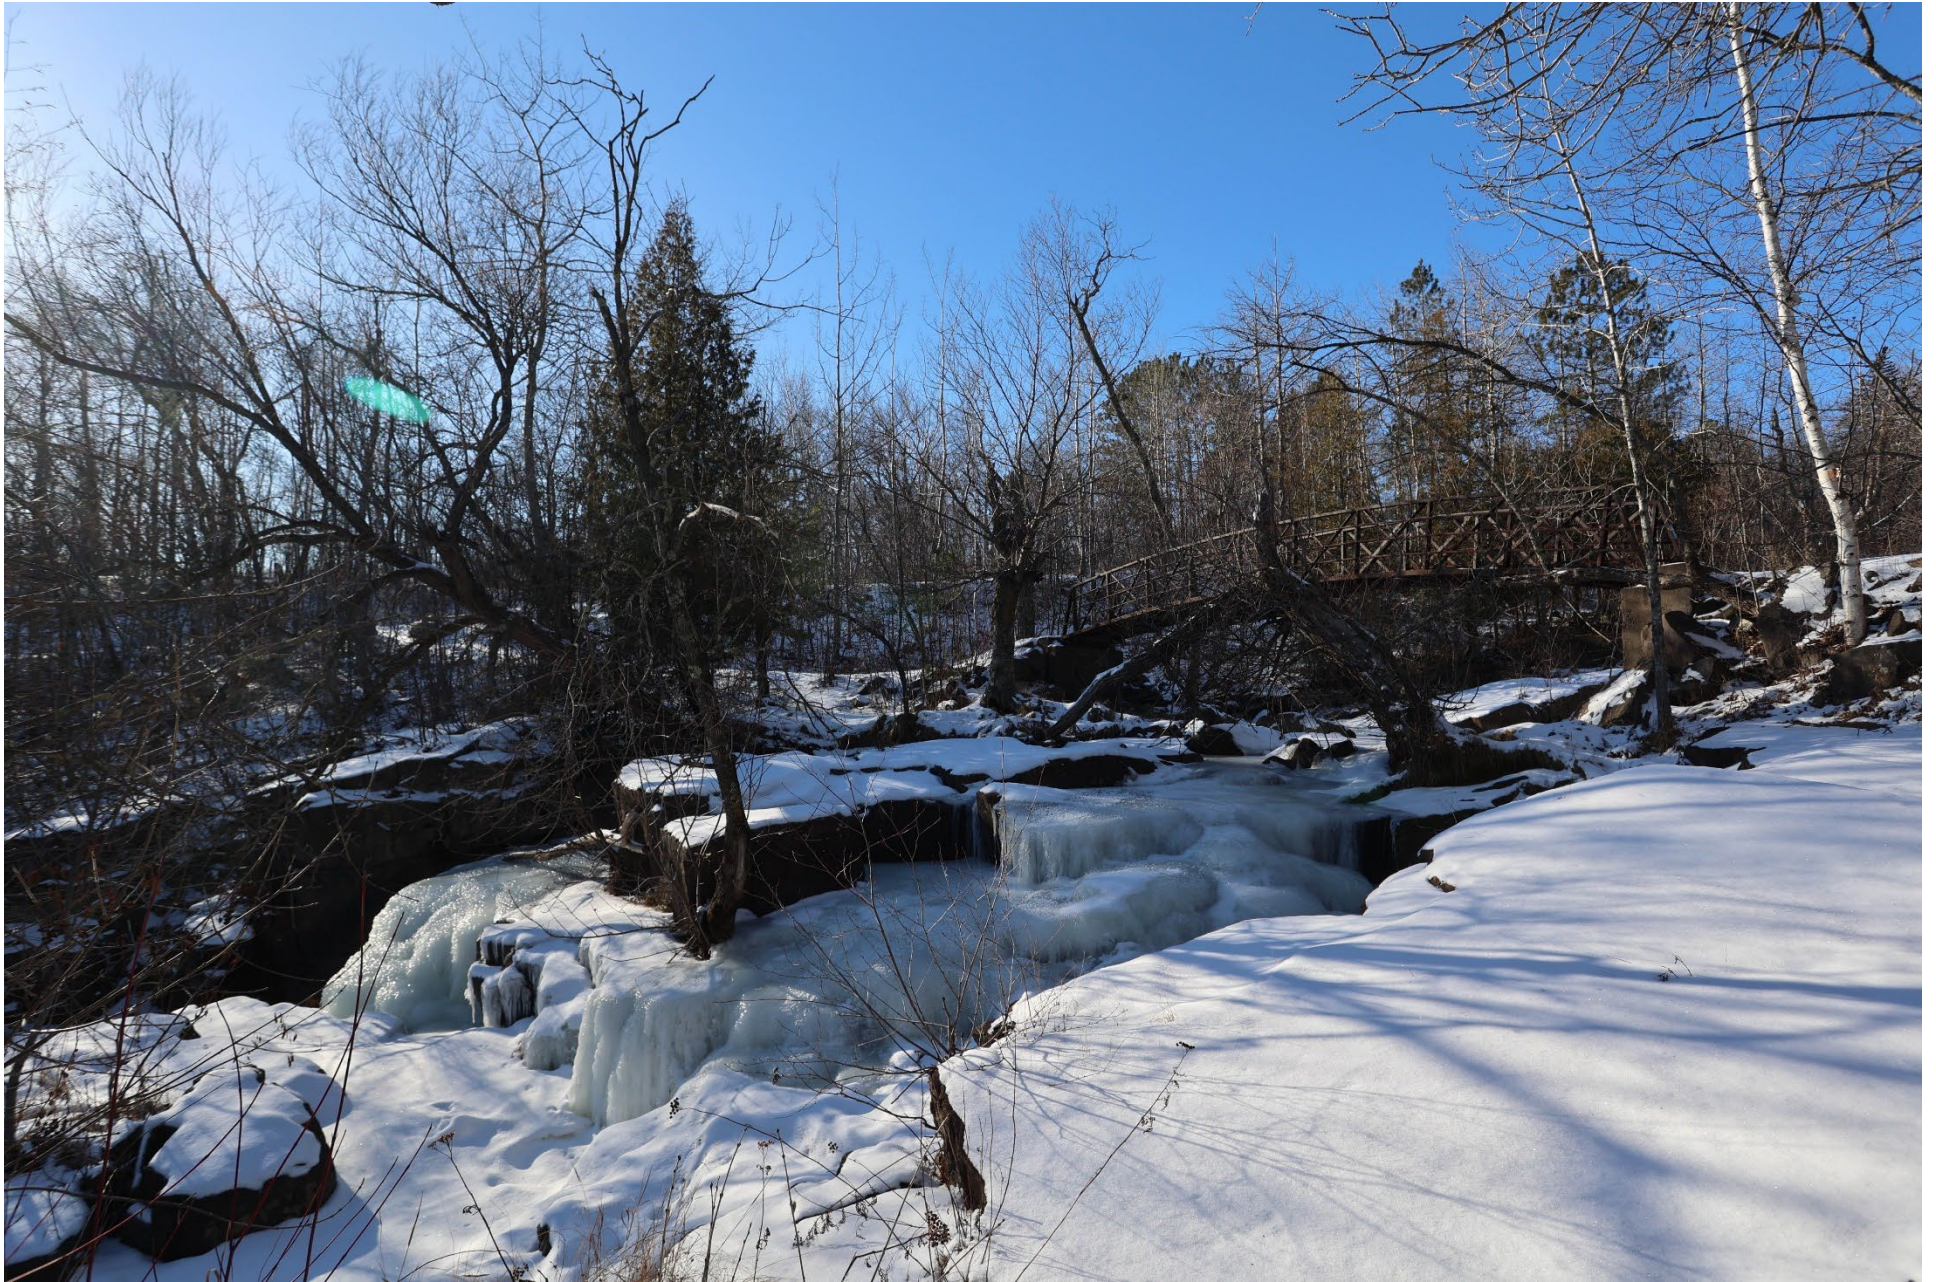
MN_St. Louis County_Lincoln Park_0005

The south elevation of the 12th Street Pedestrian Bridge over Miller Creek. Looking northwest.

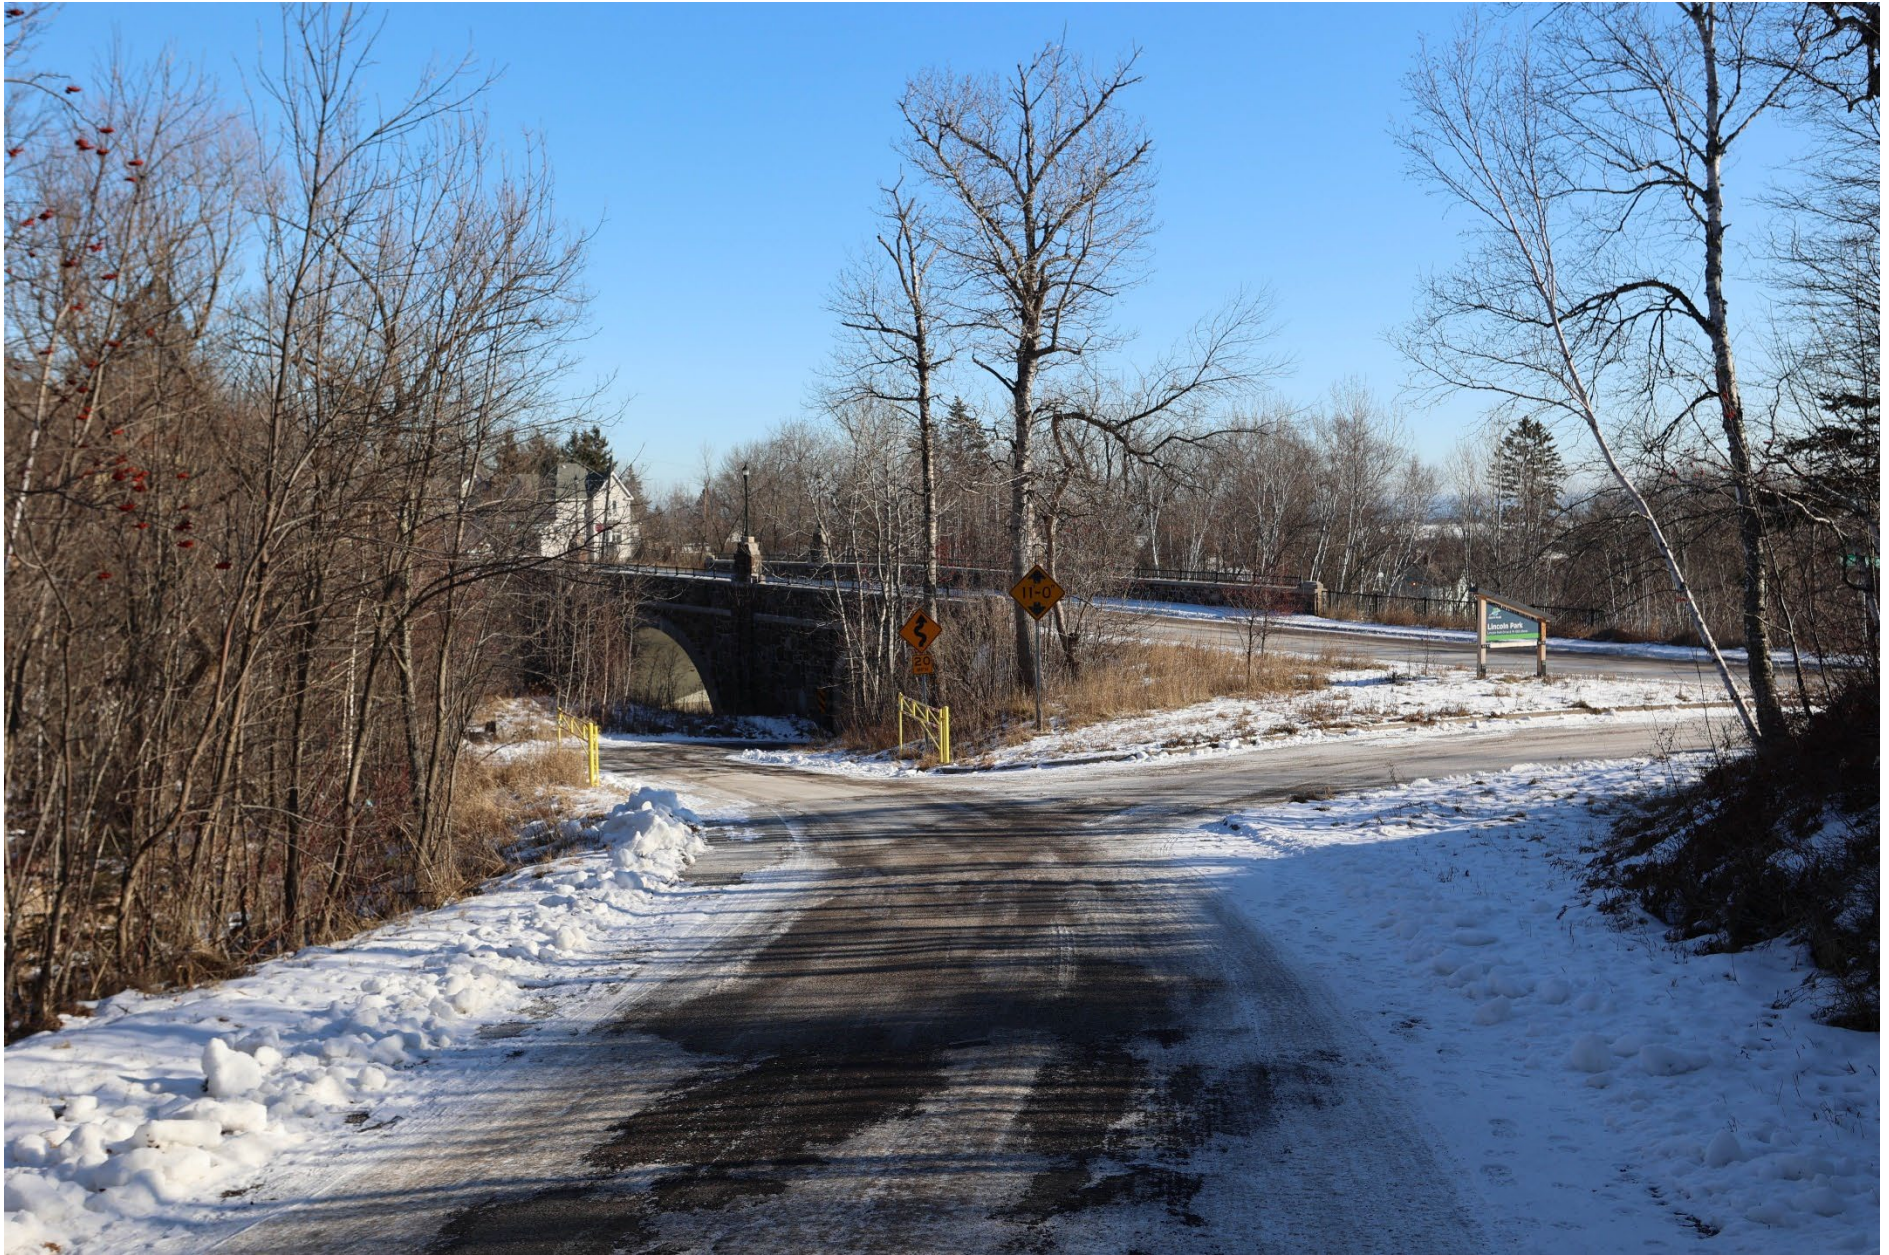
MN_St. Louis County_Lincoln Park_0007

Lincoln Park Drive approaching the Lincoln Park Bridge from the north. The road goes beneath the bridge's western span; Miller Creek and a trail run under the eastern span. A spur connects Lincoln Park Drive and 10th Street. Looking southeast.

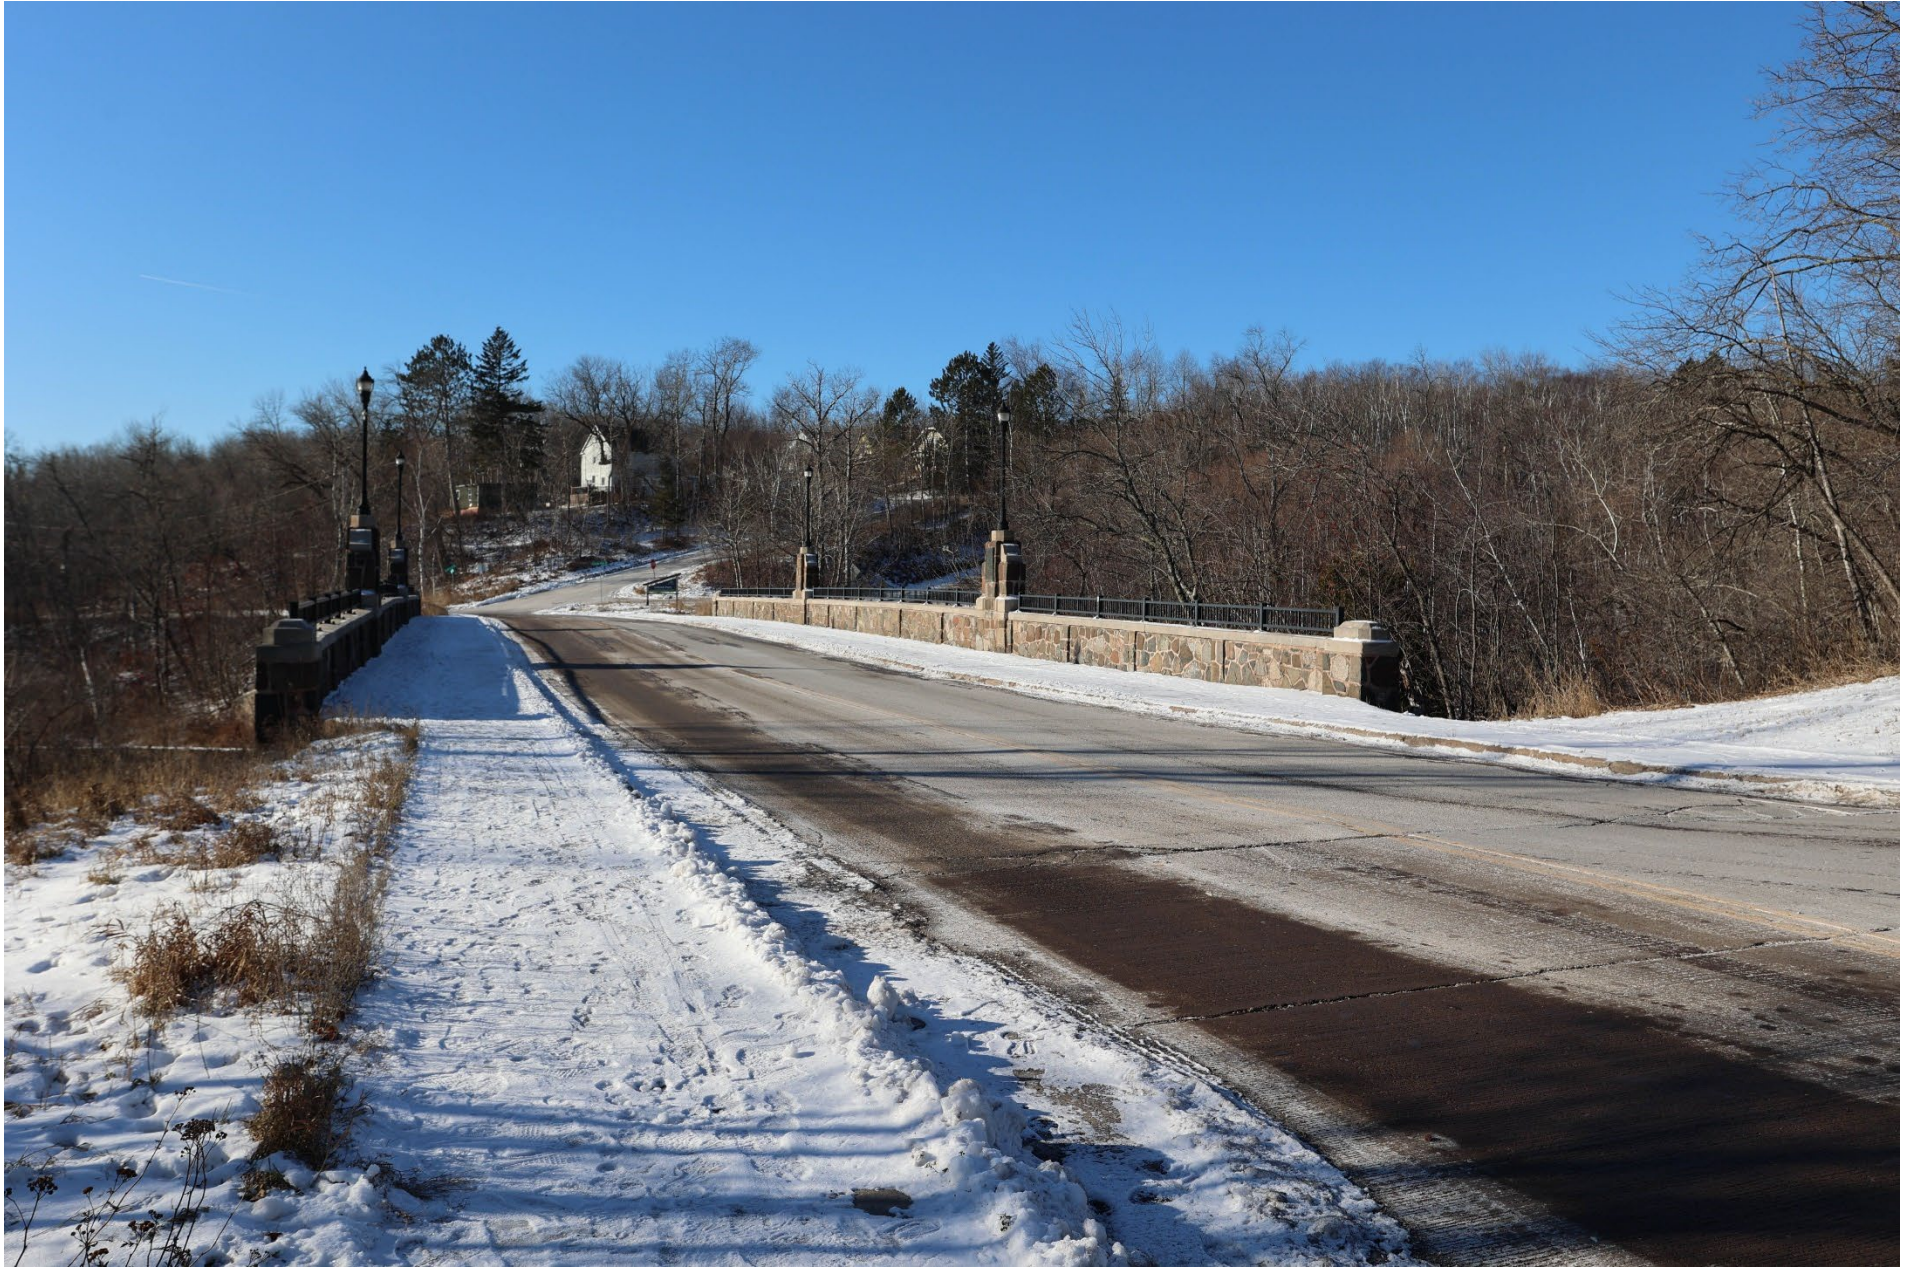
MN_St. Louis County_Lincoln Park_0008

East approach to the Lincoln Park Bridge, which carries 10th Street over the Miller Creek ravine. The road angling to the right at the west end of the bridge is 25th Avenue. The spur connecting 10th Street to Lincoln Park Drive is at the base of 25th Avenue. Looking northwest.

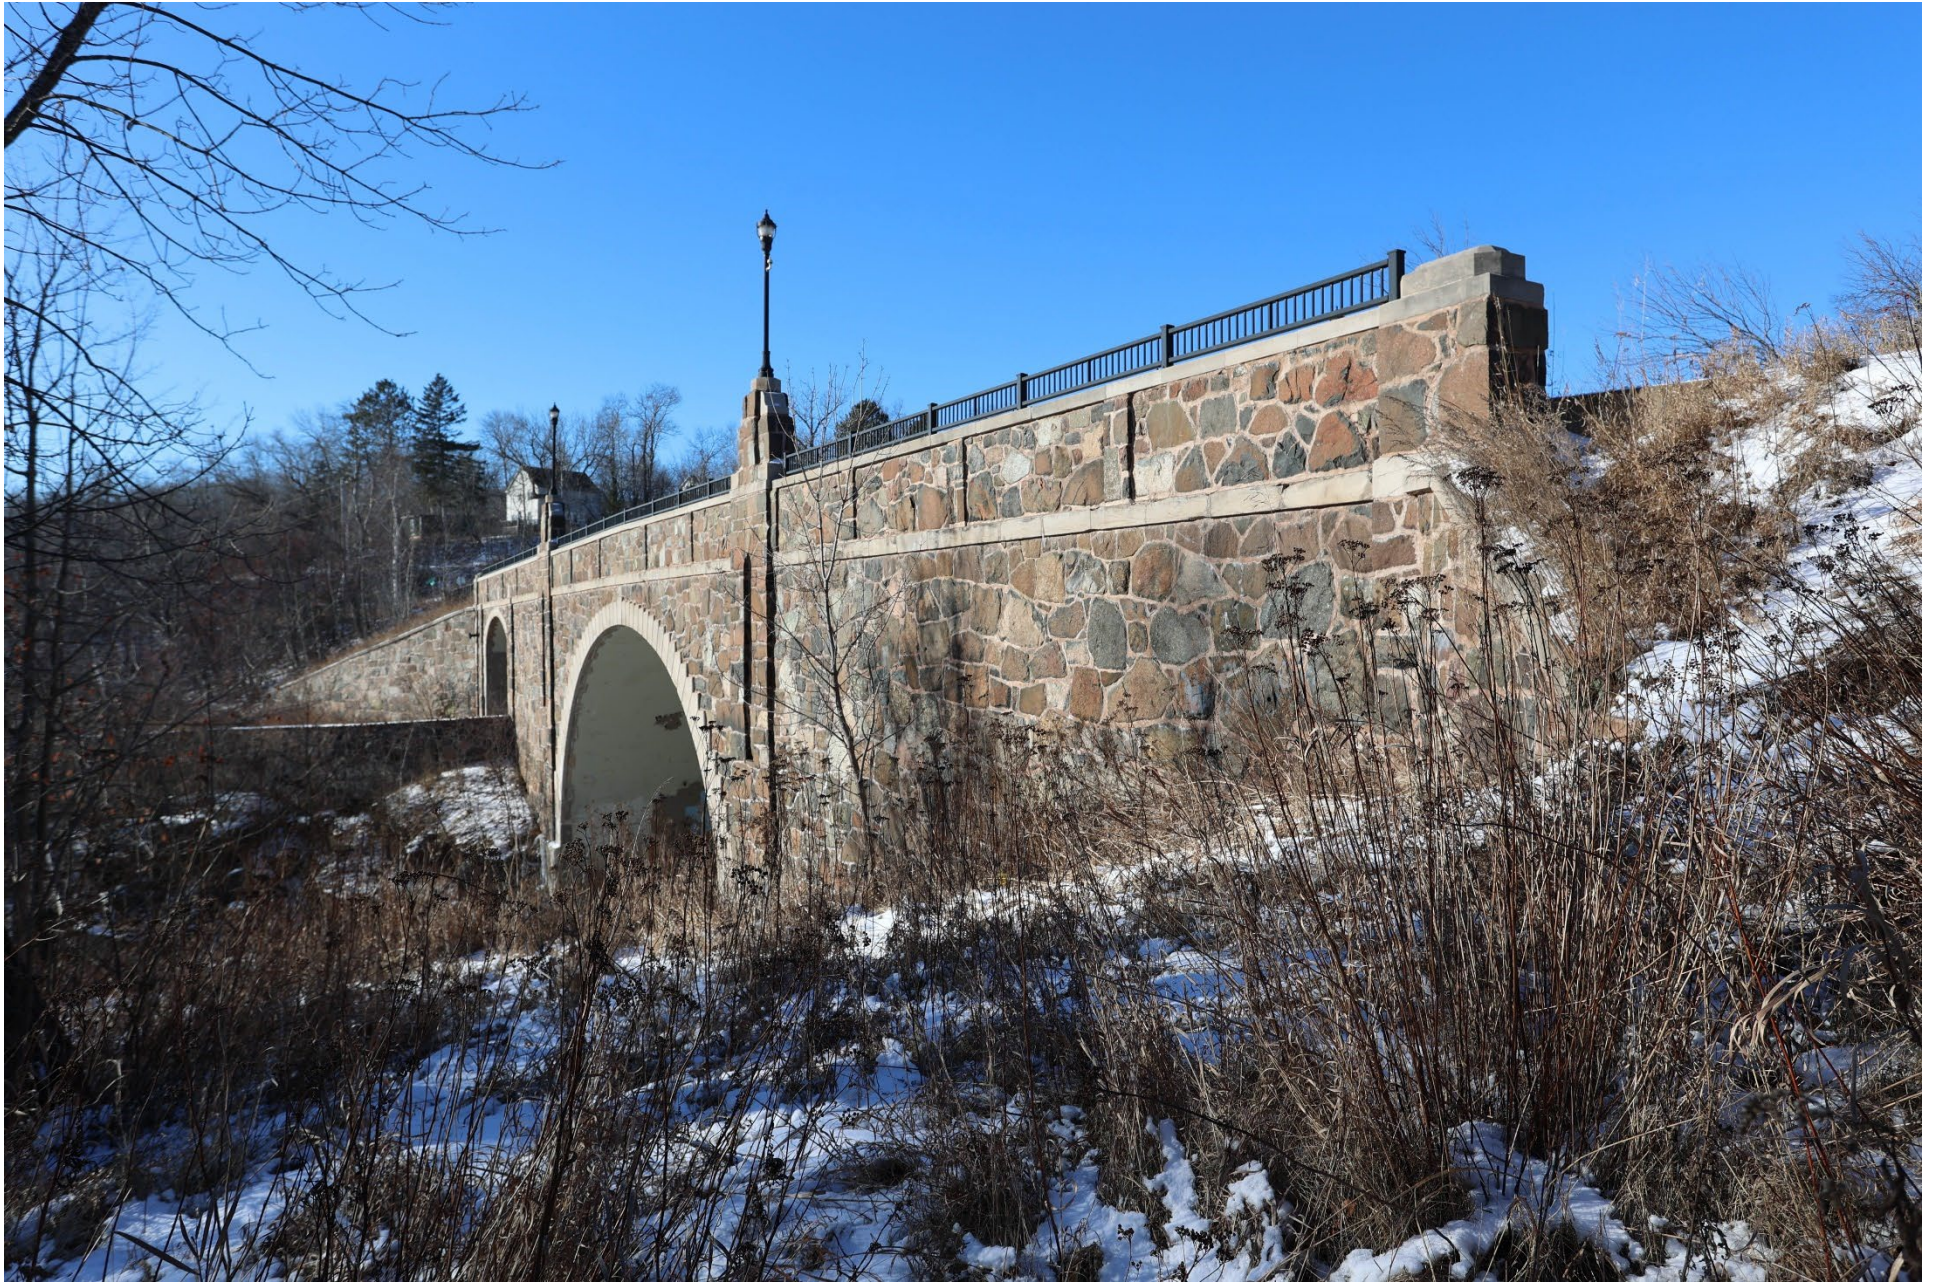
MN_St. Louis County_Lincoln Park_0009

South elevation of Lincoln Avenue Bridge. A stone retaining wall along Lincoln Park Drive extends from the western span. Looking northwest.

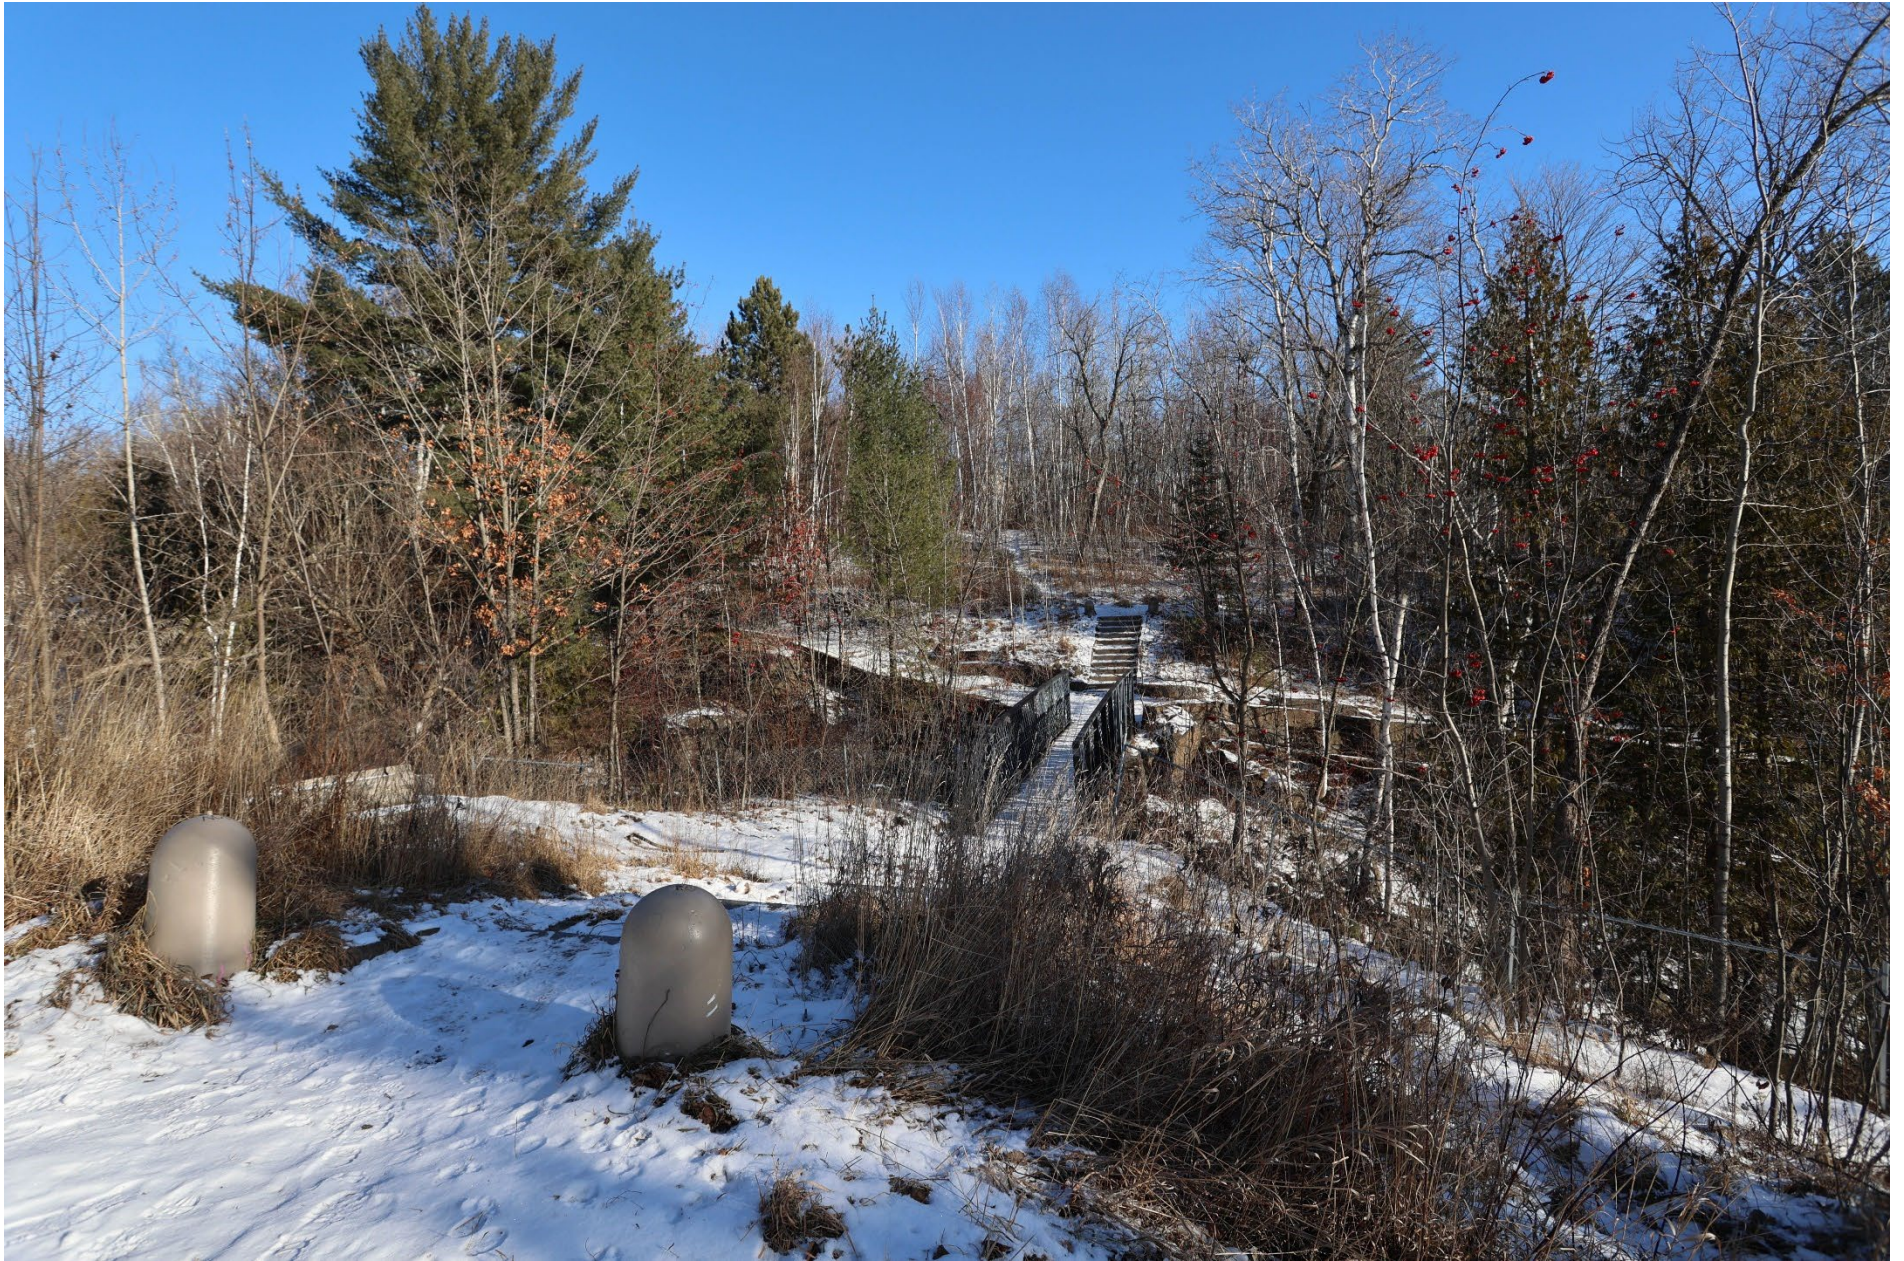
MN_St. Louis County_Lincoln Park_0012
8th Street Pedestrian Bridge over Miller Creek. Looking east.

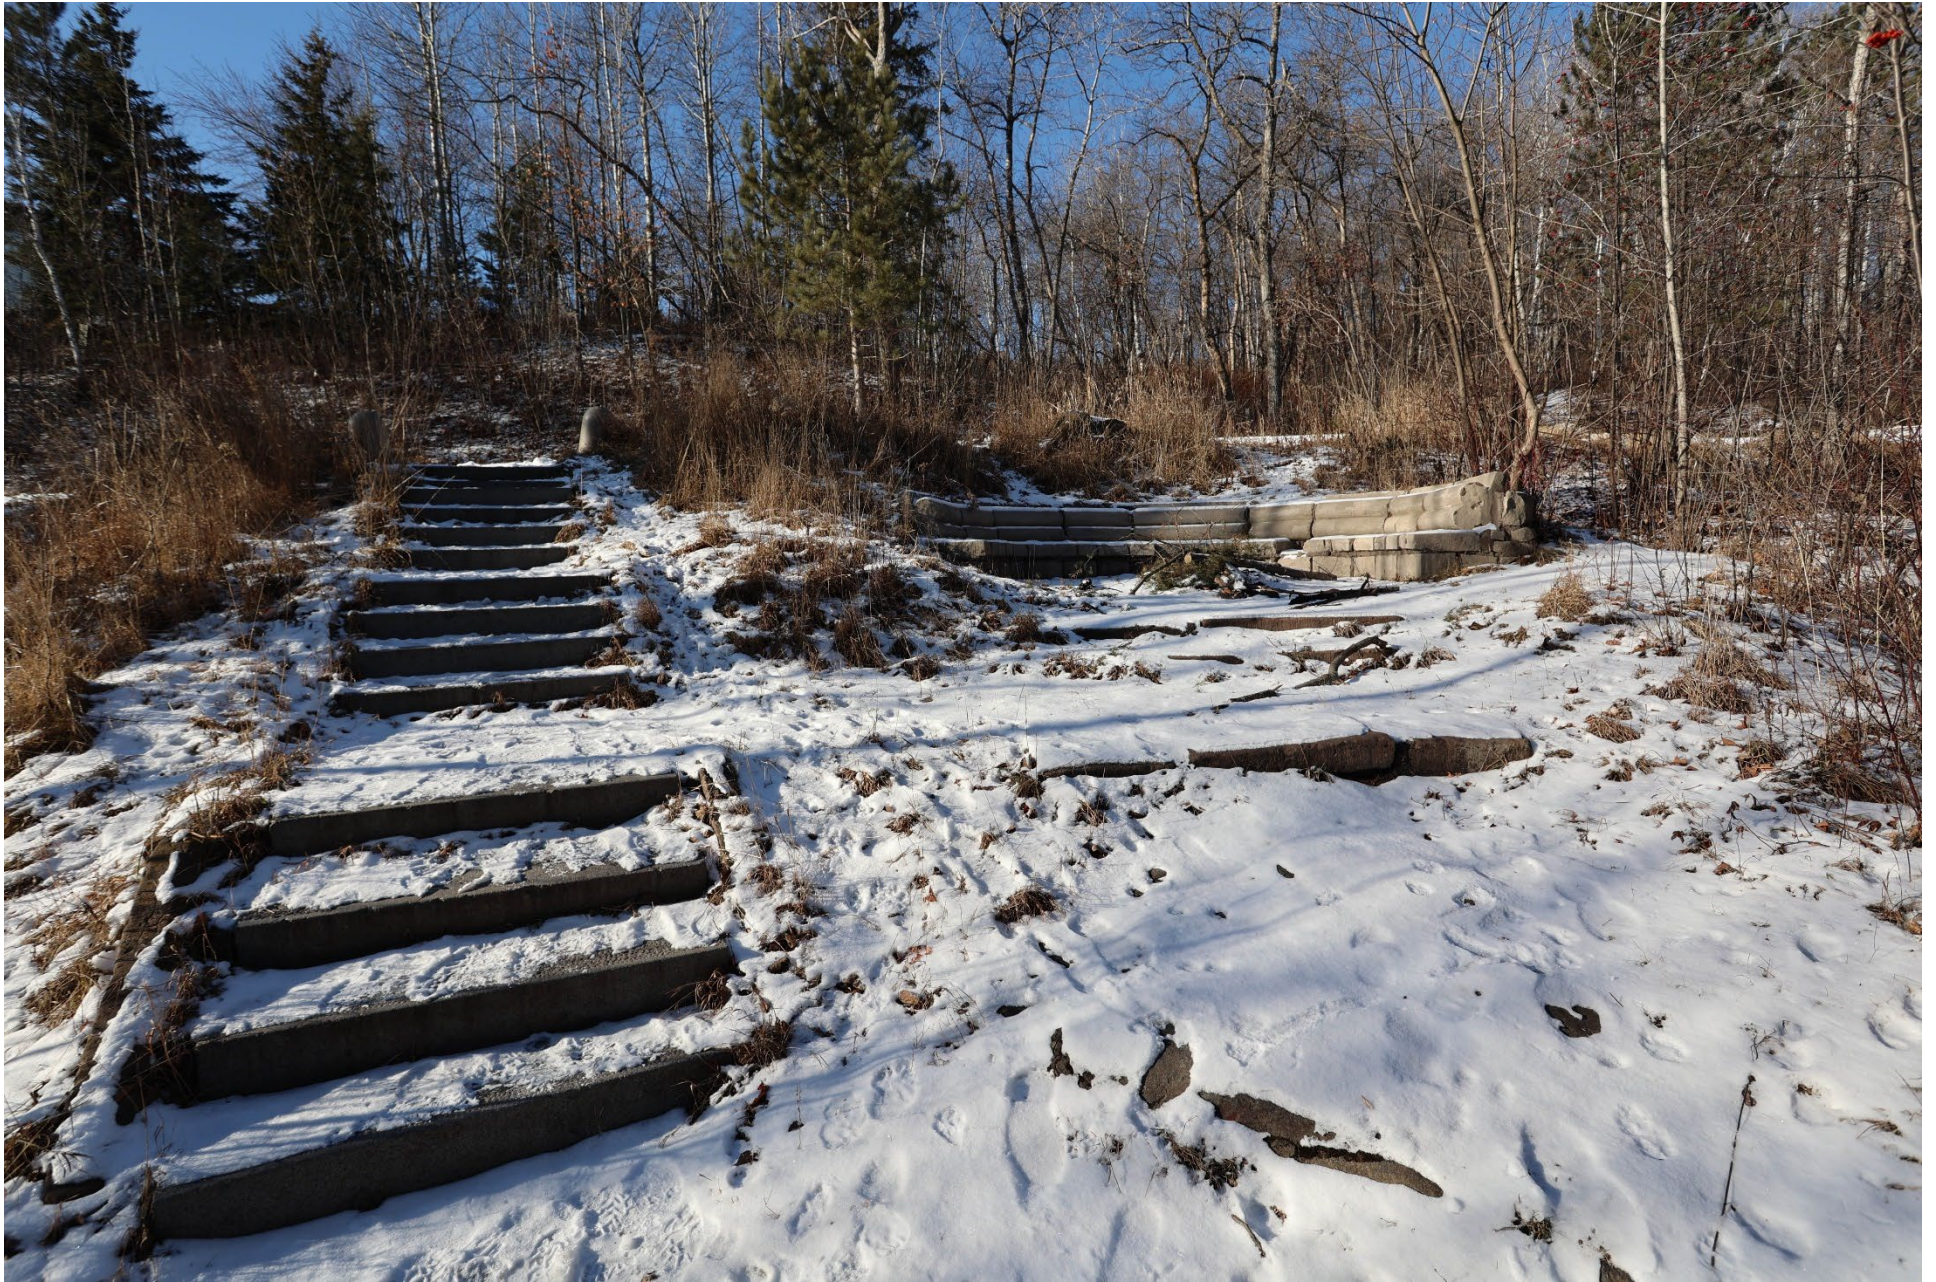
MN_St. Louis County_Lincoln Park_0013

Stairway and stone settee at west end of 8th Street Pedestrian Bridge. Looking west.

A curved stone settee with a backrest of cylindrical stone bolsters is between Lincoln Park Drive and Miller Creek at the west end of the 8th Street Pedestrian Bridge (Photo 13). Joints between masonry units have been repaired poorly or not at all and the bench is in poor condition. The settee, along with other stonework in the area, was installed by the National Youth Administration in 1940. Due to its substantial size the settee is considered contributing.

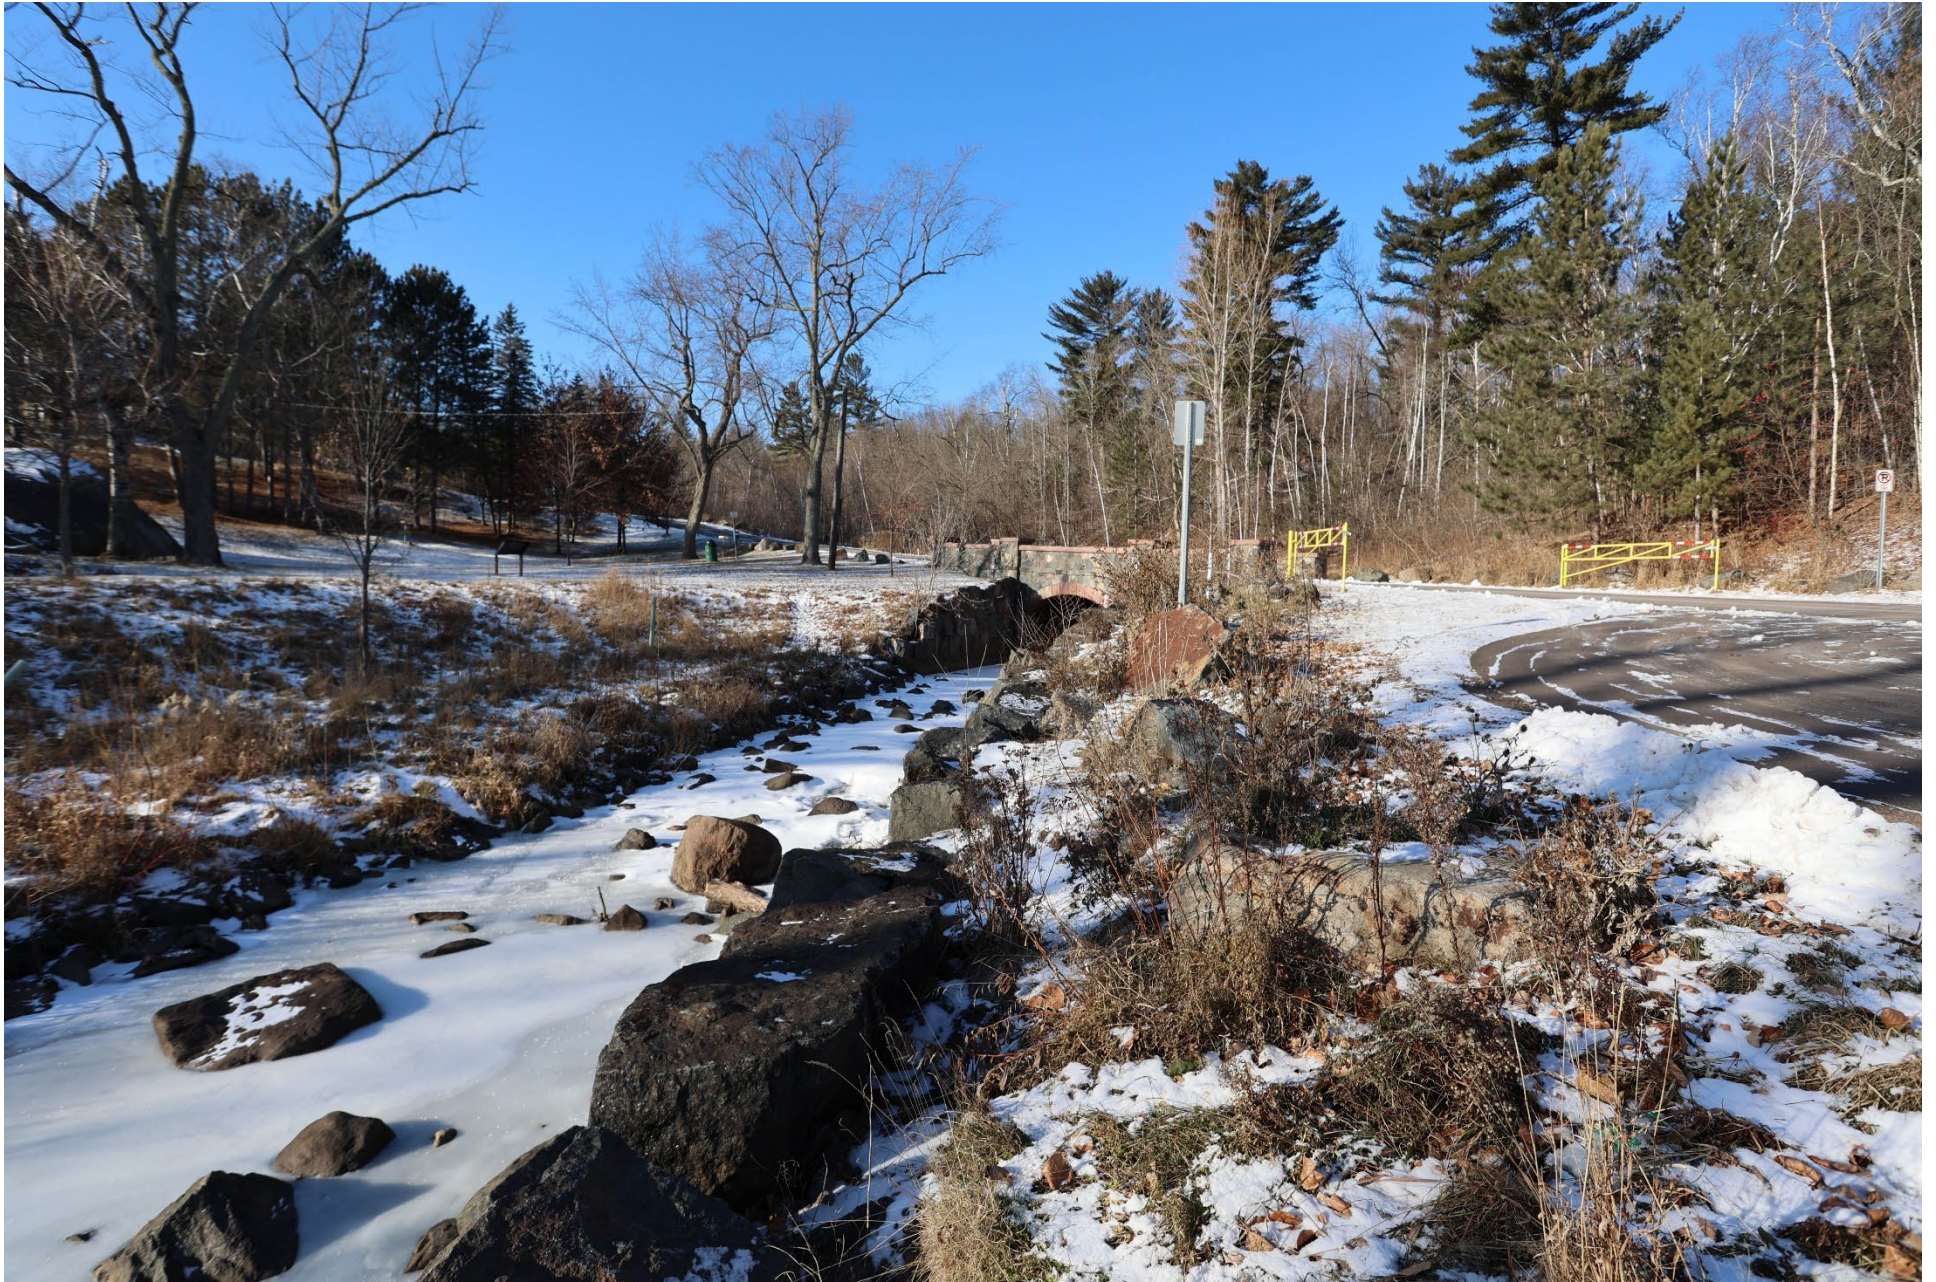
MN_St. Louis County_Lincoln Park_0019

Bridge 69679 carries Lincoln Park Drive over Miller Creek around 6th Street. Elephant Rock is visible at the left edge of the photo. Looking north.

Bridge 69679 carries Lincoln Park Drive over the creek at the alignment of 6th Street (Photos 19-20). In 2011, the bridge replaced Bridge L8476, which was constructed in the 1930s. The southeast end of the new structure, which was designed by LHB, was moved slightly south to improve the alignment of the road's southeast approach. The deck of the skewed, concrete-slab structure is 31 feet wide in section. Concrete headwalls rise above the deck to form railings and extend down to conceal the slab. The base of each headwall is a low arch trimmed with architectural concrete voussoirs, recalling the arched form of the earth-filled, concrete-arch structure that it replaced. The fascia and wingwalls are faced with stone salvaged from that structure. The project included raising the grade of Lincoln Park Drive near the bridge and installing a bituminous surface. The terminus of an 8-foot-wide pedestrian pathway on the west side of the creek, which was immediately north of the old bridge, was moved about 25 feet to the west. The new section of the path curves southeast to join the existing alignment. Several silver maples were removed from near the bridge and new Fall Fiesta sugar maples were planted.¹¹ The bridge is considered a contributing resource.
