RE: **Certified Local Government Comment on the nomination of: Lincoln Park, 25th Avenue West and 5th Street, Duluth, St. Louis County to the National Register of Historic Places**

Lincoln Park
Name of Property

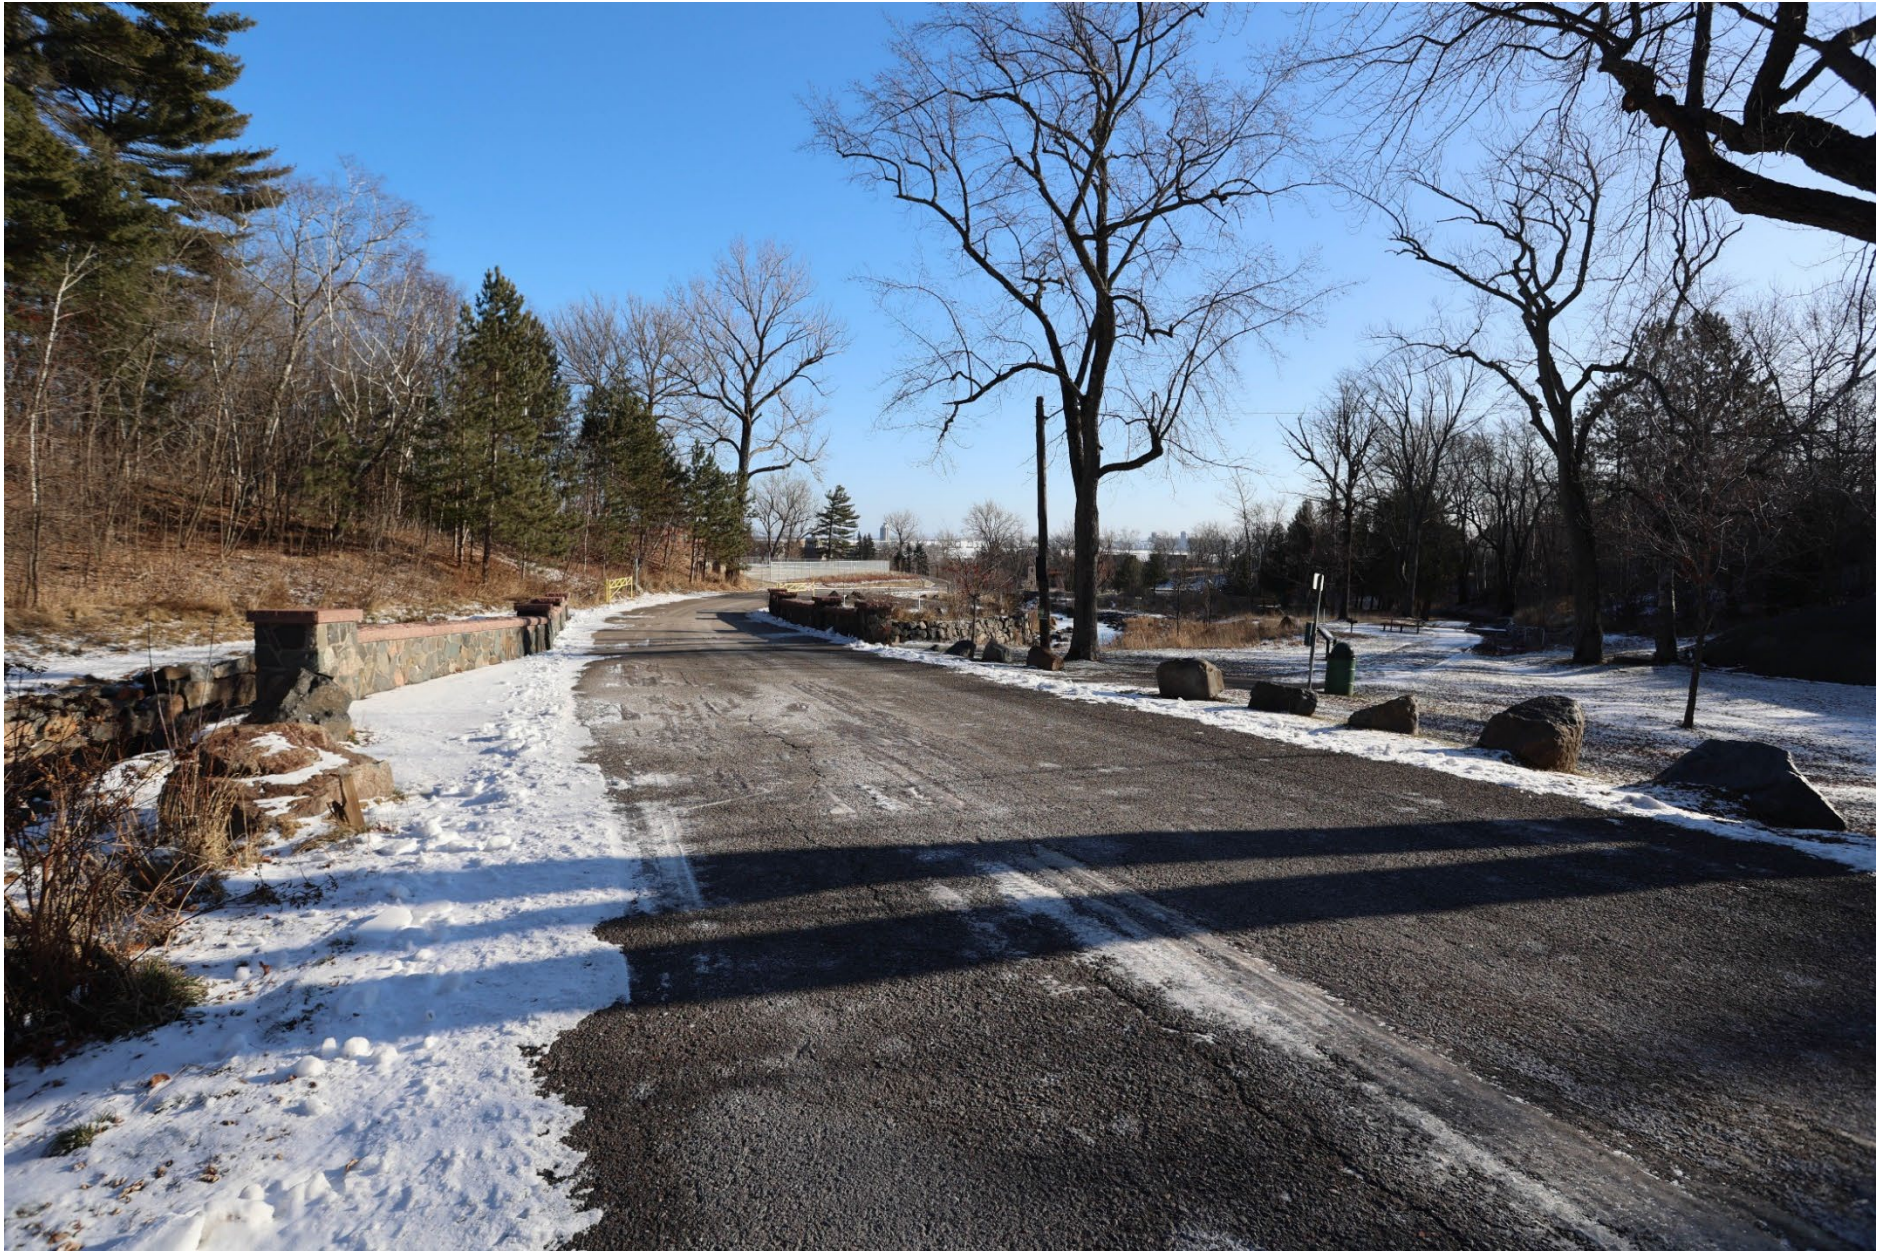
MN_St. Louis County_Lincoln Park_0020

Lincoln Park Drive approaching northern end of Bridge 69679. Chain-link fencing around the terrace is in the distance. Looking southeast.

Bridge 69679 carries Lincoln Park Drive over the creek at the alignment of 6th Street (Photos 19-20). In 2011, the bridge replaced Bridge L8476, which was constructed in the 1930s. The southeast end of the new structure, which was designed by LHB, was moved slightly south to improve the alignment of the road's southeast approach. The deck of the skewed, concrete-slab structure is 31 feet wide in section. Concrete headwalls rise above the deck to form railings and extend down to conceal the slab. The base of each headwall is a low arch trimmed with architectural concrete voussoirs, recalling the arched form of the earth-filled, concrete-arch structure that it replaced. The fascia and wingwalls are faced with stone salvaged from that structure. The project included raising the grade of Lincoln Park Drive near the bridge and installing a bituminous surface. The terminus of an 8-foot-wide pedestrian pathway on the west side of the creek, which was immediately north of the old bridge, was moved about 25 feet to the west. The new section of the path curves southeast to join the existing alignment. Several silver maples were removed from near the bridge and new Fall Fiesta sugar maples were planted.¹¹ The bridge is considered a contributing resource.

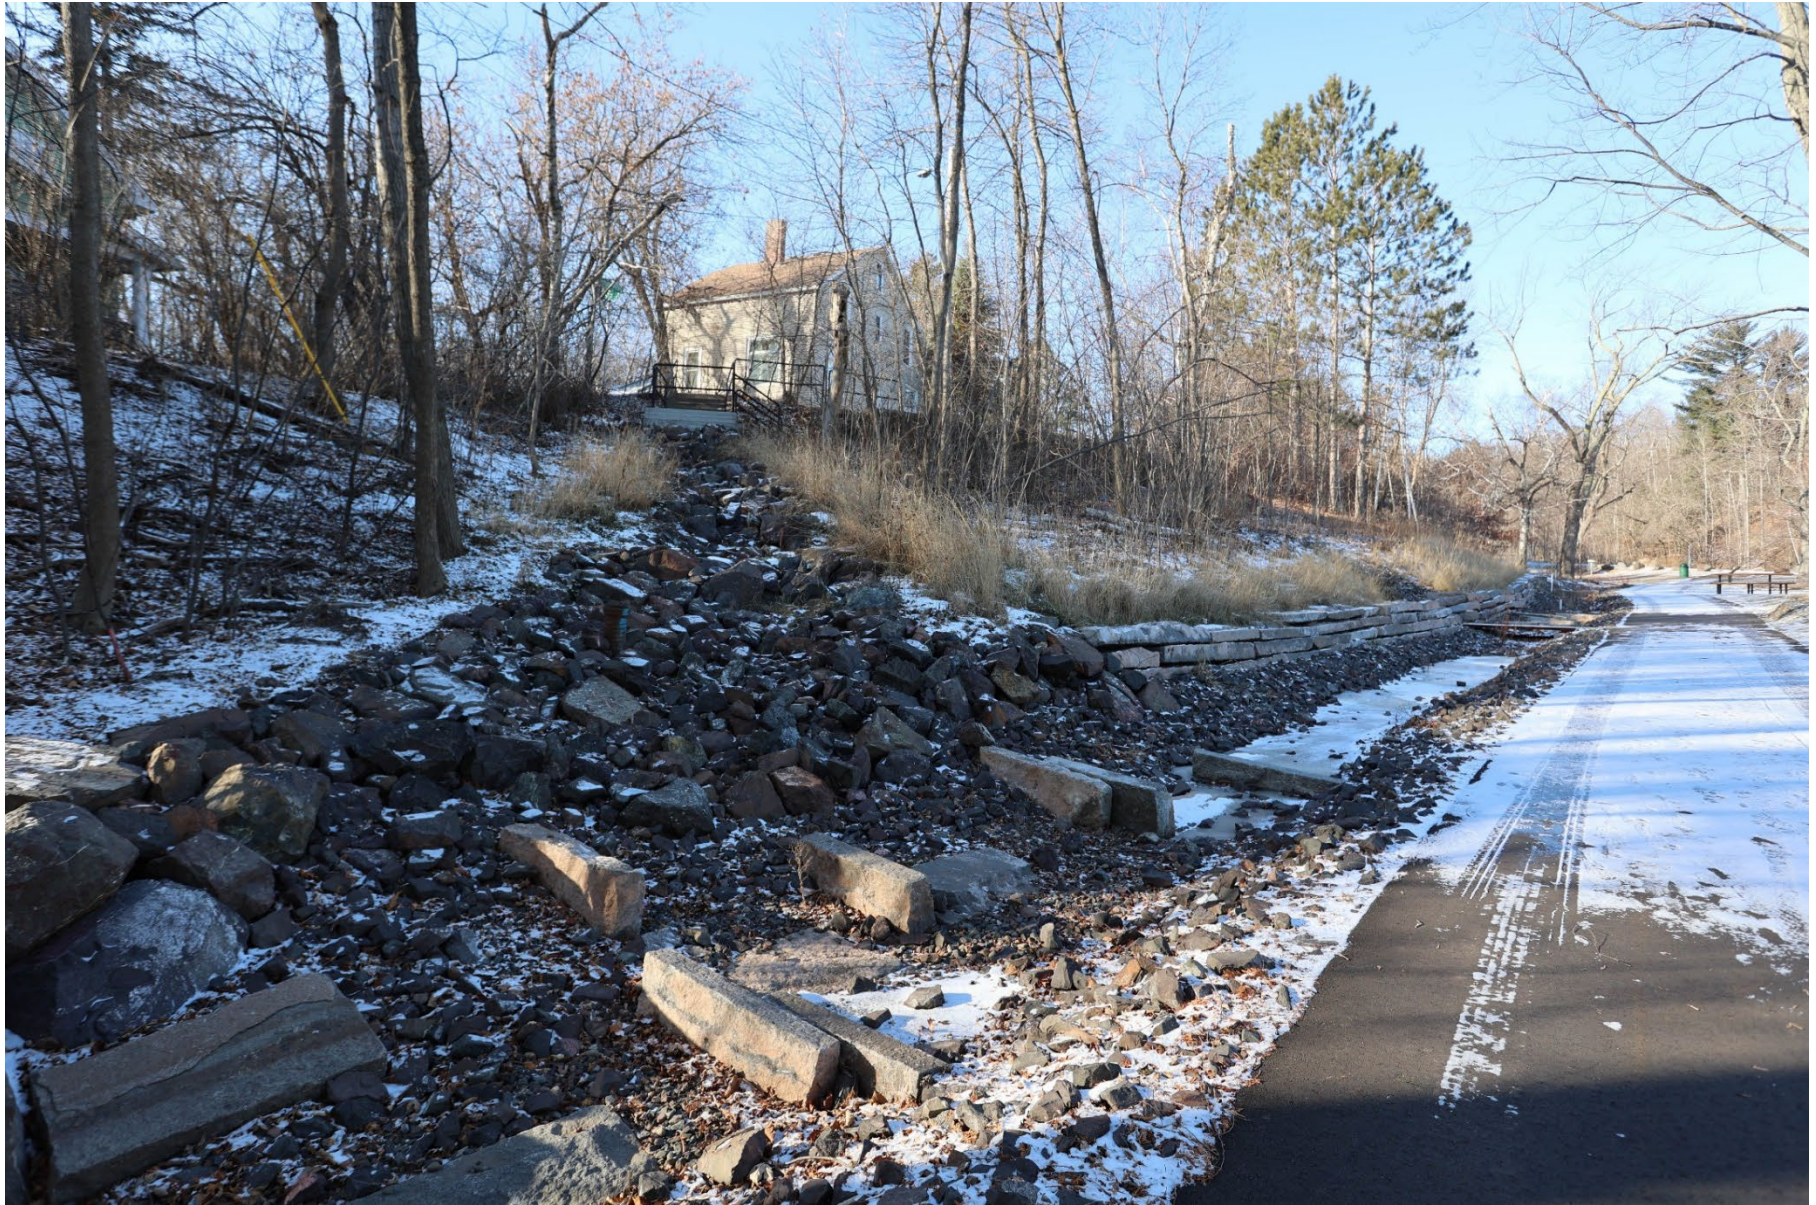
MN_St. Louis County_Lincoln Park_0025

Dry-laid ashlar walls, individual ashlar blocks, irregular stones, native plants, and swales were integrated into the landscape on the west side of the Plateau during the 2023 renovation to address erosion and improve drainage. The ashlar was salvaged from the failing wall below the terrace on the Plateau's east side that had to be removed. The black pipe railing of a stairway into the park from the corner of Lincoln Parkway and 6th Street is visible at the top of the slope. Looking northwest.

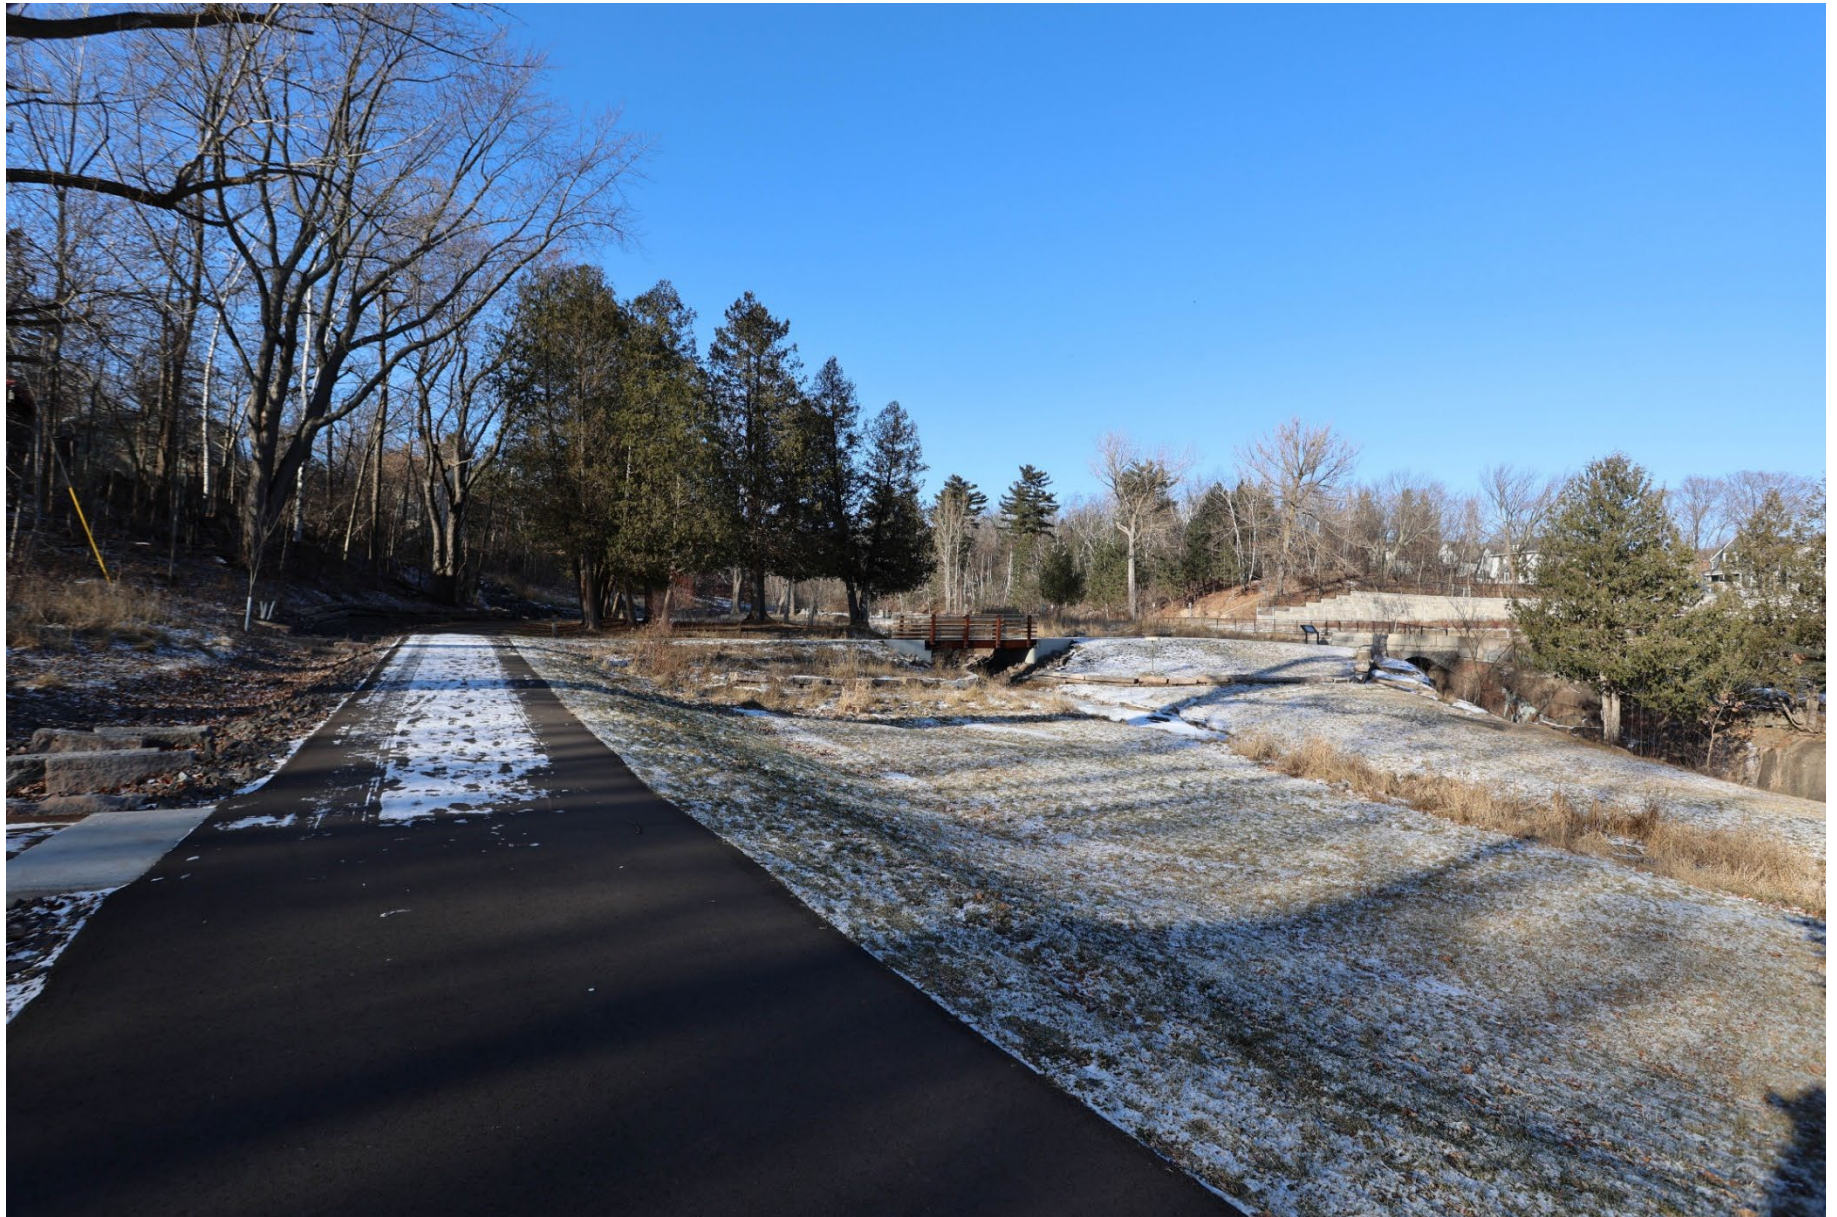
MN_St. Louis County_Lincoln Park_0026

The asphalt trail in the foreground generally reflects the alignment of a loop from Lincoln Park Drive that once came through this area. A trail extending perpendicularly to the east passes over a wood-stringer bridge near the center of the photo and a historic arch bridge over Miller Creek to the right. The wood bridge was installed in 2023 to make this path accessible and allow passage of water when the creek overtops its banks. Looking northeast.

The 5th Street Pedestrian Bridge is not included in the Minnesota Department of Transportation's inventory and little information is available about the rustic stone-arch structure (Photos 24, 26). It was perhaps one of two "rock arch bridges" that were in place by 1926 according to an inventory prepared in the 1930s. Stone-arch bridges were popular in the late nineteenth and early twentieth centuries and were considered particularly appropriate in picturesque landscape settings. The existing deck, railings, and wing walls are of coursed ashlar and concrete from a later period, probably the product of a depression-era federal relief project. In 1940, the NYA was working just across Lincoln Park Drive from this site on stone walls at the terrace. The park department's annual report from that year noted that the NYA built a 20-foot-long stone and concrete bridge at 5th Street with a 6-foot-wide deck and 3-foot-tall railings. The stonework was completed in 1941. Miller Creek runs in a narrow gorge just upstream from the bridge and the creek's flooding has been hard on the structure, which appears to have multiple repairs, including rehabilitation of the stone railings in 2023.¹² The bridge is considered a contributing resource.

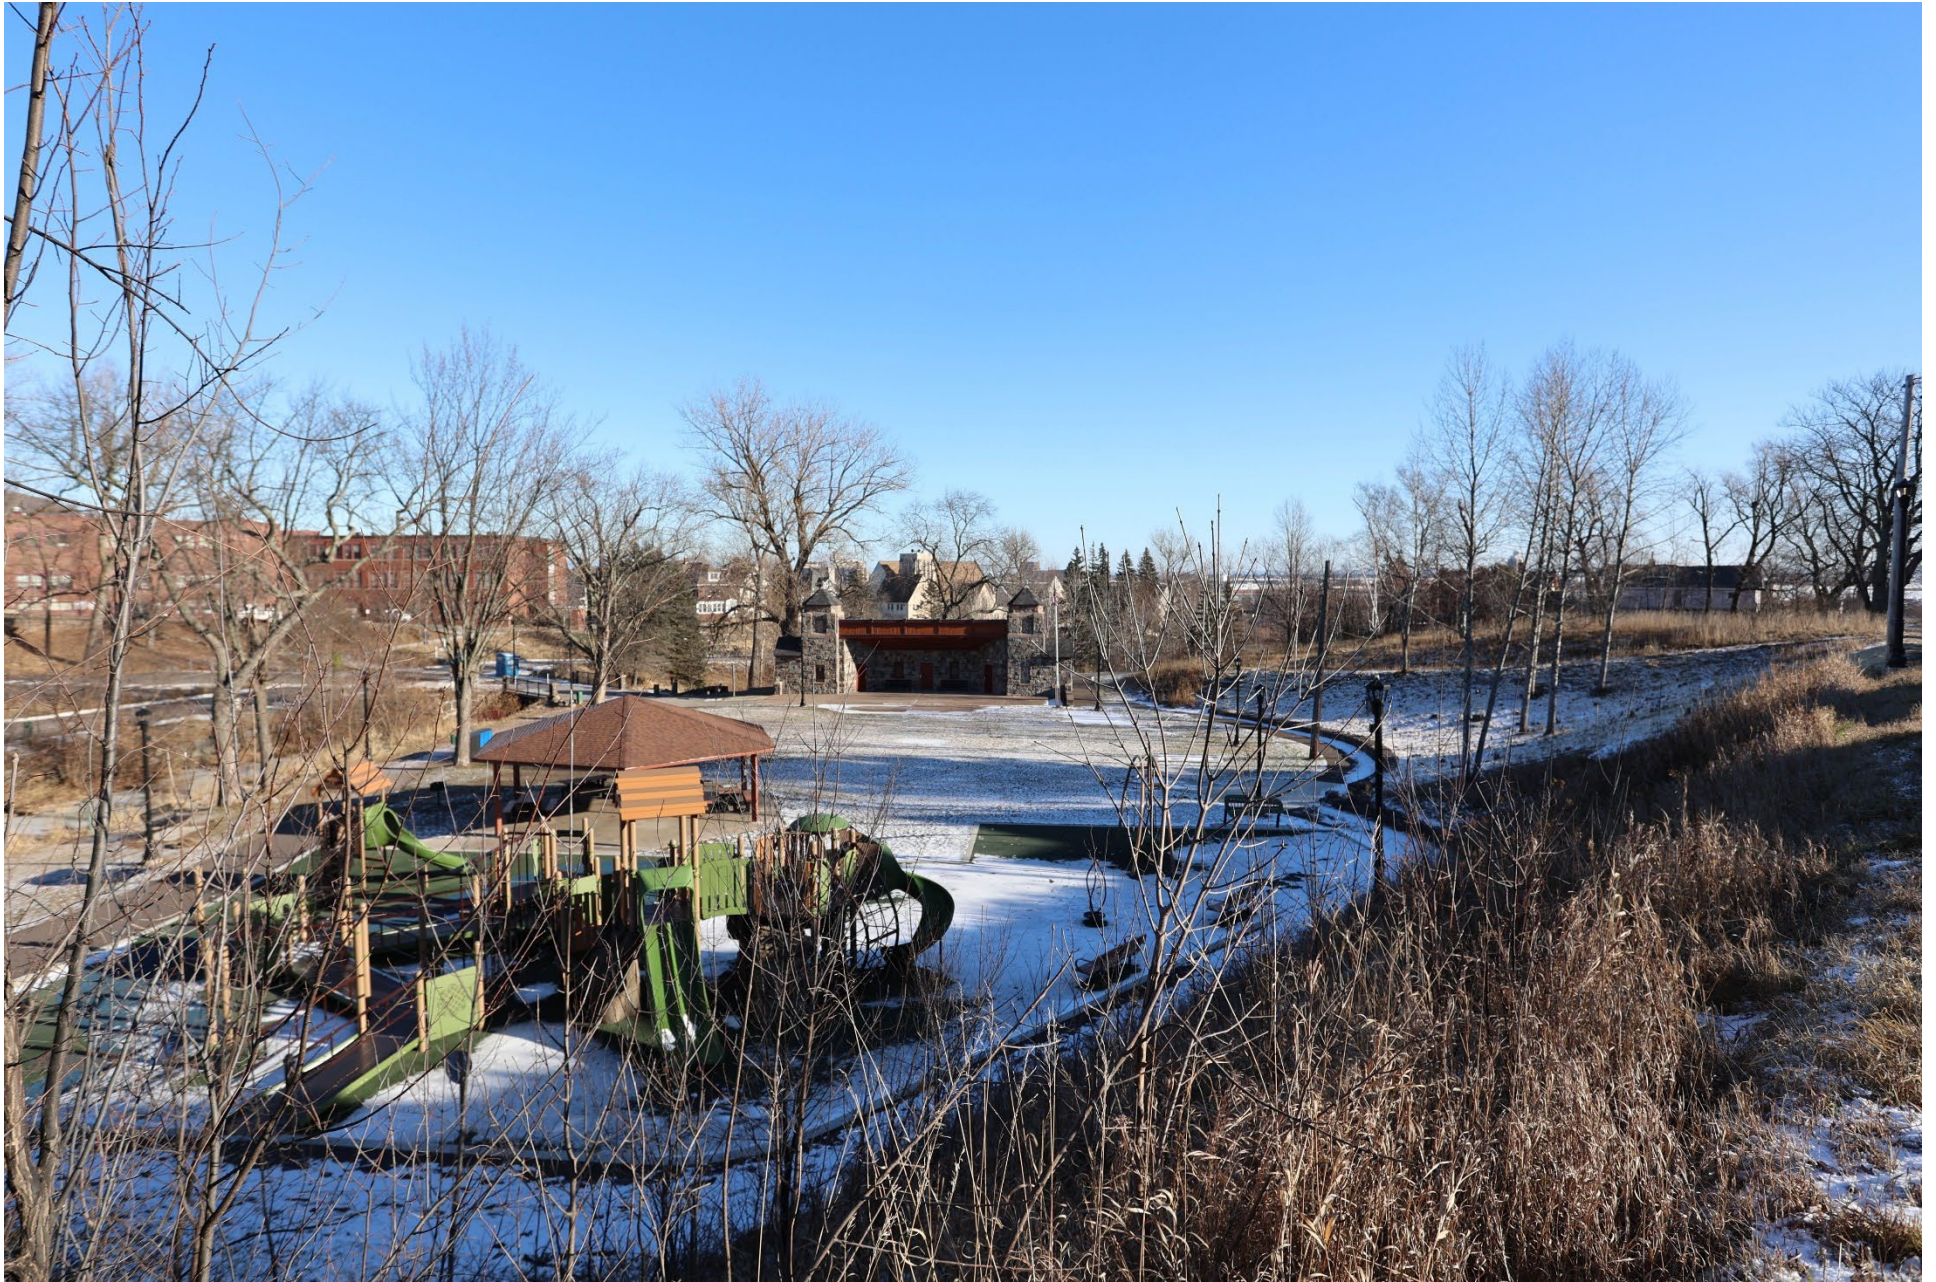
MN_St. Louis County_Lincoln Park_0027

Stone pavilion, picnic shelter, and playground, from 26th Avenue. Looking southeast.

The park's two other structures are modern picnic shelters. Both are considered noncontributing to the district. The west picnic shelter (Photos 27-28) is on the north side of the lawn in front of the pavilion. Picnic tables are beneath the hexagonal, shingle-roofed, open-sided shelter, a standard design used in many of the city's parks. The shelter has been in place since 1986¹⁵ but the adjacent playground with a variety of earth-toned equipment was developed in 2023. The playground was previously on the other side of the creek and Lincoln Park Drive, a safety hazard for families using both the picnic shelter and the play equipment. The east picnic shelter (Photos 22-23, 28), similar in design but smaller and with only four sides, was installed at the north end of the Plateau's sports terrace in 2023. The adjacent nature play area dates from the same time and is considered a noncontributing site.

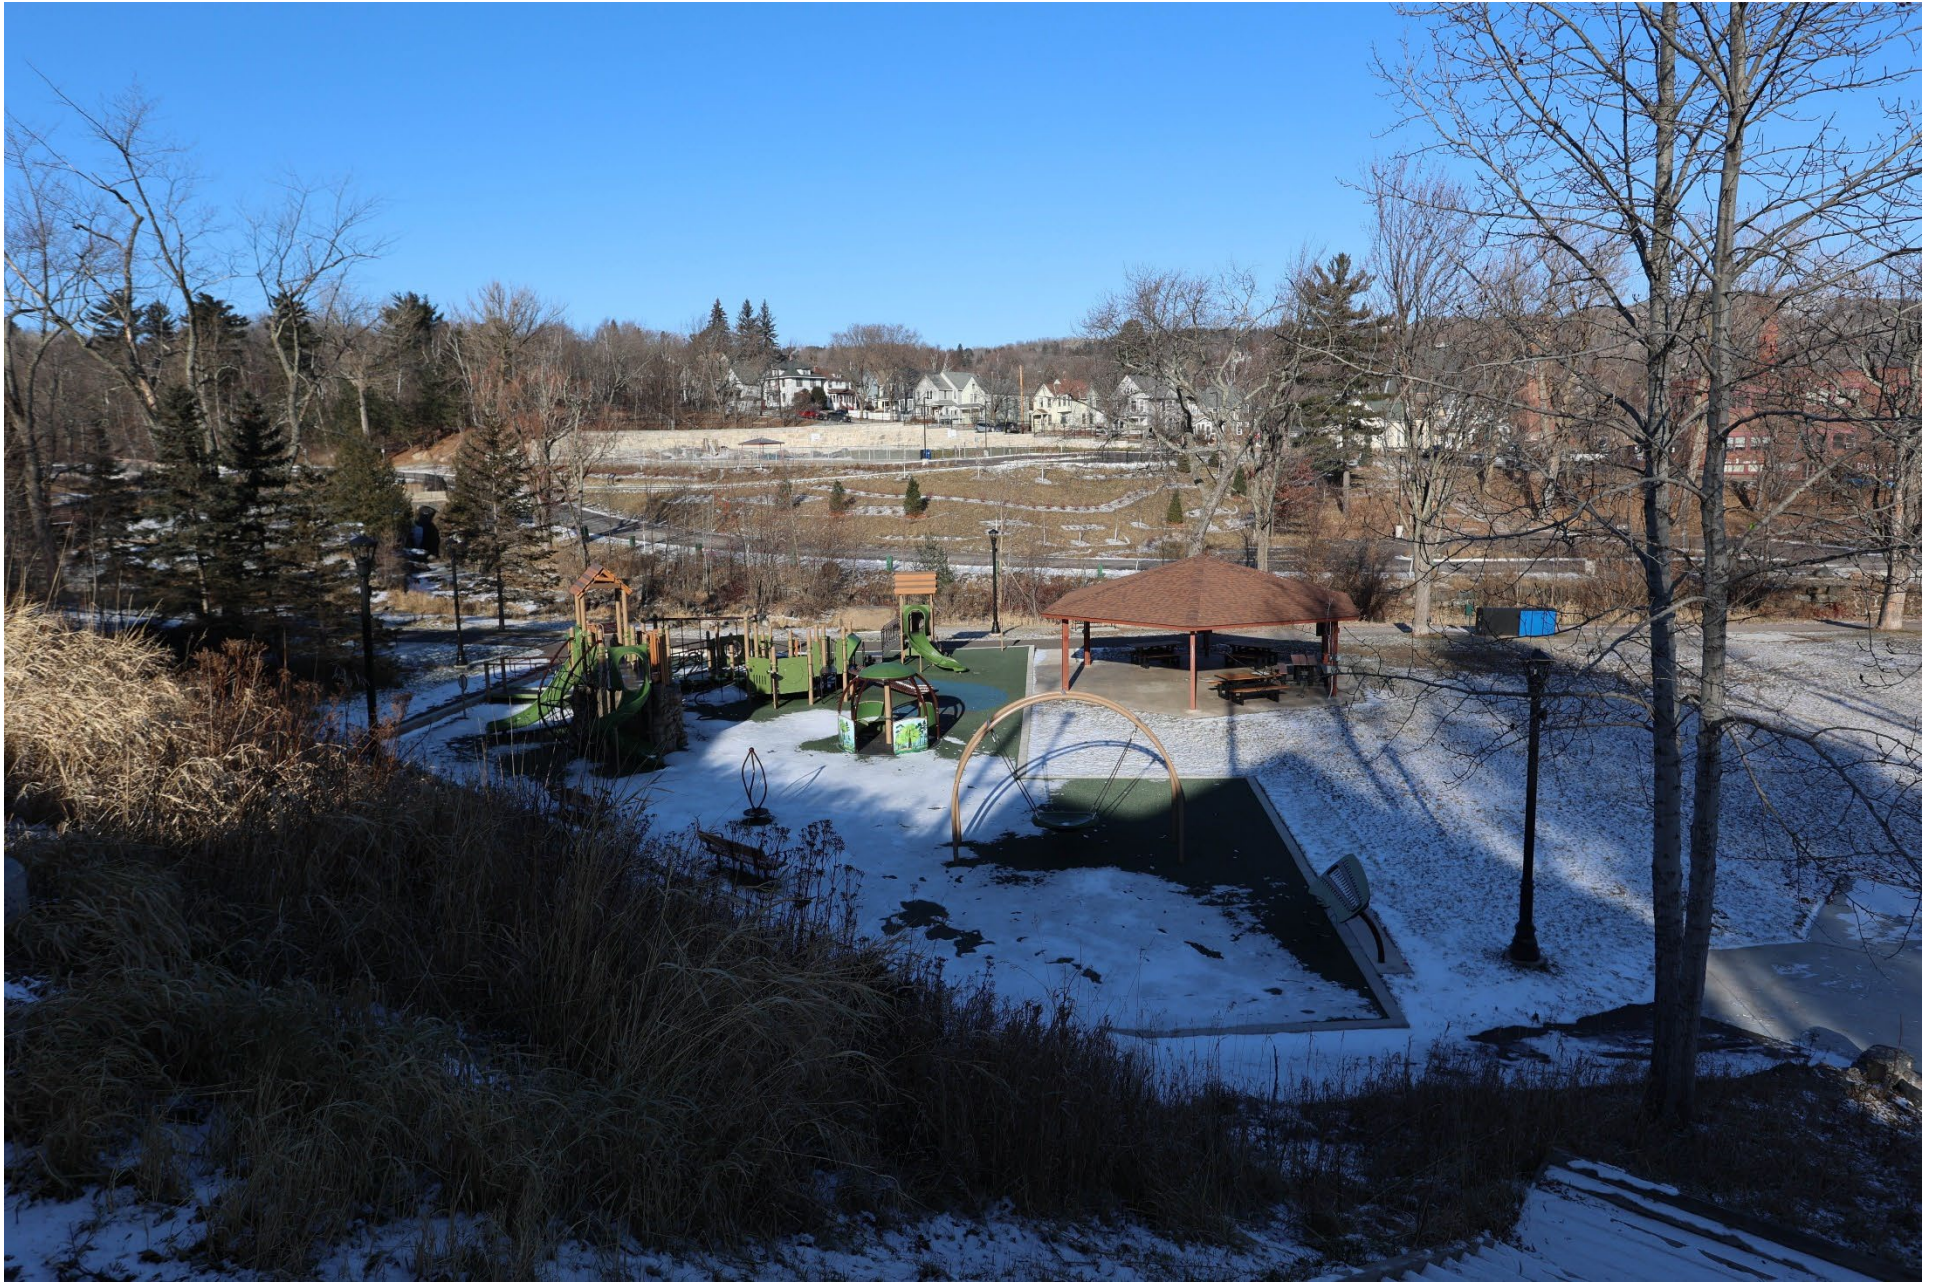
MN_St. Louis County_Lincoln Park_0028

View from 26th Avenue with picnic shelter and playground in foreground, Miller Creek, Lincoln Park Drive, and terrace beyond. Looking northeast.

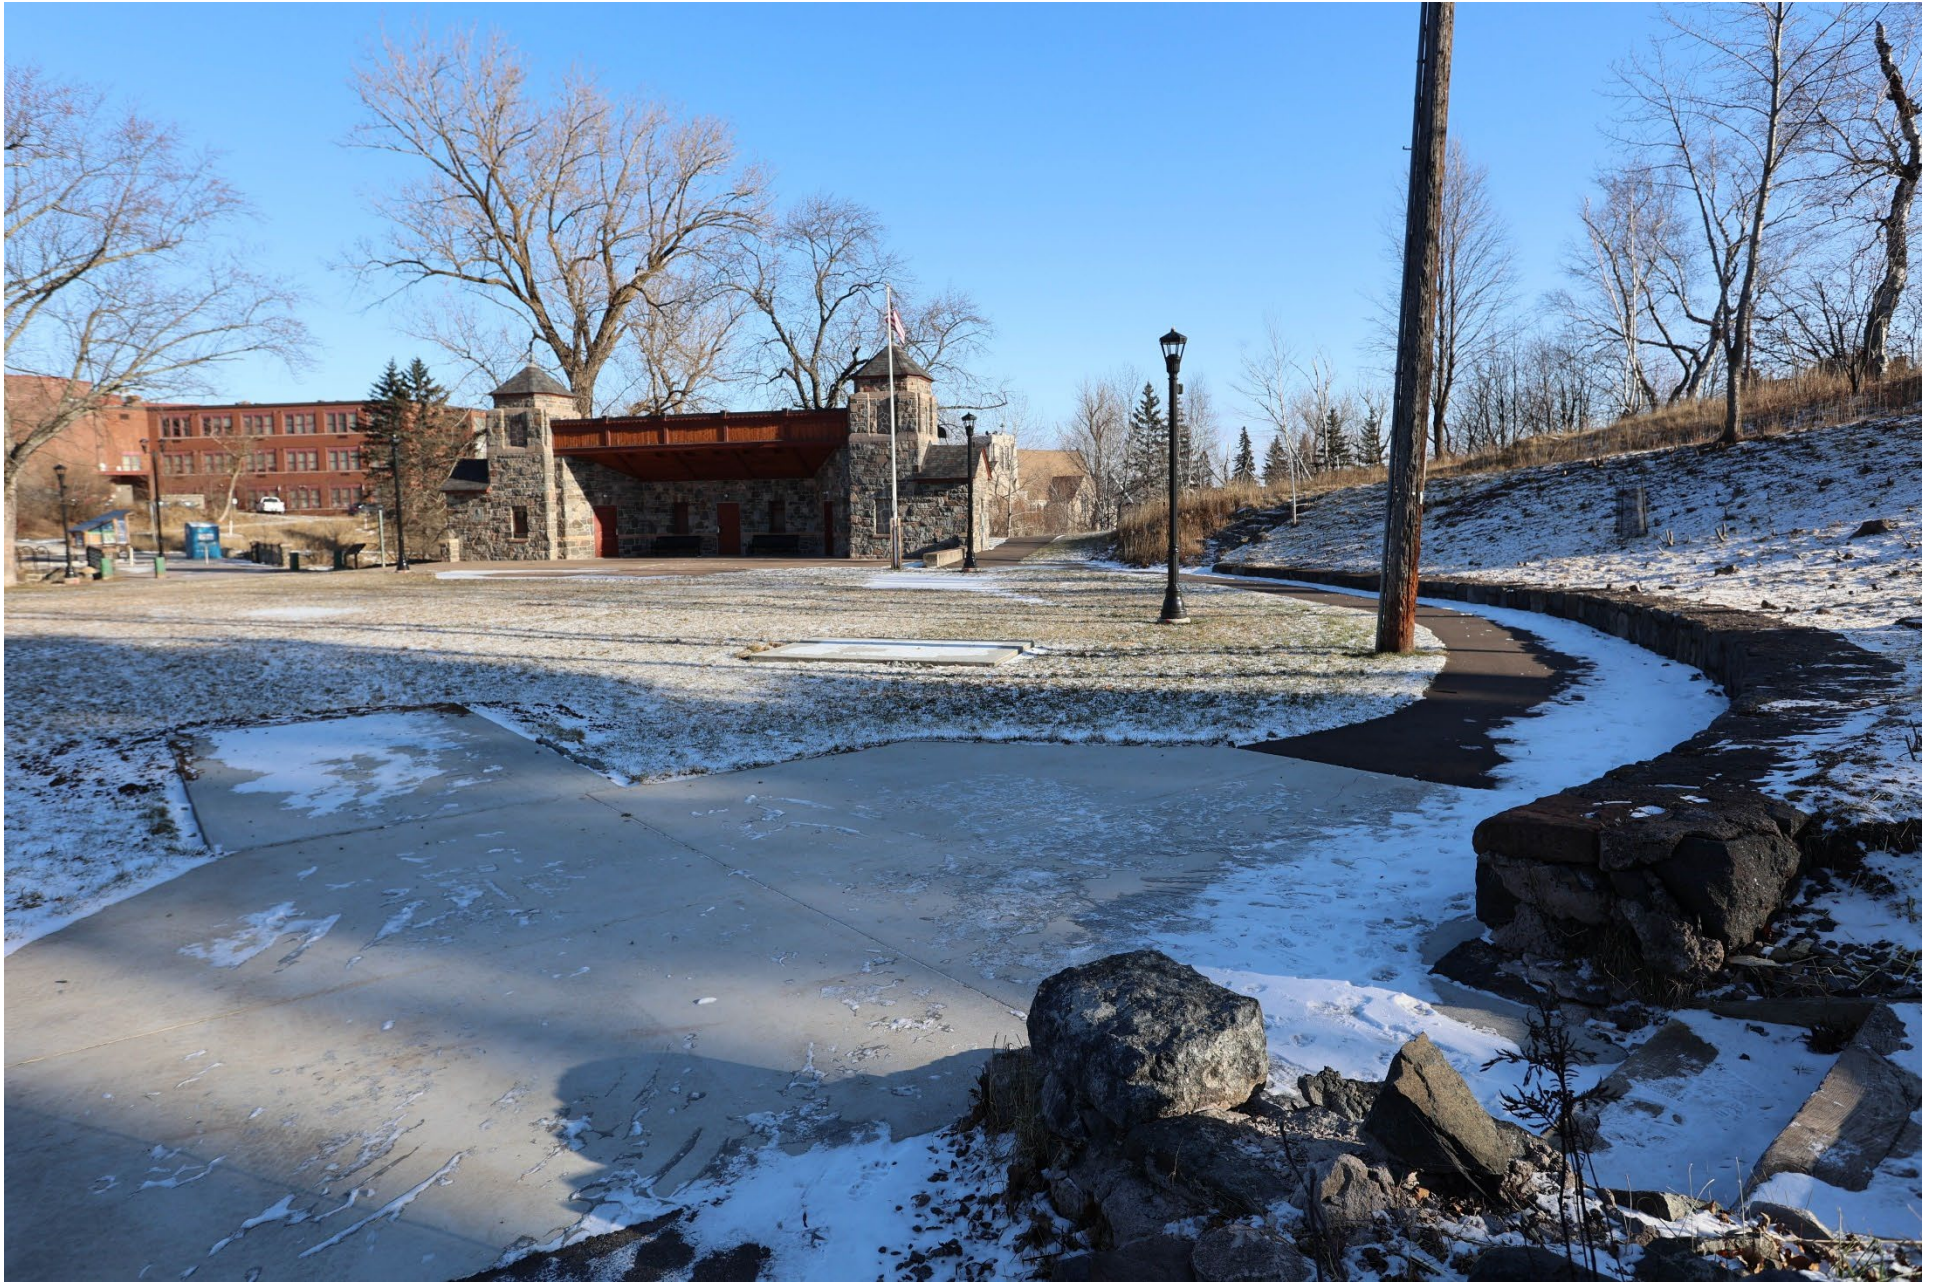
MN_St. Louis County_Lincoln Park_0029
Stone pavilion and stone wall from the 1930s. Looking southeast.

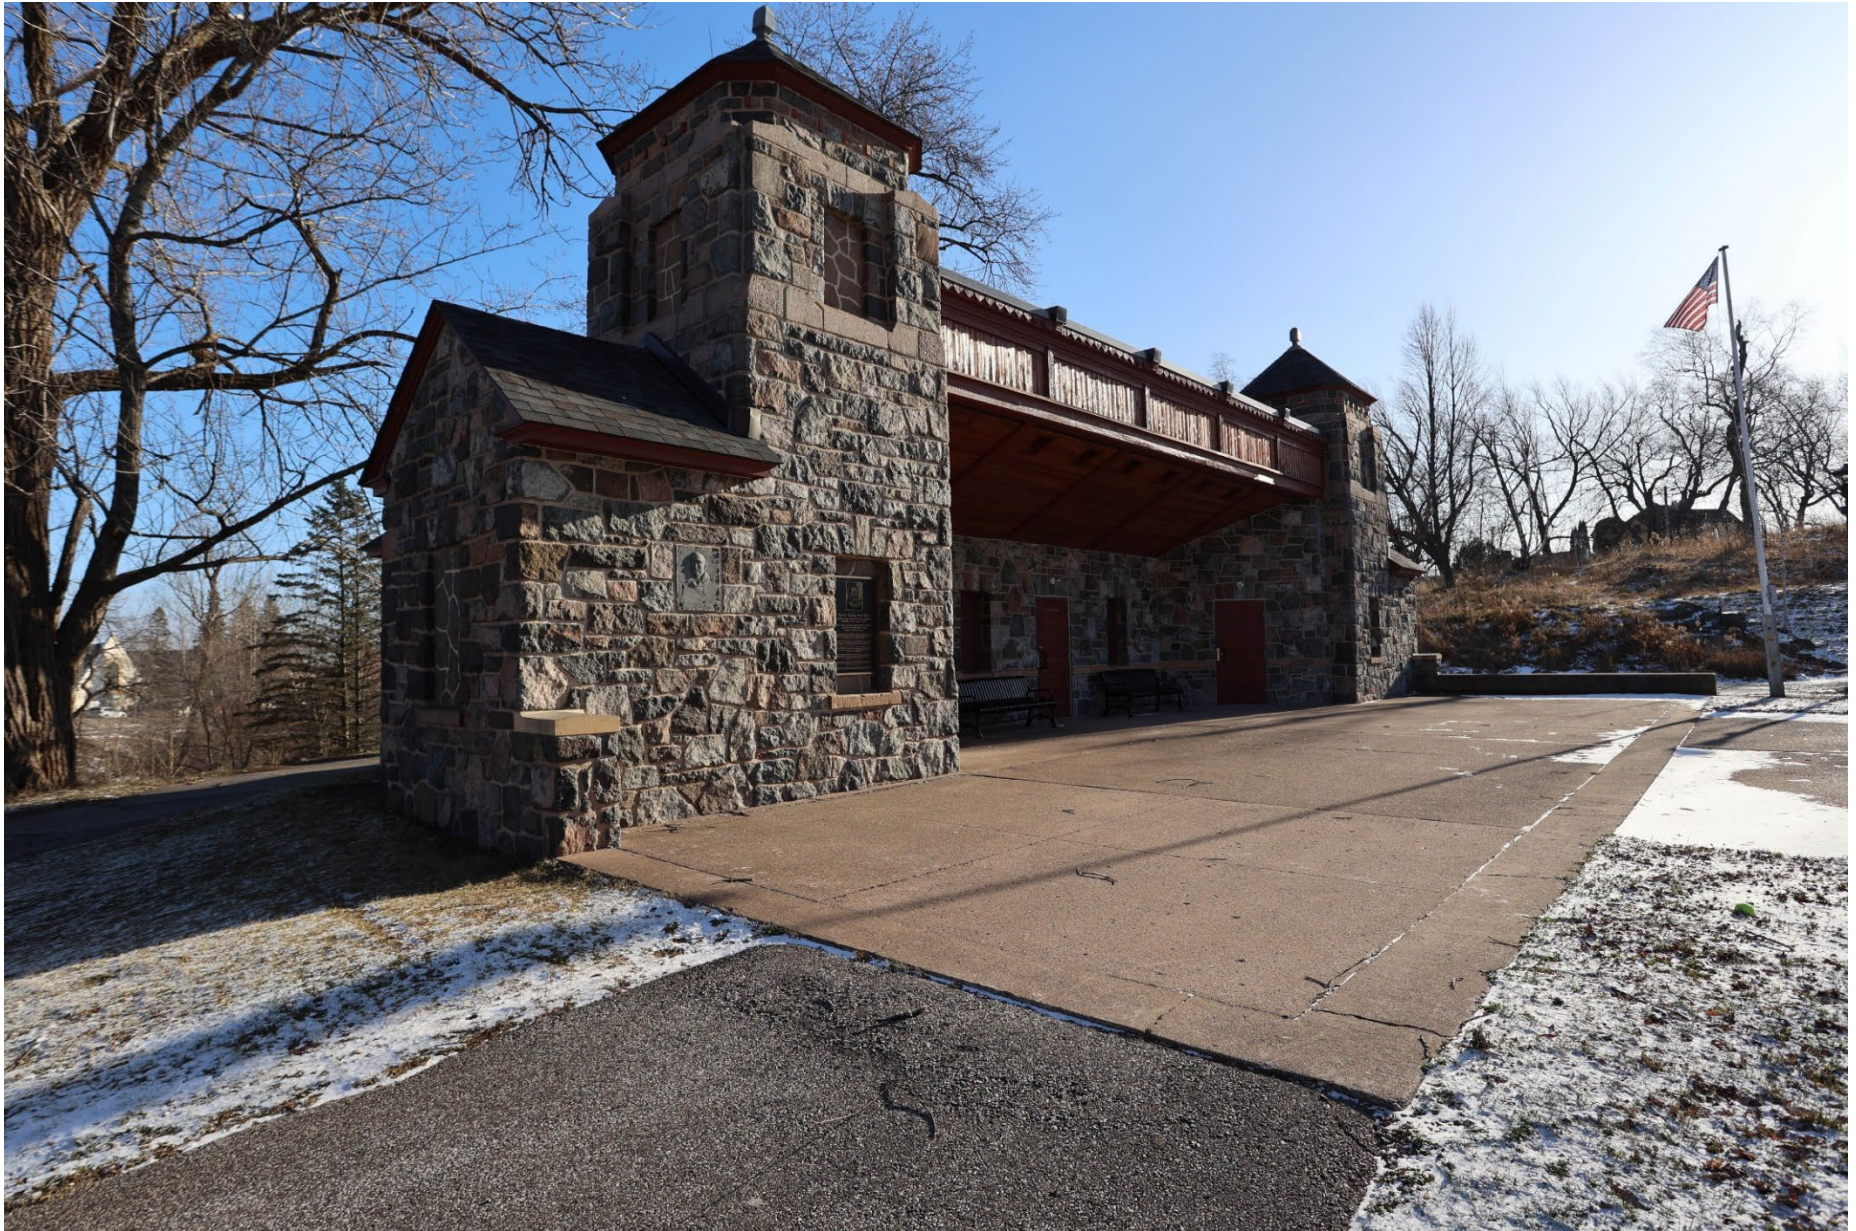
MN_St. Louis County_Lincoln Park_0030

Front (northwest) and northeast facades of stone pavilion. A flagpole is near northwest corner of projecting stage. A plaque honoring Councilmember Renee Kathy Van Nett and a bas-relief remnant of plaque for Samuel Snively are on the left end of the front facade. Looking southwest.

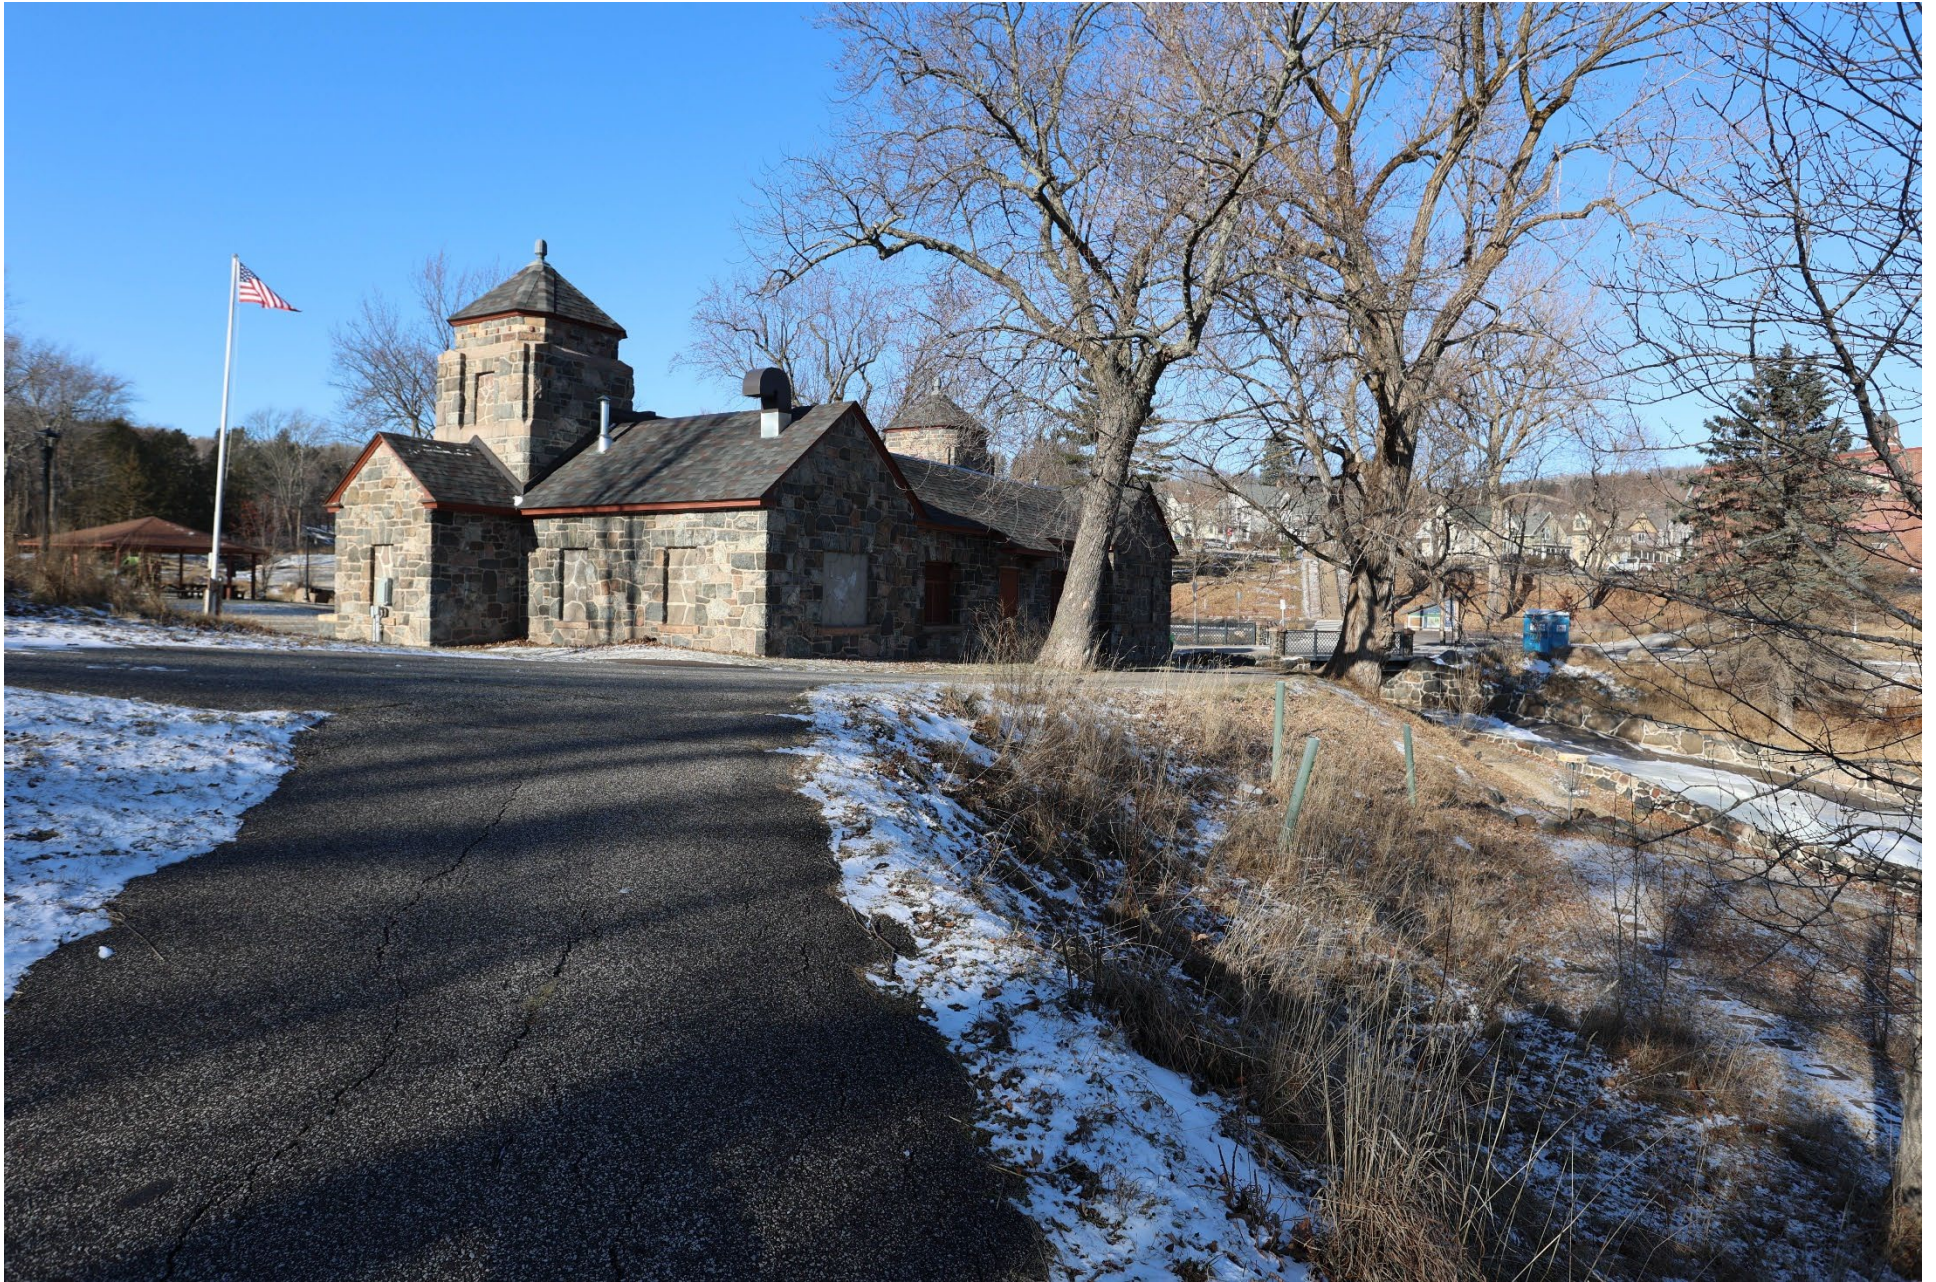
MN_St. Louis County_Lincoln Park_0031

Southwest side and rear of stone pavilion. The stone-lined channel of Miller Creek is to the right. Bridge 69650 carries pedestrians over the creek between the pavilion and Lincoln Park Drive. Looking northeast.

Bridge 69650 crosses Miller Creek between the stone pavilion and the parking lot along Lincoln Park Drive (Photos 31-32). It replaced an earlier bridge in the same location in 2003. The skewed, 26-foot, steel-beam span has a 26-foot-wide concrete-slab deck edged by 40-inch-tall ornamental metal railings with stone end posts. Existing stone walls were partially removed, and the stone was used as a veneer for new concrete abutments. Landscape architects Sanders Wacker Bergly and Northland Consulting Engineers worked on plans for the prefabricated structure.¹³ Because it was erected after the period of significance the structure is considered non-contributing.
