RE: **Certified Local Government Comment on the nomination of: Lincoln Park, 25th Avenue West and 5th Street, Duluth, St. Louis County to the National Register of Historic Places**

Lincoln Park
Name of Property

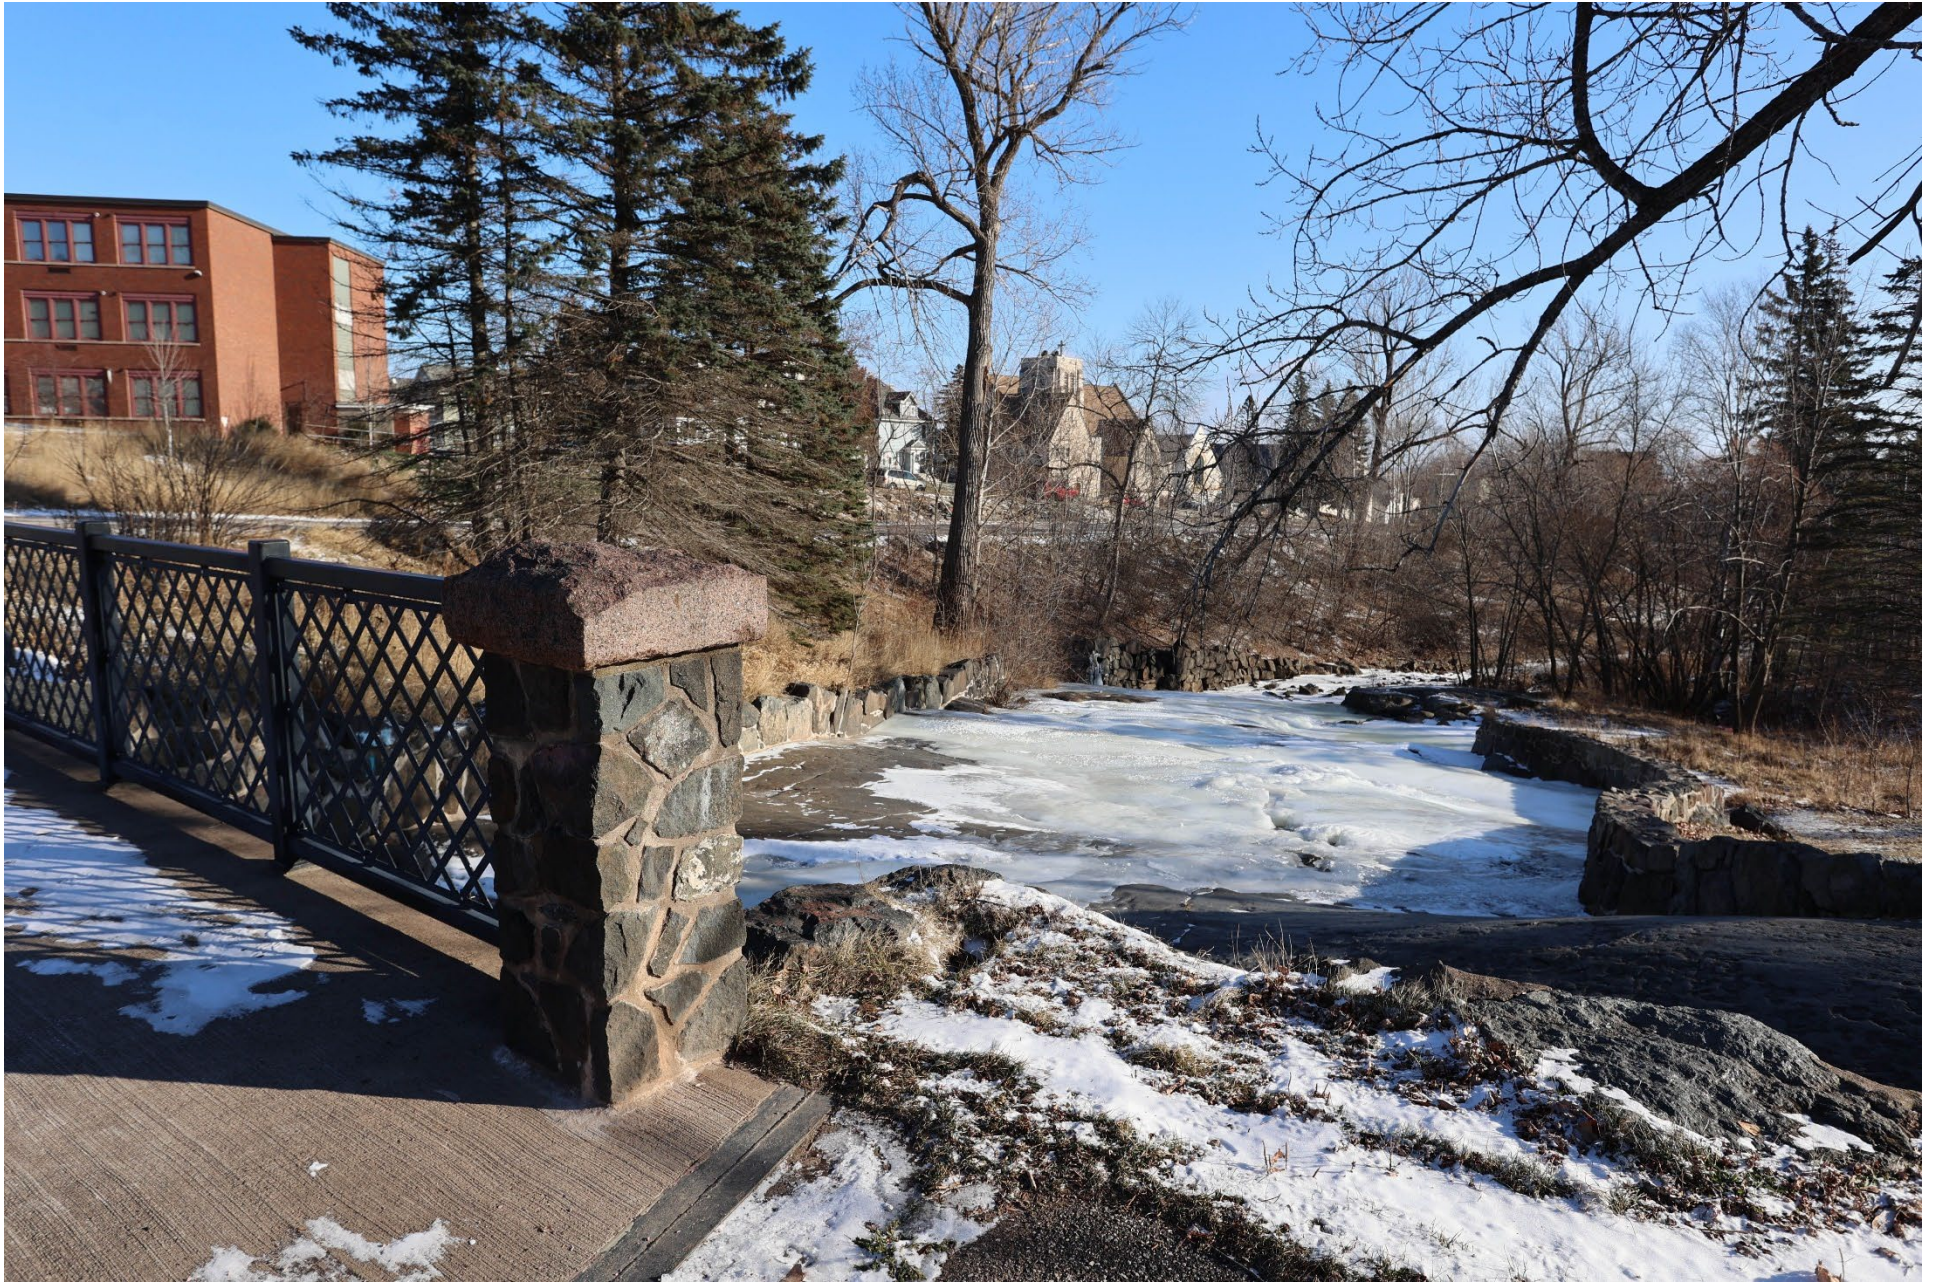
MN_St. Louis County_Lincoln Park_0032

A view down Miller Creek from the west end of Bridge 69650. The design of the iron railing and stone end posts was based on an earlier bridge at this location, which was replaced in 2003. Looking southeast.

Bridge 69650 crosses Miller Creek between the stone pavilion and the parking lot along Lincoln Park Drive (Photos 31-32). It replaced an earlier bridge in the same location in 2003. The skewed, 26-foot, steel-beam span has a 26-foot-wide concrete-slab deck edged by 40-inch-tall ornamental metal railings with stone end posts. Existing stone walls were partially removed, and the stone was used as a veneer for new concrete abutments. Landscape architects Sanders Wacker Bergly and Northland Consulting Engineers worked on plans for the prefabricated structure.¹³ Because it was erected after the period of significance the structure is considered non-contributing.

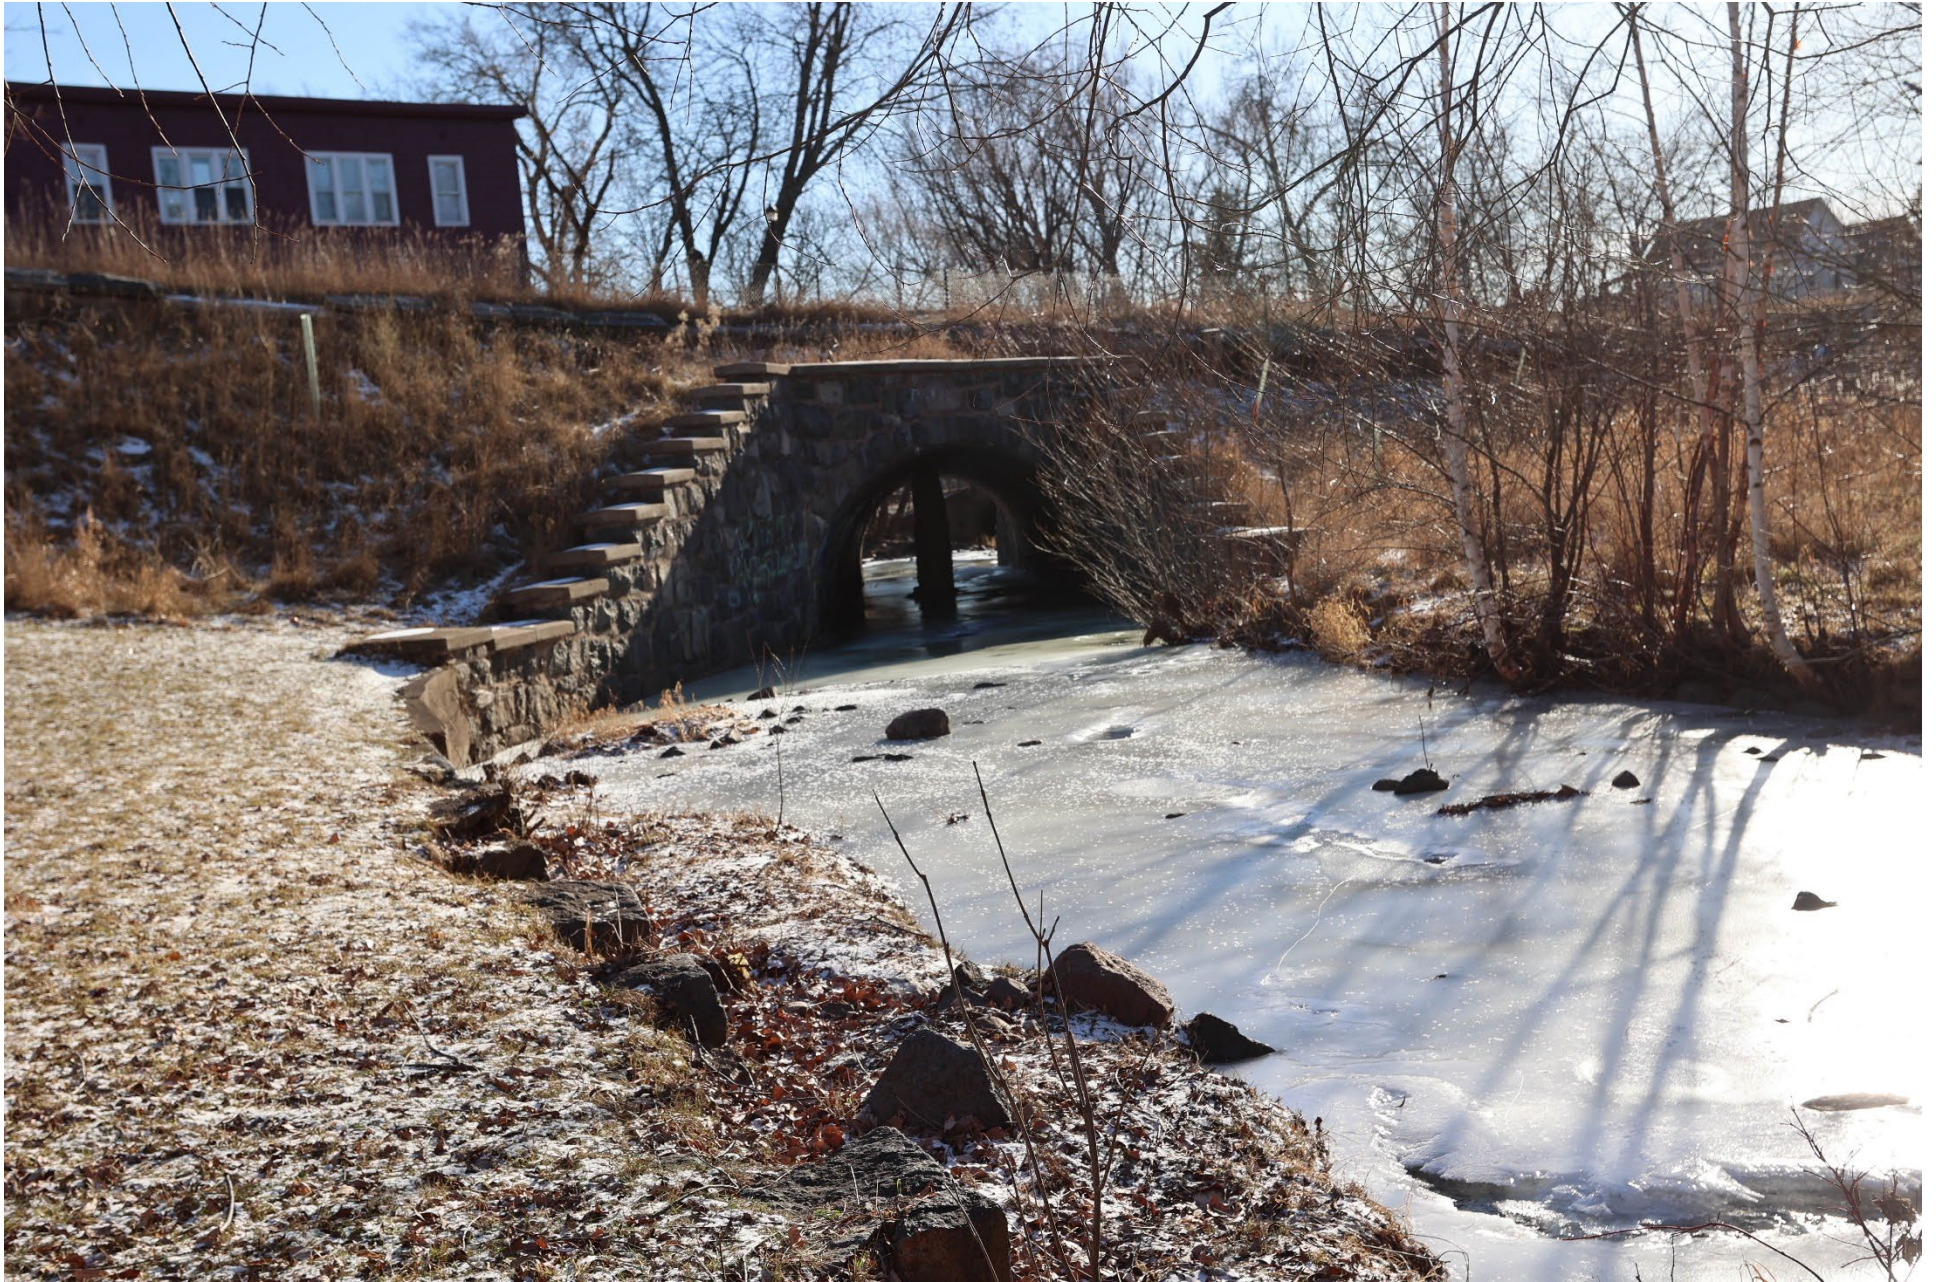
MN_St. Louis County_Lincoln Park_0037
Bridge 88552 carrying 3rd Street over Miller Creek. Looking southwest.
