Duluth Spirit Mountain Tourism Industry Infrastructure

Predesign Report Spirit Mountain Recreation Area City of Duluth, MN

TKDA No. 18185.000 October 15, 2021

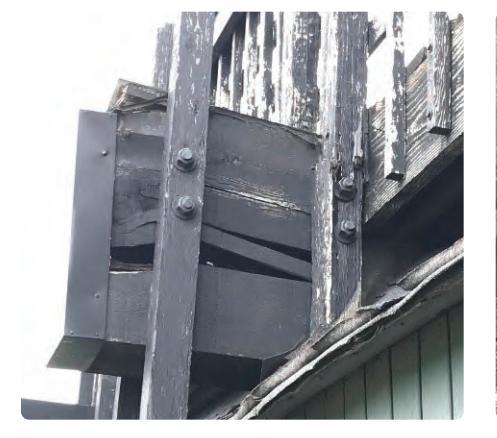
Delaminated beam at deck support

Members damaged by weather should be removed or replaced.

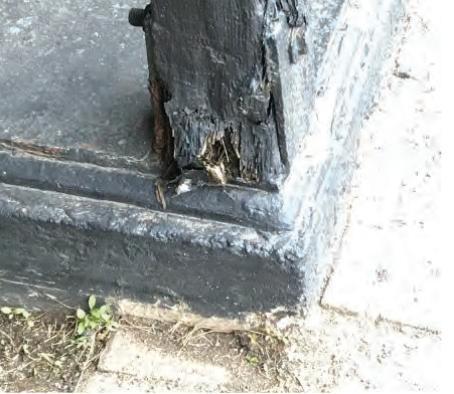
Rotted column base

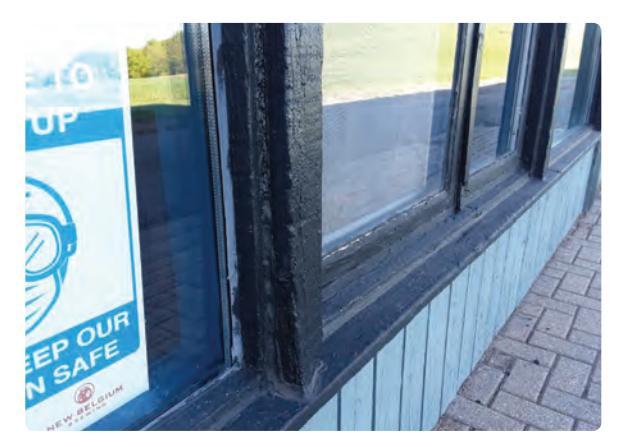
Sealant at gaps in window frame from wood warping

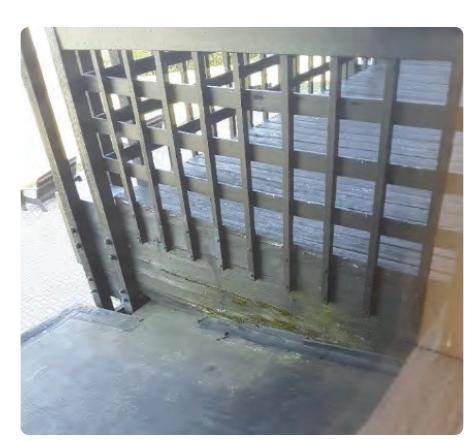
Flashing at roof to wall intersection is compromised

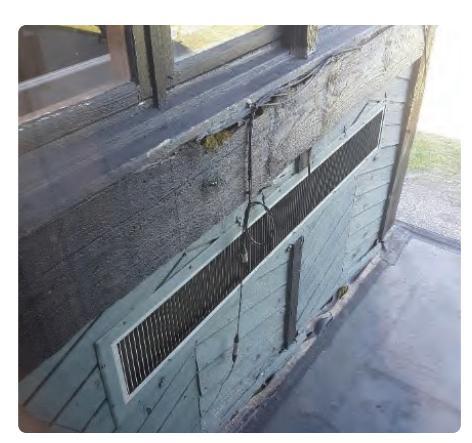
Flashing at roof to wall intersection is compromised

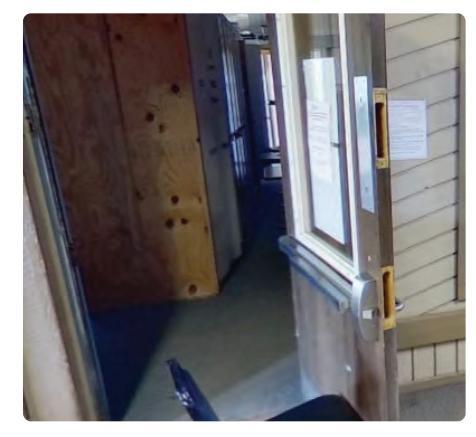
Door hardware has been modified from original functions

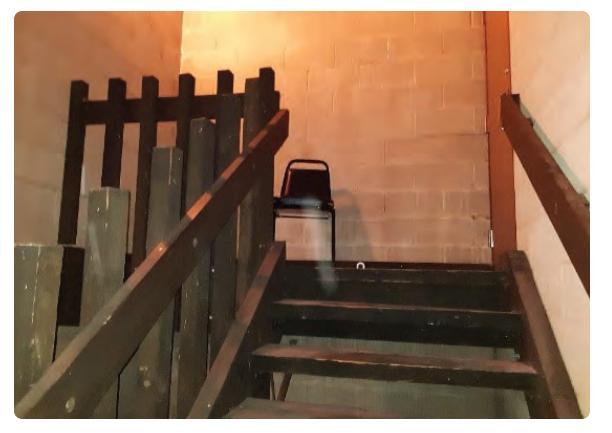
Regarding the stair system, the guard railings and open risers are not compliant with current code. In addition, some of the boards that make up the stair landing surface are loose and the landing floor surface is uneven where individual floor planks meet.

Typical stair landing and guardrail at Moosehead Saloon

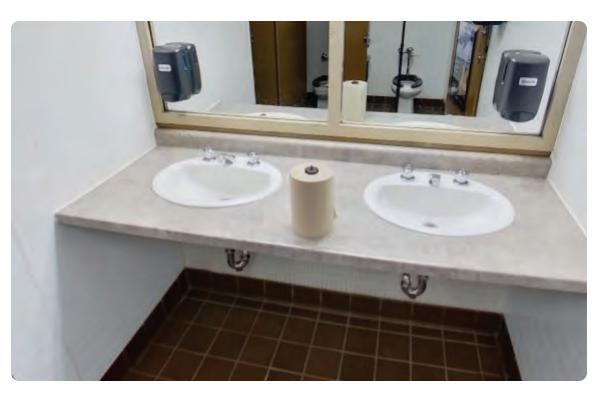
Rationale for condition rating: Fixtures no longer operate as intended and create continuous maintenance for staff while offering visitors a poor quality of use.

Non-ADA compliant sinks

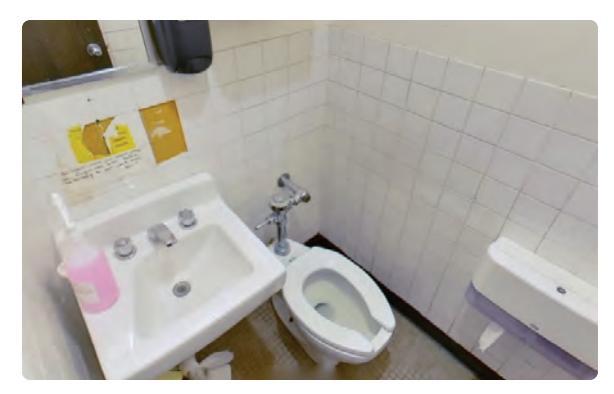
Non-ADA compliant men's room toilet

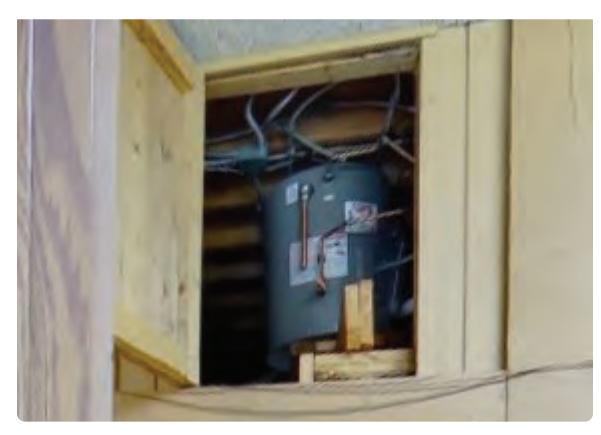
Rationale for Condition Rating: These water heaters work but have reached the end of their useful life, (with less than 5 years remaining).

Residential-grade domestic hot water heater serving Moosehead Saloon

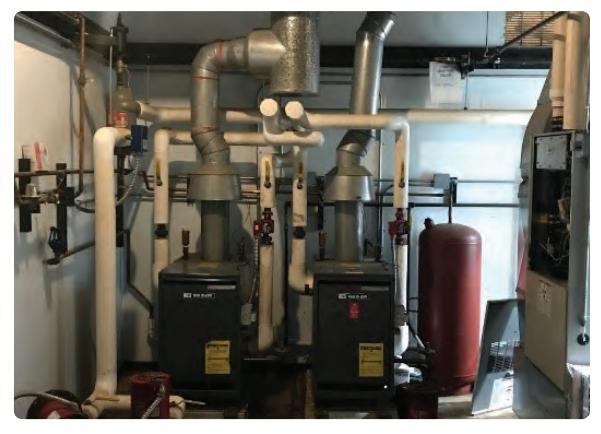
Rationale for Condition Rating: Age of system. Boiler still works but is nearing the end of its expected useful life. (Lifespan: less than 5 years remaining). System is inefficient and hard to maintain. Temperature control is poor. Does not incorporate heating of outside air that would be required in a remodel effort.

Residential-grade natural gas boilers

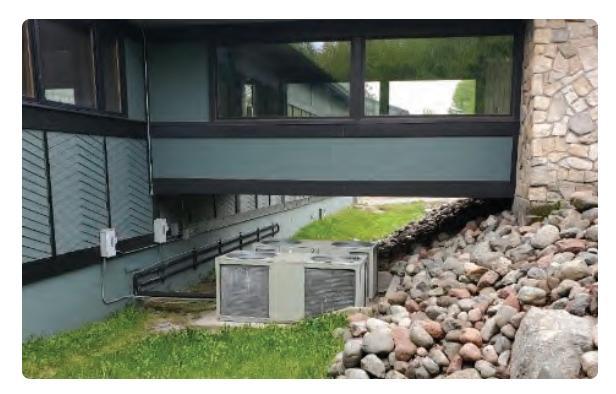
DX condensing units

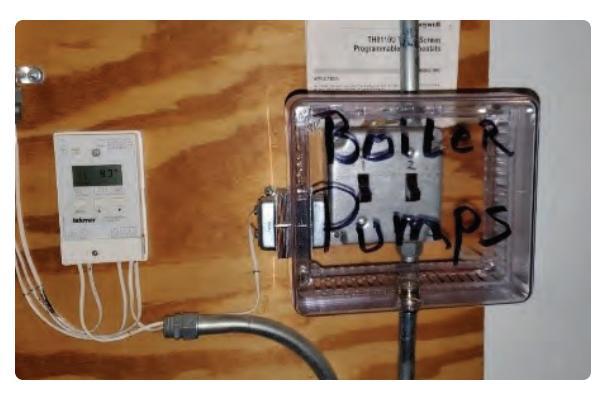
Boiler controls

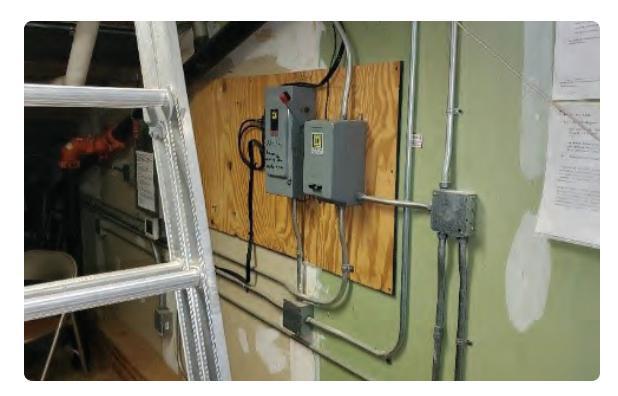
Air handler unit controls condensing units

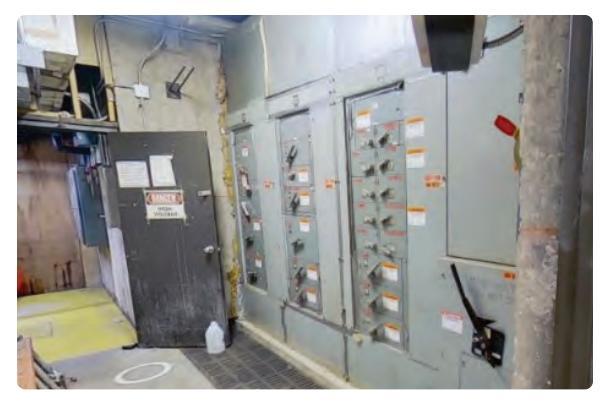
Rationale for Condition Rating: Age of system (lifespan: Approximately 45 years, useful lifespan of equipment is normally 30 years). There has been a few instances where breakers have not tripped and started fires in panel boards. This is most likely due to age of circuit breakers, where internal parts degrade over time/use.

Main switchboard in lower level of Moosehead Saloon

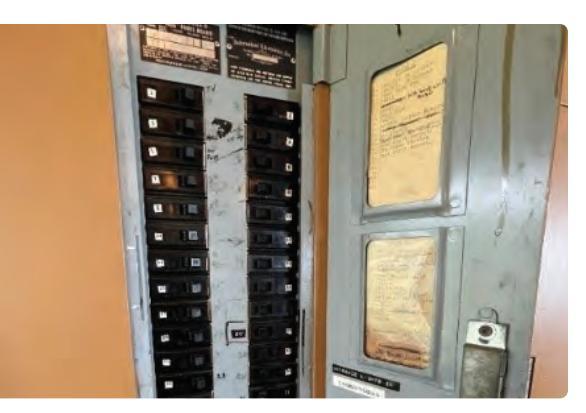
Typical vintage branch panels

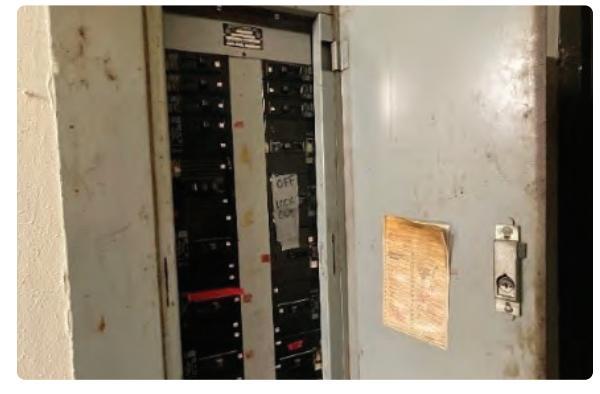
Typical vintage branch panels

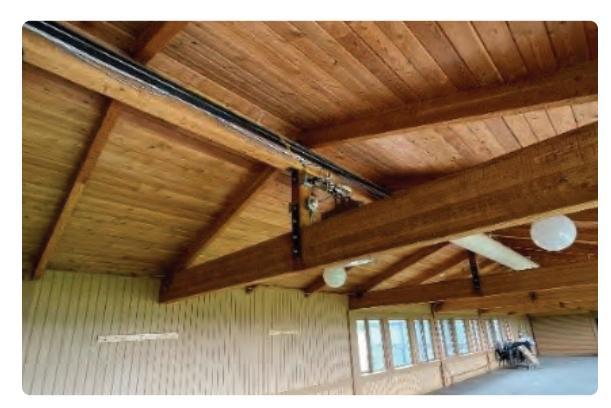
Communication cables can be seen throughout public areas strung along pipes and attached via zip-ties. Proper raceways and supports should be used, which also would create a more visually appealing aesthetic.

Exposed cabling at link

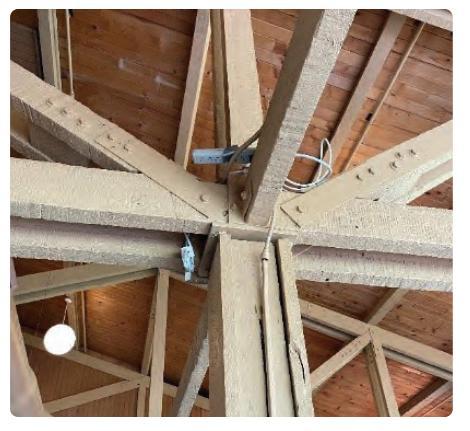
In a few instances the dimmable switches/dials are seen as broken or missing the dial. Additional receptacles are needed throughout building. Extension cords are used to supply power to areas that require additional receptacles. Extension cords, by code, are only to be used for temporary power and should be unplugged after use. Anytime extension cords are left plugged in over an extended period of time, they become a tripping hazard and internal degradation occurs.

Extension cord with power strip in trusses because of lack of power receptacles

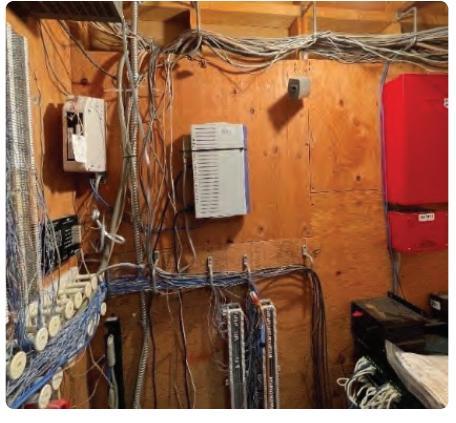
Telecom wiring is obsolete

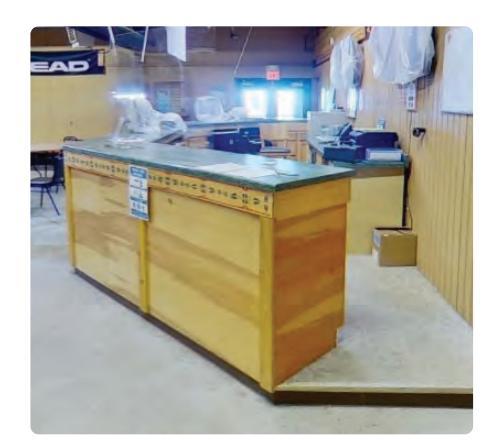
Rationale for Condition Rating: Age of equipment, showing wear consistent with age. Expected useful life of cabinets is 25 years. Service counters are in areas that are not ADA compliant.

Fixed casework at rental

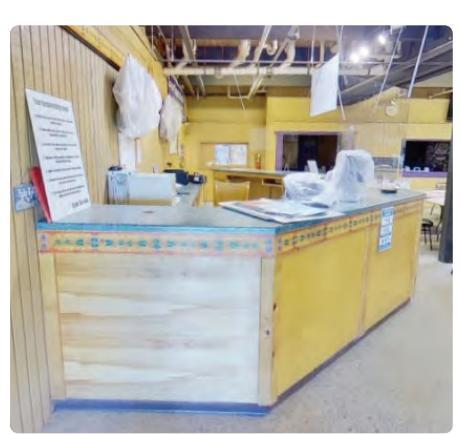
Fixed casework at rental

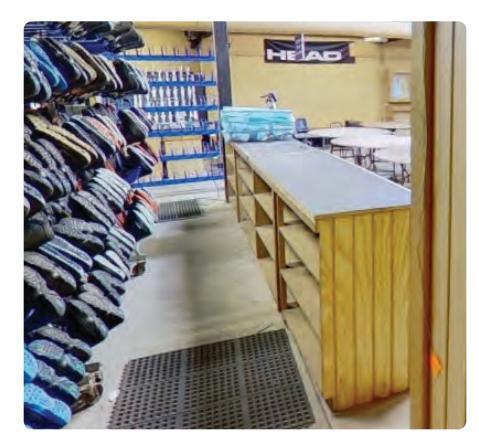
Fixed casework at rental

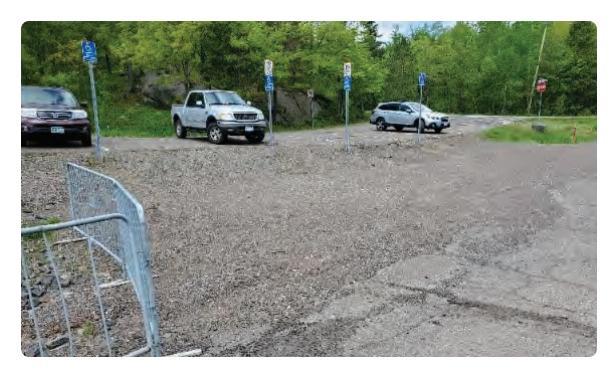
Rationale for Condition Rating: Slopes around the building are problematic and contribute to water infiltration to the building. The ADA parking area has drainage issues causing ice build-up in ADA walkways and parking areas. Most drainage grates are handmade, failing, and not based on any standards. Stormwater leaks into the sanitary system during spring thaw and causes backups into the building, which require yearly maintenance.

Ada parking – drainage – iced in winter

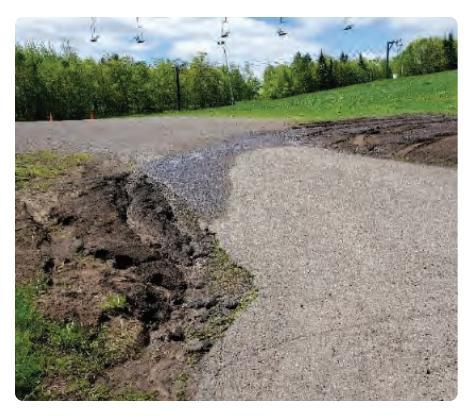
Gravel parking lot drainage & slopes

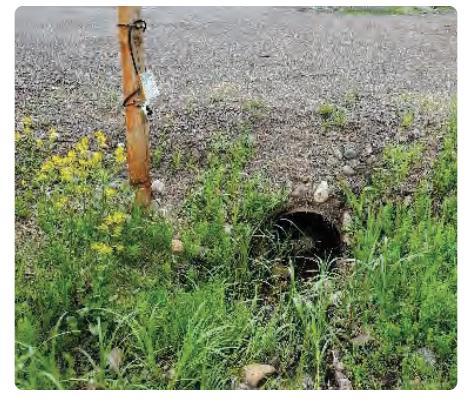
Extension cord with power strip in culvert causing back-ups

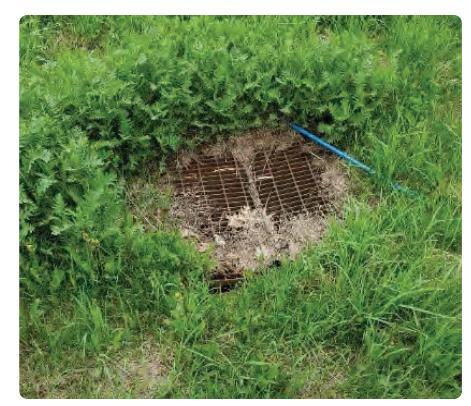
Catch basin

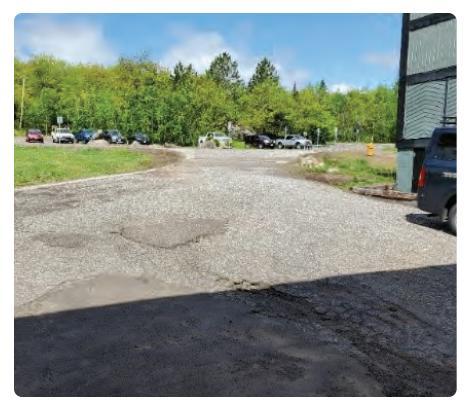
Negative drainage toward building

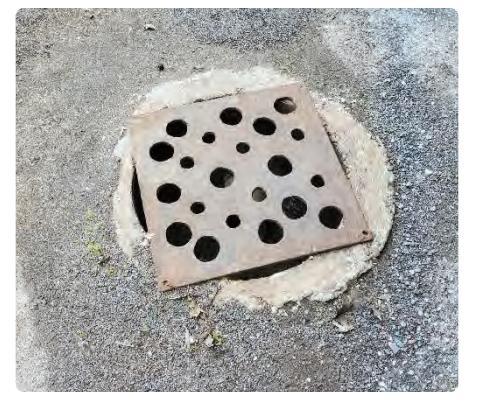
Catch basin in pavement

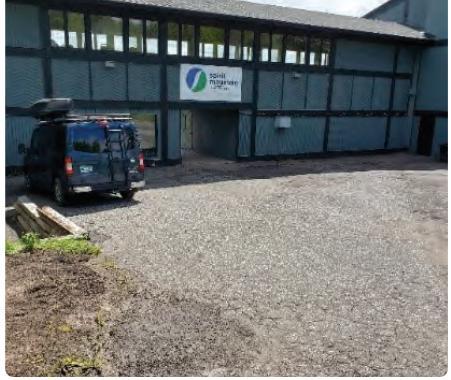
Drainage slope into bridge area
