ENVIRONMENTAL ASSESSMENT WORKSHEET

1. Project title: Pastoret Terrace Building Potential Demolition

2. Proposer: Duluth Economic Development Authority

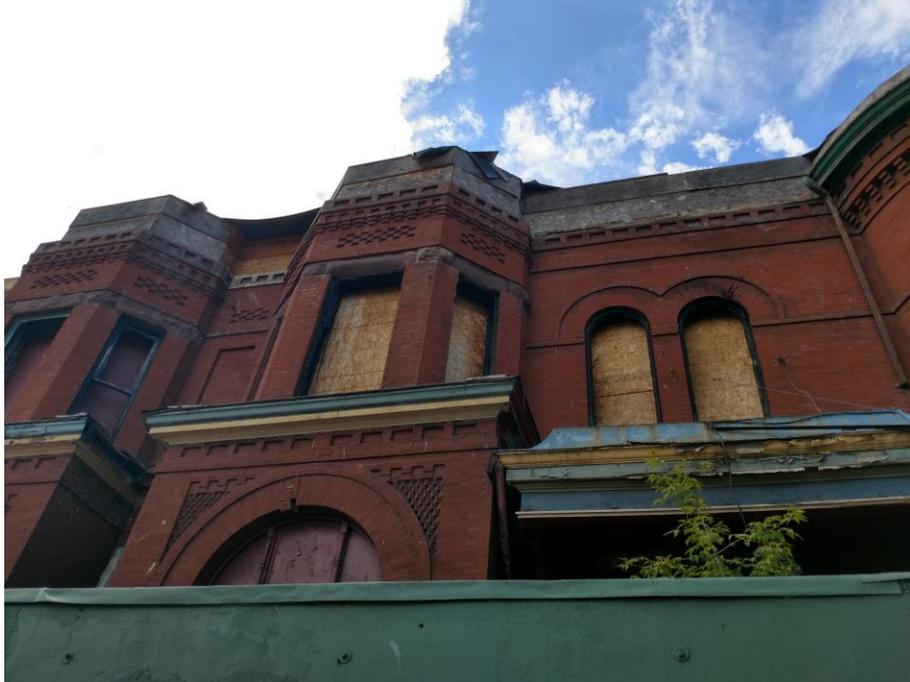
Exterior view from 2nd Ave East

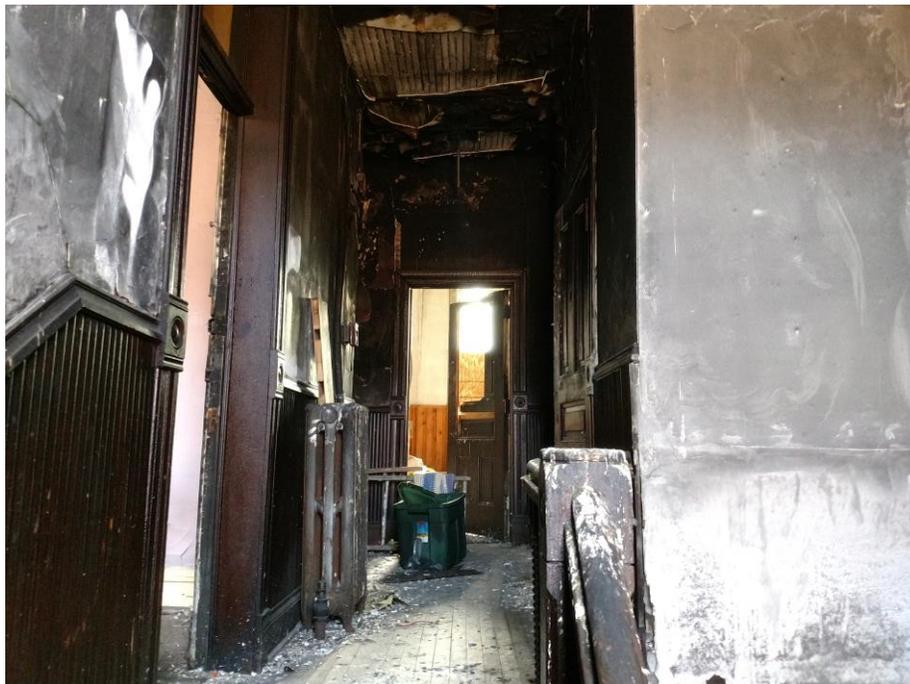
View of interior hallway

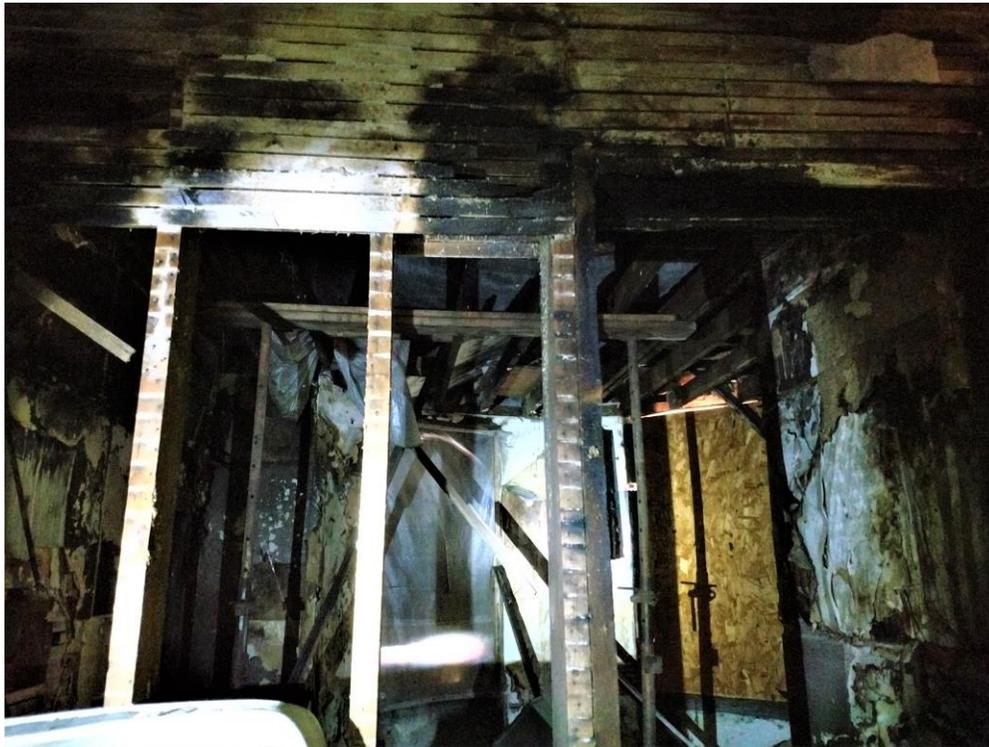
2nd floor- along 1st Street.

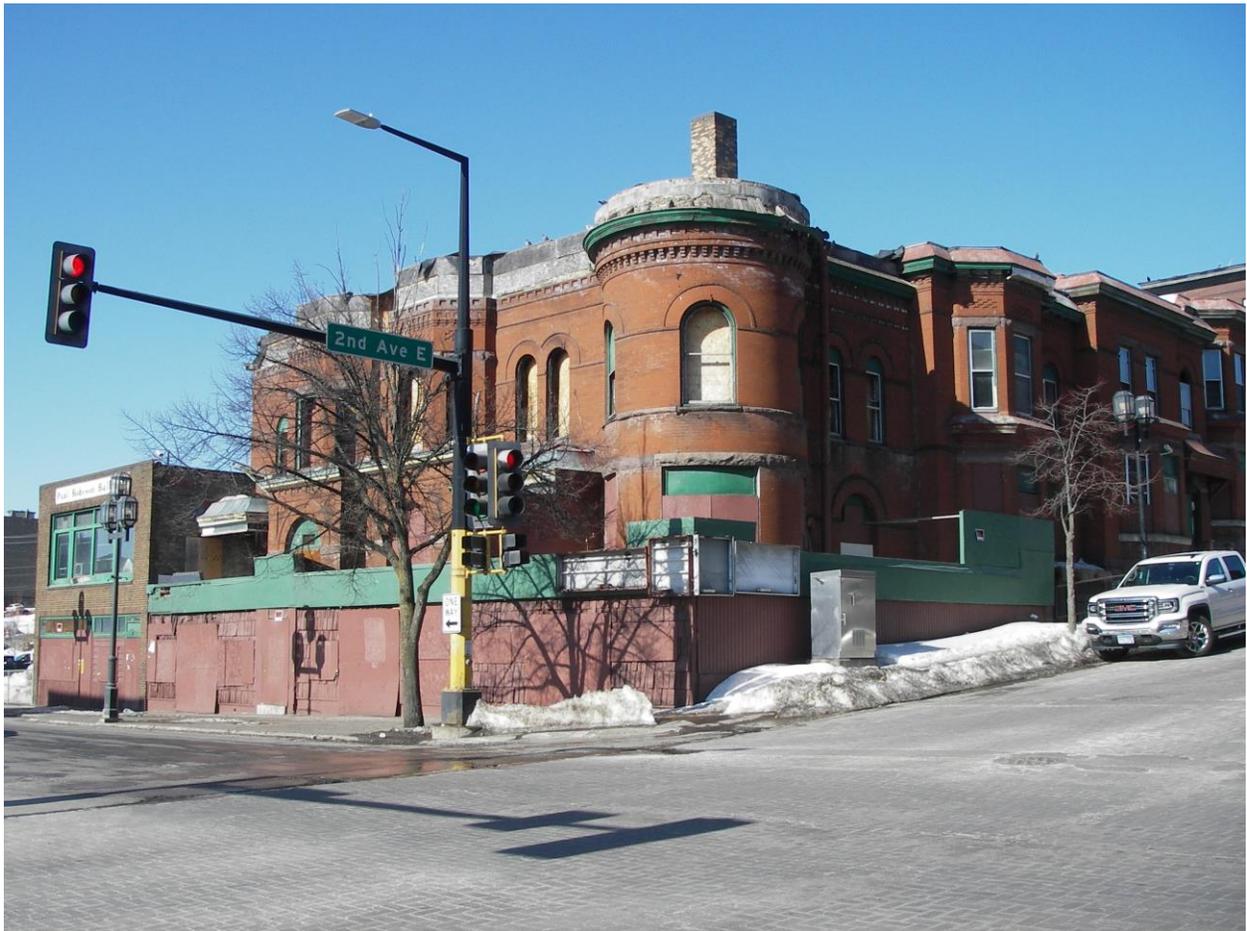
2018 Overview of the Pastoret Terrace Building.

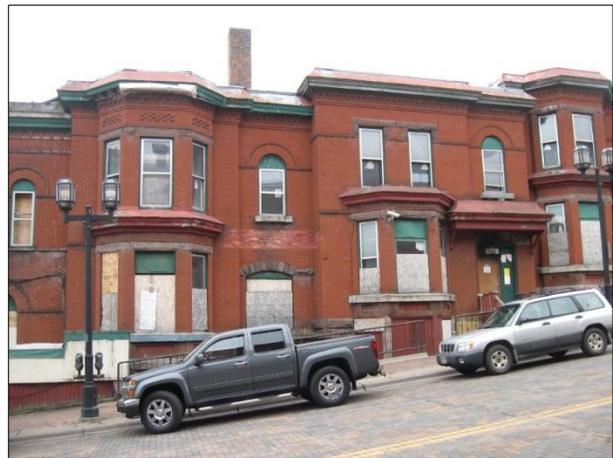
Figure 2 Middle of Avenue side. Note 10% sidewalk slope and stepped units.

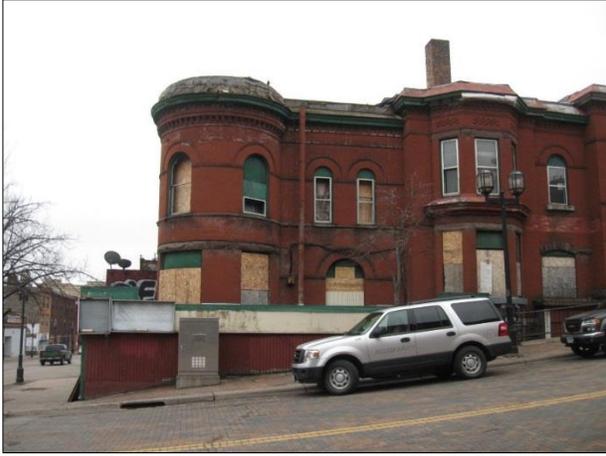
Figure 3 Avenue corner showing wrapping of Kozy bar addition

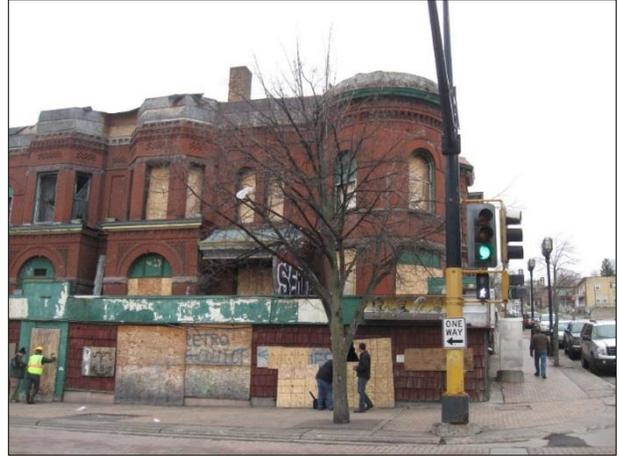
Figure 4 Street corner

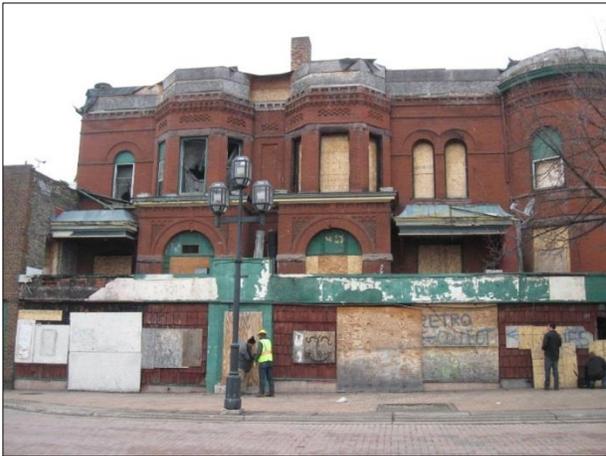
Figure 5 Westerly end of Street Façade, Pastoret Terrace

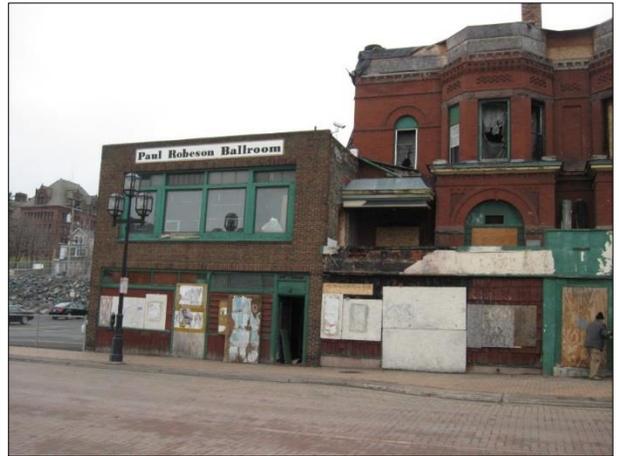
Figure 6 Western Façade at Street showing Ballroom building

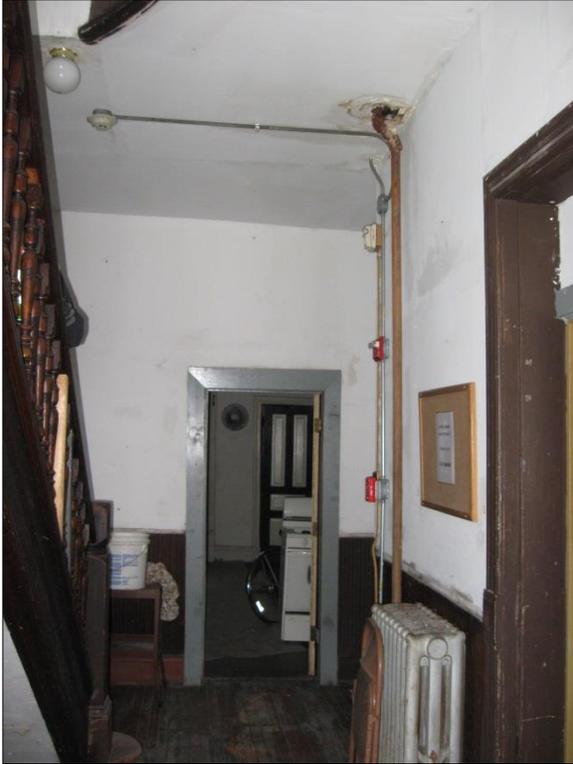
Figure 7 Interior of stair and corridor

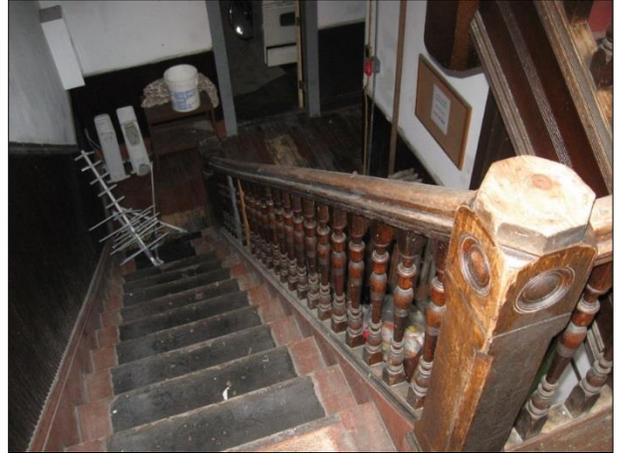
Figure 8 Example of interior wood stairs that can be retained serving second floor

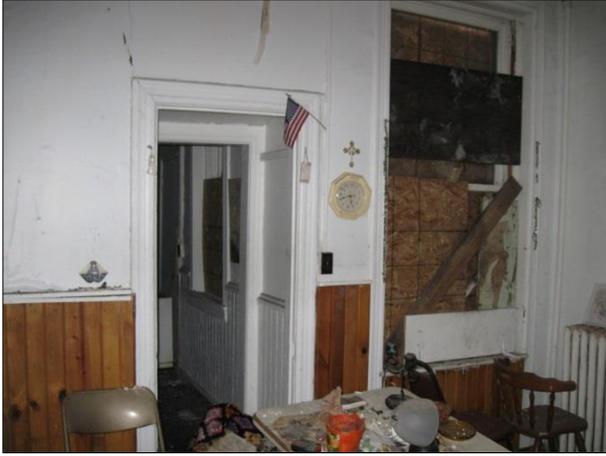
Figure 11 Typical unit interior

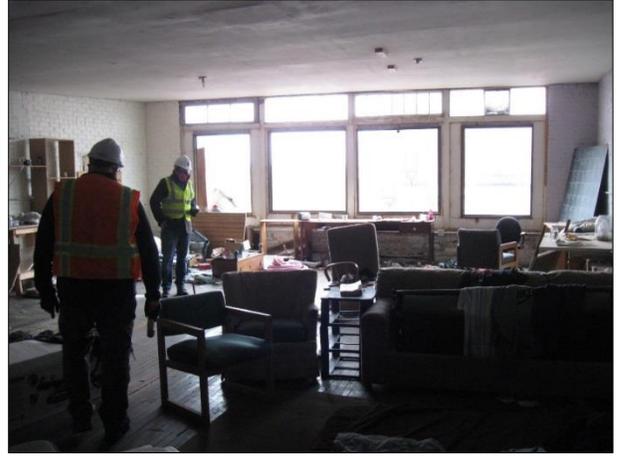
Figure 16 Second Level of Ballroom

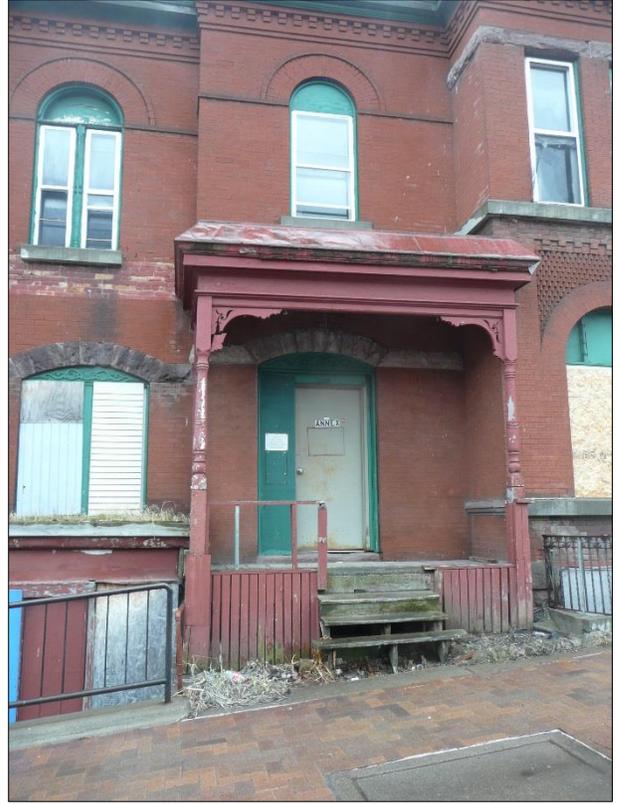
Figure 28 Typical entry porch Roof.

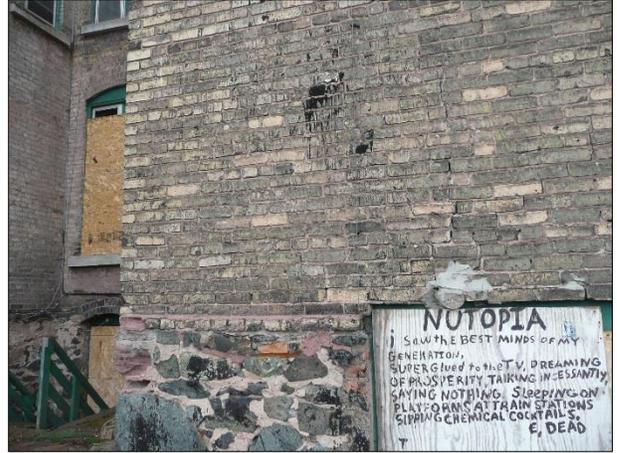
Figure 30 Brick on rear of Pastoret building needs to be tuck-pointed
